DOT HS 812 912

**Special Crash Investigations:  
On-Site Guardrail End Terminal  
Crash Investigation;  
Vehicle: 2002 Ford F-150;  
Location: Missouri;  
Crash Date: December 2017**

**Special Crash Investigations**  
**On-Site Guardrail End Treatment Investigation**  
**Case Number: IN17037**  
**Vehicle: 2002 Ford F-150**  
**Location: Missouri**  
**Crash Date: December 2017**

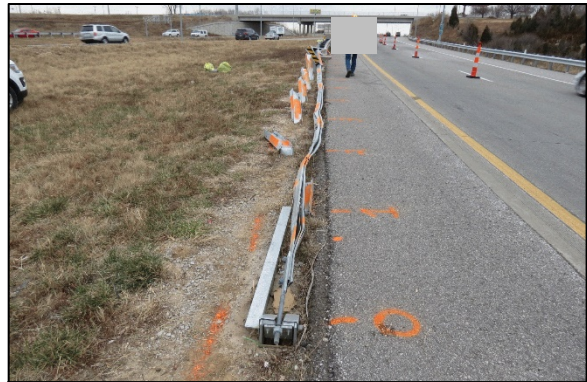
This report documents the on-site investigation of a Ford F-150's impact to a Soft Stop guardrail end treatment (**Figure 1**) that is of interest to the Federal Highway Administration (FHWA). This crash was identified by an engineer with the Missouri Department of Transportation, who submitted photographs of the vehicle and the damaged guardrail end treatment to the FHWA. The FHWA determined that the guardrail end treatment and crash type were of interest. This crash investigation was then initiated by the National Highway Traffic Safety Administration in December 2017 and assigned to the Special Crash Investigation team at the Indiana University Transportation Research Center. This single-vehicle crash involved a 2002 Ford F-150 Supercrew pickup truck (**Figure 2**). The crash occurred in Missouri in December 2017 during the early evening and was investigated by a local police agency. The guardrail and crash scene were inspected in December 2017. An in-person interview was conducted with the driver in December 2017.

**Figure 1.** The damaged guardrail, view north.

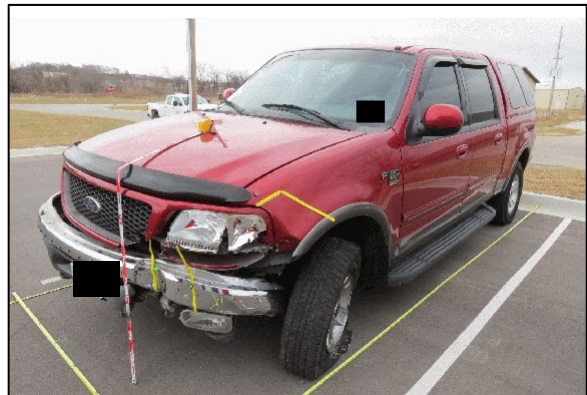
**Figure 2.** The damaged 2002 Ford F-150.

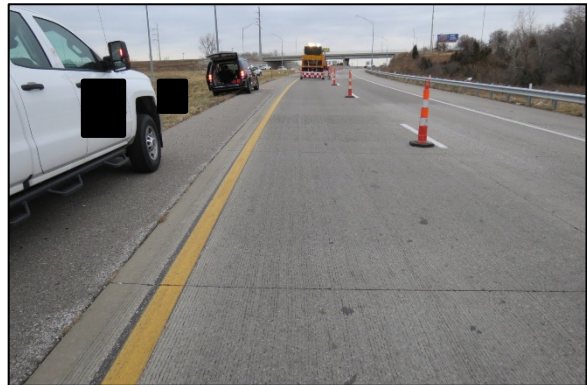
The Ford was traveling north in the left lane of the ramp (**Figure 3**) at a driver-reported speed of 97 km/h (60 mph) and the driver intended to negotiate the right curve and merge onto the northbound interstate. According to the driver, another vehicle in the right lane encroached into his lane and he steered left to a crash. The Ford then departed the west roadside.

**Figure 3.** Northwest view of the Ford's approach to guardrail head impact.

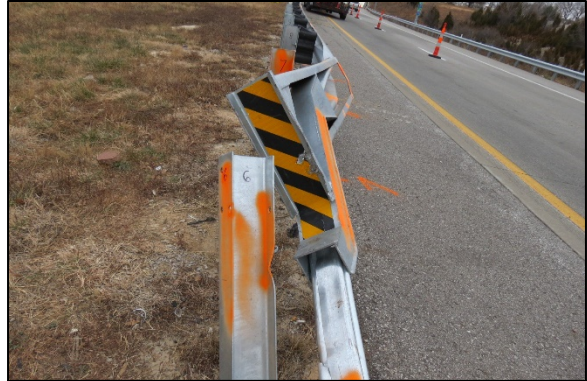
The front plane of the Ford struck the end terminal (**Figure 4**), which was mounted on top of an angular guide chute. The end of one 3.8 m (12.5 ft) long section of guardrail was routed through the guide chute and attached by a bolt to the ground anchor (Post 0, **Figure 5**). During a terminal impact, these guardrail sections are designed to enter the upstream end of the terminal and pass through the chute, which is angled downward and rearward. The rail is extruded underneath the vehicle, dissipating crash energy. During this crash, 10.5 m (34.5 ft) of guardrail was extruded through the chute onto the ground extending from the ground anchor to the end terminal. A total of 14.2 m (46.7 ft) of guardrail was damaged.

The end terminal was 18 cm (7.1 in) wide and 51 cm (20.1 in) high and sustained minor damage. Posts 1 and 2 collapsed downstream to the ground and detached from the damaged guardrail. Posts 3, 4, 5, and 6 were all bent downstream and were detached from the damaged guardrail. Post 7 was detached from the guardrail and slightly displaced in the ground. Posts 8 to 12 were not damaged and remained attached to the guardrail. Composite offset blocks were installed on all posts, except post 1. The offset blocks on posts 2 to 7 became detached as a result of the crash. The offset blocks for posts 8 to 12 were still firmly attached and were undamaged. There were no kinks to any of the guardrail sections. The FHWA guardrail form is attached to the end of this report as **Appendix A**.

**Figure 4.** The damaged Soft Stop end terminal, view north.

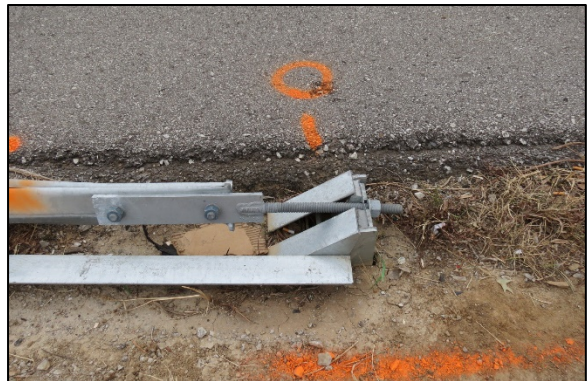
**Figure 5.** Post zero with anchoring bolt intact.

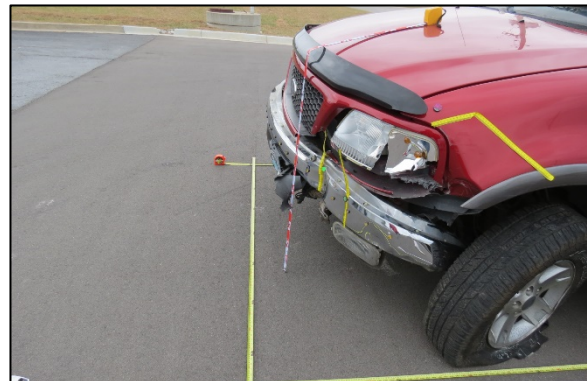
The Ford sustained direct damage to the left corner of the front bumper during the impact with the delineator post (**Figure 6**). The direct damage included the left head/turn signal assembly, left fender, and left front wheel well guard. Direct damage began at the left front bumper corner and the damage width was 12 cm (4.7 in). A crush profile could not be obtained since there was overlapping damage from the end terminal impact.

**Figure 6.** Front and left side damage from contact with delineator post.

The collision deformation classification (CDC) was 12FLEE2 (0 degrees). The severity of the damage was minor.

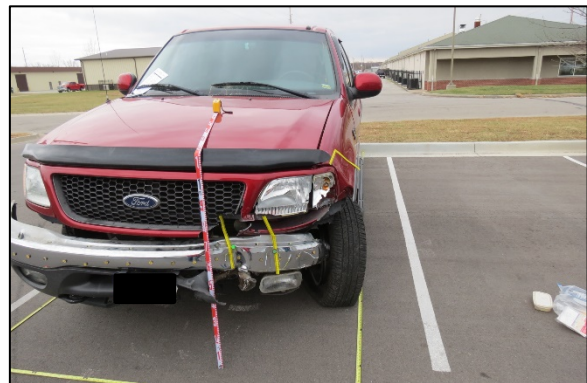
The Ford sustained direct damage to the front plane during the impact with the end terminal. The front bumper, grille, and left headlamp/turn signal assembly were directly damaged (**Figure 7**). The direct damage width from the end terminal impact to the bumper began 37 cm (14.6 in) left of the vehicle's centerline and extended 17 cm (6.7 in) to the left on the bumper. The total width of the direct damage, which included damage above the bumper as the guardrail deformed, was 46 cm (18.1 in). The Field L was 168 cm (66.1 in). Crush measurements were taken at the bumper level and the maximum crush was 18 cm (7.1 in), occurring 85 cm (33.5 in) left of the vehicle's centerline. The crush values were  $C_1 = 18$  cm, (17.1 in),  $C_2 = 6$  cm (2.4 in),  $C_3 = 0$  cm,  $C_4 = 0$  cm,  $C_5 = 0$  cm, and  $C_6 = 0$  cm. The WinSMASH program could not be used to calculate delta V since an impact with a yielding object is out of scope for the program. However, the

**Figure 7.** Damage from guardrail impact.

barrier algorithm of WinSMASH was used to calculate a Barrier Equivalent Speed (BES) based on the crush to the front plane. The calculated BES was 14 km/h (9 mph).

The CDC was 12FLEW1 (0 degree). The severity of the damage was minor.
