DOT HS 812 915

**Special Crash Investigations
On-Site Rear Impact Crash and
Fire Investigation
Vehicle: 2007 Jeep Liberty
Location: Ohio
Date: August 2017**

**Special Crash Investigations
On-Site Rear Impact Crash and Fire Investigation
Office of Defects Investigation
Case Number: CR17025
Vehicle: 2007 Jeep Liberty
Location: Ohio
Crash Date: August 2017**

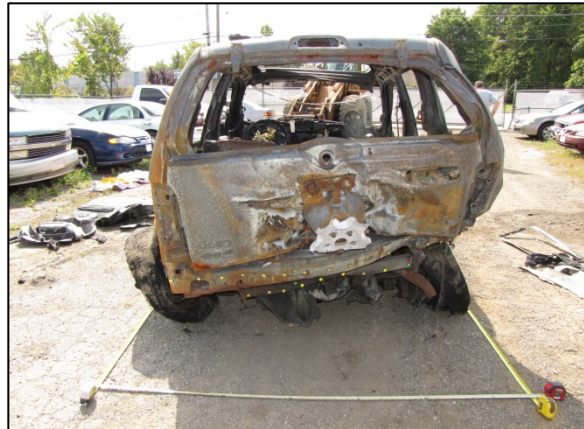
The report documents the on-site investigation of the rear impact and post-crash fire in a 2007 Jeep Liberty (**Figure 1**) that was struck on the back plane by a 2003 Buick Century. The Jeep was driven by a 58-year-old female who sustained fatal injuries related to the fire. The Jeep Liberty in model years 2002 to 2007 was under recall for the potential of a post-collision fire after a rear impact (NHTSA Campaign Number 13V252000). The remedy to the recall was the installation of an OEM rear trailer hitch. A query of the NHTSA website www.nhtsa.gov in September 2017 with the Jeep's Vehicle Identification Number (VIN) determined that there were no open recalls on the Jeep at the time of the crash. A vehicle history report indicated that in December 2014 the recall had been addressed by a vehicle maintenance inspection and the trailer hitch installation.

Figure 1. Back view of the Jeep Liberty depicting its deformation and fire damage.

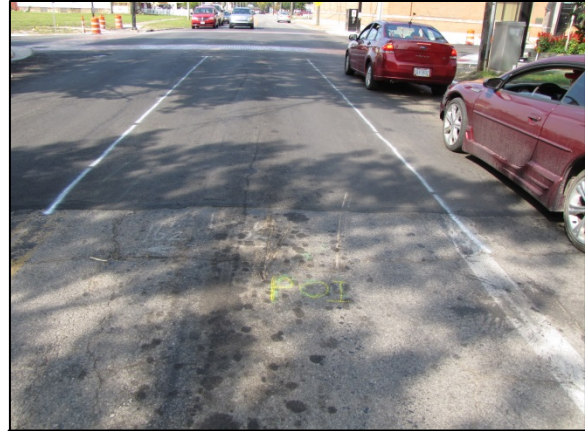
Figure 3. North-facing view of the POI.

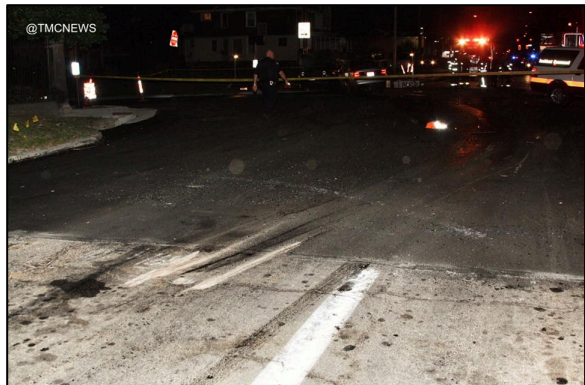
Figure 4. Northwest-facing image depicting the point of impact and the crash scene. Image supplied by an Internet news source.

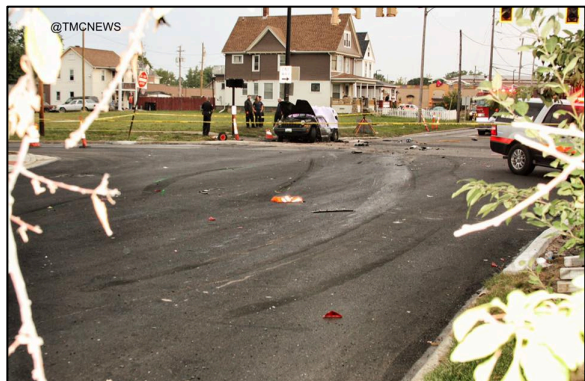
Figure 5. Northwest-facing image depicting the yaw trajectory to final rest. Image supplied by an Internet news source. Image was taken after the removal of the Buick.

Two counterclockwise-arcing tire marks attributed to the forced movement of the Jeep were observed during the SCI scene inspection. A tire mark 7.4 m (24.3 ft) in length was located in the left northbound lane and was attributed to the Jeep's left front tire. The second tire mark was located in the intersection and measured 3.7 m (12.1 ft) in length. This mark was attributed to the left rear tire of the Jeep after it had separated from the Buick.

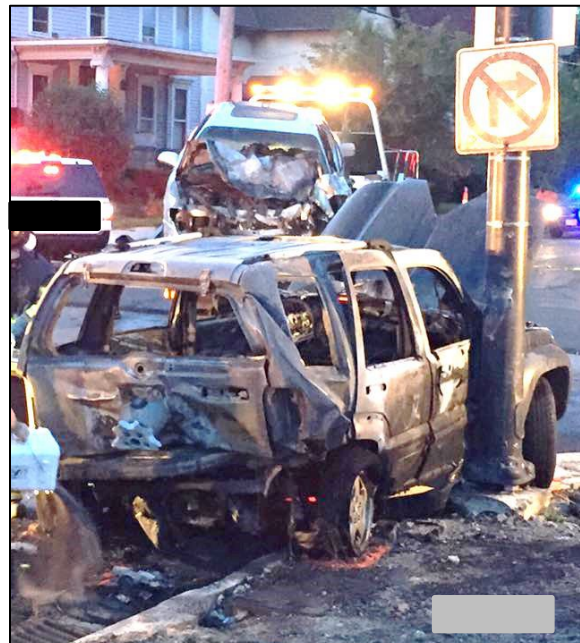
The fire consumed the aft two-thirds of the Jeep and was spreading to the Buick at the arrival of the first responders. The flames were too intense for the first responders to approach the Jeep and

Figure 6. Southeast-facing view depicting the final rest position of the Jeep. Image supplied by an Internet news source.

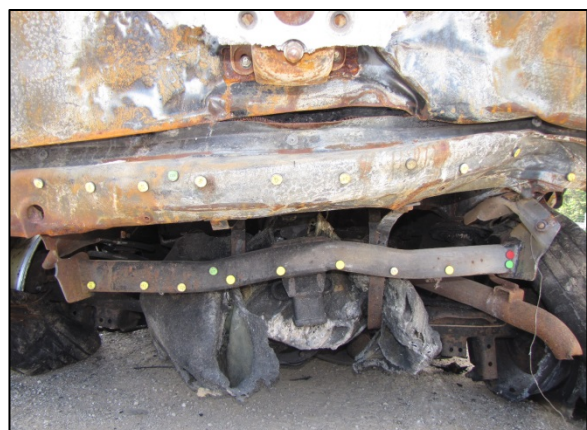
Figure 8. Forward-looking view of the Jeep's deformed trailer hitch.

III trailer hitch. The hitch was displaced forward and rotated downward 90 degrees, evidenced by the vertical position of the 5 cm (2 in) receiver sleeve (**Figure 8**). It should be noted that the hitch did not contain a ball-mount at the time of the inspection. The left frame attachment bracket of the hitch tore and deformed over a 6 cm (2.5 in) length. The aft attachment bolt at the right frame attachment bracket pulled through the frame and deformed (**Figure 9**). Consequently, the trailer hitch compressed the HDPE fuel tank against the rear differential and axle tubes. The HDPE fuel tank ruptured from a probable over-pressurization of fuel, causing an immediate fuel leakage and subsequent fire (Event 2).

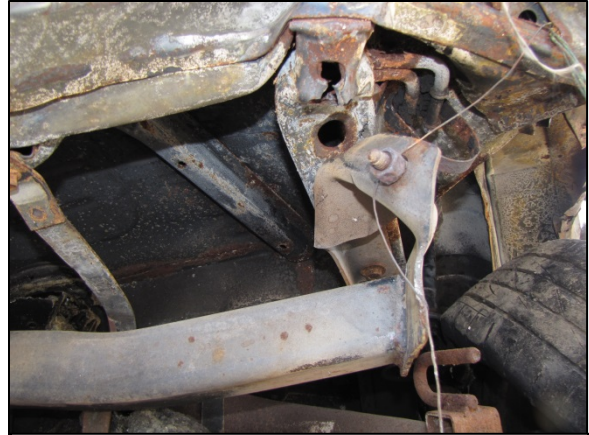
Figure 9. Forward-looking view of the right aspect of the Jeep's trailer hitch and the deformed right frame attachment bracket.

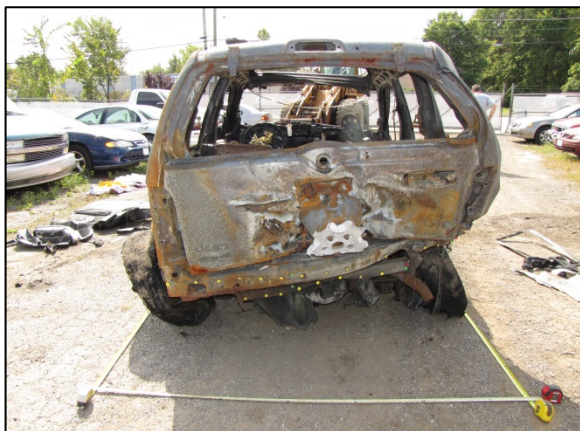
Figures 10 and 11 are the back and right lateral views of the Jeep depicting the deformation of the back structure. The direct contact damage was documented at the level of the bumper beam as the polymer bumper fascia was completely consumed by the ensuing fire. The direct contact damage began 19 cm (7.4 in) left of the vehicle's centerline and extended 98 cm (38.4 in) to the right corner. The combined direct and induced damage was 154 cm (60.5 in) and extended the full width of the bumper beam. The crush profile documented at the level of the bumper beam less freespace was as follows: C1 = 0, C2 = 15 cm (5.9), C3 = 20 cm (7.9 in), C4 = 24 cm (9.4 in), C5 = 31 cm (12.2 in), and C6 = 40 cm (15.7 in). Maximum crush was located at the right end of the bumper beam. The right wheelbase was reduced 22 cm (8.5 in) with collapse of the right rear wheelhouse. The Collision Deformation Classification (CDC) representative of this damage pattern was 06BZEW3. The delta V calculated by the WinSMASH Damage Algorithm was 51 km/h (32 mph) with longitudinal and lateral components of -51 km/h (-32 mph) and -0, respectively.

Figure 10. Back view of the Jeep depicting the deformation.

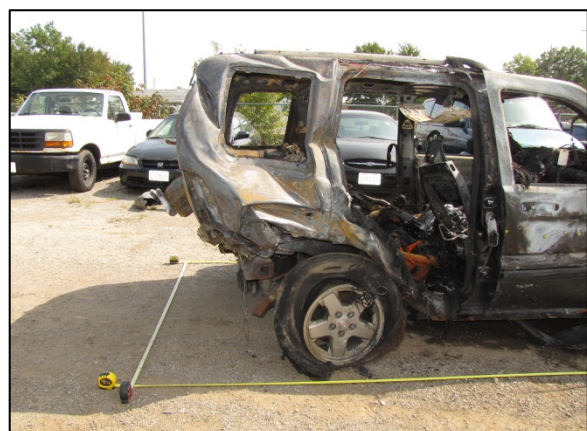
Figure 11. Right lateral view of the Jeep at its back plane.

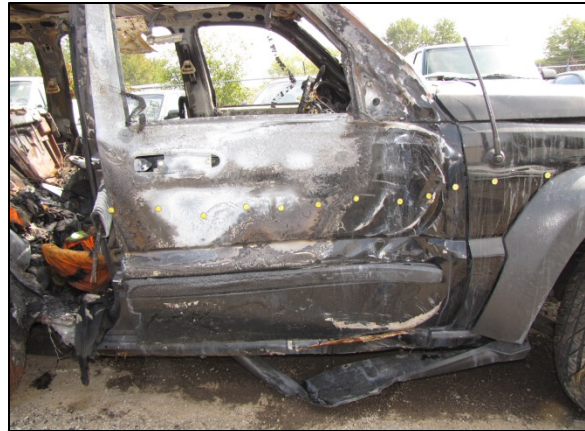
The right plane of the Jeep (**Figure 12**) sustained impact damage consistent with the impact to the traffic light support located at the northwest quadrant of the intersection (Event 3). The direct contact damage began 5 cm (2 in) forward of the leading edge of the right front door [64 cm (25.0 in) aft of the right front axle]. The direct damage extended 41 cm (16.0 in) rearward. Vertically, the pole contact damage extended 33 cm (13.0 in) above the beltline onto the upper right A-pillar. The combined direct and induced damage length for the Event 3 crash event was 100 cm (39.5 in), extending the full length of the right front door. The crush profile was documented along the mid-door and was as follows: C1 = 1 cm (0.4 in), C2 = 4 cm (1.6 in), C3 = 7 cm (2.8 in), C4 = 10 cm (3.9 in), C5 = 9 cm (3.5 in), and C6 = 2 cm (0.8 in). The WinSMASH delta V calculated by the barrier algorithm was 10 km/h (6 mph) with longitudinal and lateral components of -5 km/h (-3 mph) and -9 km/h (-5 mph), respectively. The CDC for this event was 02RPAW2.

Figure 12. Right view depicting the Jeep's pole impact damage.

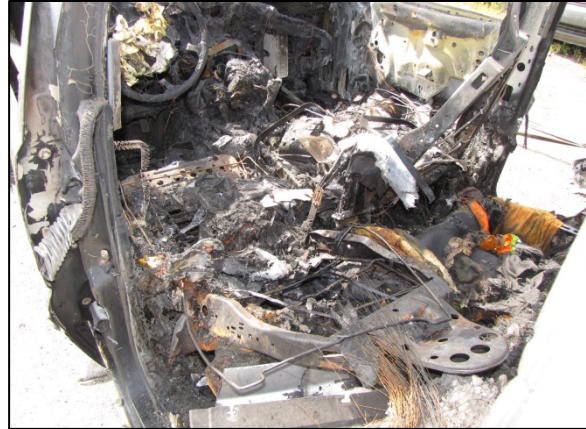
The interior of the Jeep (**Figure 13**) was completely destroyed by the fire. All combustible materials were consumed, with only the steel framework of the seats and instrument panel remaining. The driver's seat back was deflected rearward onto the seat frame of the second-row

Figure 13. Interior view of the Jeep at the second row left looking forward.

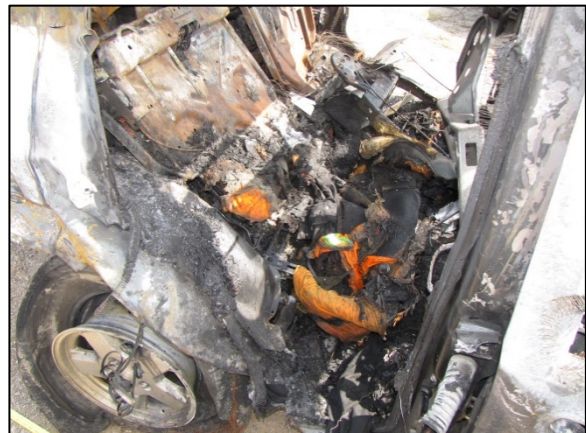
The second-row interior of the Jeep was reduced in size by intrusion of the second-row seat resulting from structural deformation to the back plane (**Figure 14**). The seat bight was displaced forward and was used to document the extent of occupant compartment intrusion. The intrusions at the second-row seat bight were 9 cm (3.5 in) at the left position, 17 cm (6.5 in) at the second-row center position and 22 cm (8.5 in) at the second-row right position.

Figure 14. Right interior view depicting the second-row intrusion of the Jeep.

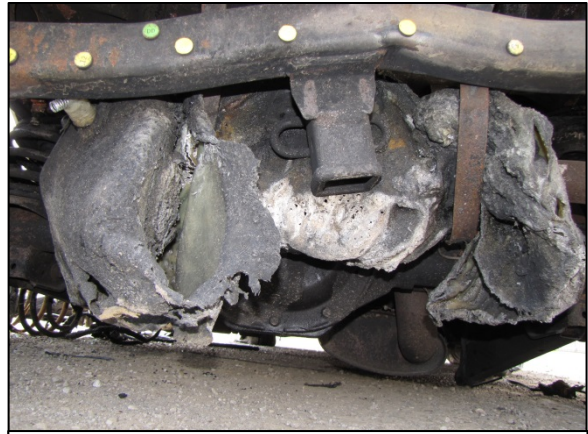
The compression and deformation of the Jeep's rear structure compressed the fuel tank forward against the rear axle and differential. The high-density polyethylene (HDPE) fuel tank deformed and ruptured. Fuel vapors ignited after the impact (Event 2) and were subsequently fueled by the leakage.

Figure 16. Rear of the ruptured, deformed, and melted fuel tank of the Jeep.

Based on an exemplar vehicle inspection, the HDPE fuel tank was positioned 20 cm (8 in) forward of the back plane bumper beam at the midline location and 6 cm (2.5 in) aft of the rear differential cover. Post-crash, remnants of the melted HDPE fuel tank (**Figure 16**) were resting on the tank straps that remained intact but deformed by the impact.

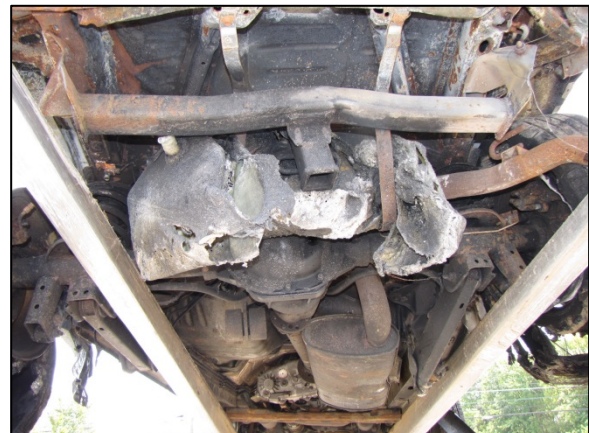
Symmetrically formed mounting brackets were welded to both ends of the square tubing and bolted to the rear frame rails with three 12 mm diameter bolts. The two aft bolts were spaced on 13 cm (5 in) centers while the center and forward bolts were on 18 cm (7.25 in) spacing. The mounting brackets were formed from 4.7 mm (3/16 in) plate steel and measured 37 cm (14.75 in) in overall length along the frame rails and were 18 cm (7 in) in height at the location of the square tube. The 38 cm (15 in) center section of the square tubing was straight. Both ends were formed forward 4 cm (1.5 in) with the bend beginning 19 cm (7.5 in) from the centerline. At the mid portion of the trailer hitch, the square tubing was 8 cm (3 in) aft of the HDPE fuel tank while the gap between the tank and the corners of the hitch measured 4 cm (1.5 in).

Figure 17. Undercarriage view of the Jeep's deformed trailer hitch and melted fuel tank.

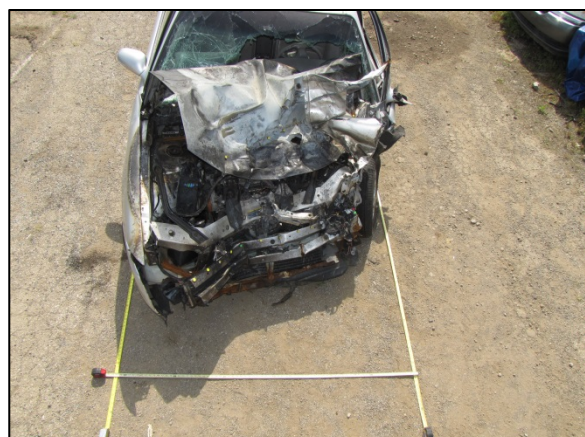
The Buick sustained underride damage, biased to the left of the front plane from the Event 1 impact with the Jeep (**Figures 20 and 21**). As the Buick engaged the back plane of the Jeep, the hood face of the Buick contacted the Jeep’s lift gate-mounted spare tire, compressing the tire and wheel into the lift gate. The direct contact damage of the hood face began 39 cm (15.5 in) right of the centerline and extended 104 cm (41 in) to the left corner of the hood face. As a result, the hood latch striker plate separated from the underside of the hood, allowing the hood to crush rearward. The upper radiator support also engaged the back plane of the Jeep. As the hood

Figure 20. Overhead view depicting the front deformation of the Buick.

was displaced rearward, it buckled at midpoint and struck and penetrated the center and left aspects of the Buick's windshield.

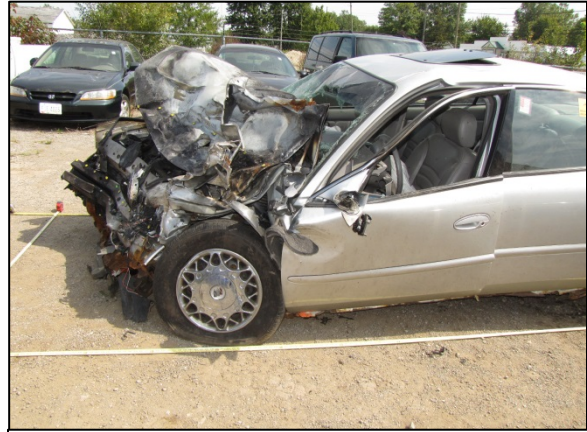
The front bumper fascia was consumed by the fire; therefore, the direct contact damage was documented at the levels of the bumper beam and the hood face. At bumper level, the direct contact began 19 cm (7.5 in) right of the vehicle's centerline and extended 95 cm (37.5 in) to the left corner. Maximum crush at bumper beam level was 81 cm (31.9 in) located at the left corner. The severity of crush deformed the entire end width of the Buick, resulting in a combined direct and induced damage length 116 cm (45.8 in) at bumper level. A crush profile was documented by the Nikon total station and was as follows: C1 = 81 cm (31.9 in), C2 = 79 cm (31.1 in), C3 = 71 cm (28 in), C4 = 65 cm (25.6 in), C5 = 50 cm (19.7 in), and C6 = 19 cm (7.4 in). The left wheelbase was shortened 27 cm (10.6 in) restricting the left front tire. The CDC assigned to the damage pattern was 12FDEW4. The damage algorithm of the WinSMASH model computed a velocity change of 64 km/h (40 mph) with longitudinal and lateral components of -64 km/h (-40 mph) and 0 km/h, respectively.

Figure 21. Right lateral view of the Buick.
