DOT HS 812 935

# **Special Crash Investigations: On-Site Air Bag Non-Deployment Crash Investigation; Vehicle: 2014 Audi Q5; Location: New York; Crash Date: April 2018**

**Special Crash Investigations  
On-Site Air Bag Non-Deployment Crash Investigation  
Case Number: CR18015  
Office of Defects Investigation  
Vehicle: 2014 Audi Q5  
Location: New York  
Crash Date: April 2018**

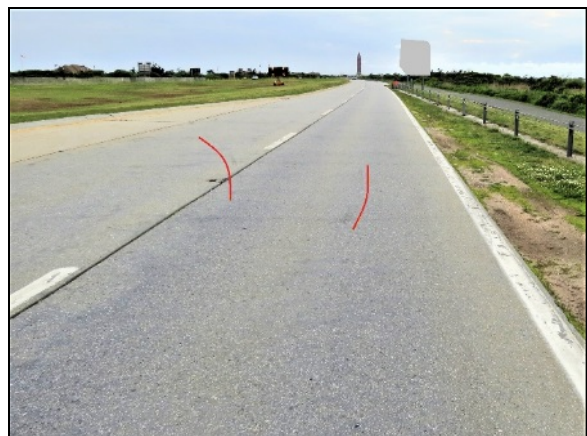
**Figure 5.** West-facing view of the Audi's tire marks, highlighted by red lines.

Lateral drag forces on the Audi's right side tires created an instability with respect to its center of mass, which tripped the Audi into a right-side-leading rollover when it achieved approximately 90 degrees of counterclockwise rotation. The vehicle rolled eight-quarter turns (two complete revolutions) over a distance of approximately 18 m (59.0 ft) from the roadway into the open grass median. According to law enforcement documentation, at final rest the Audi was centered approximately 7.6 m (25.0 ft) south of the road edge in the median.

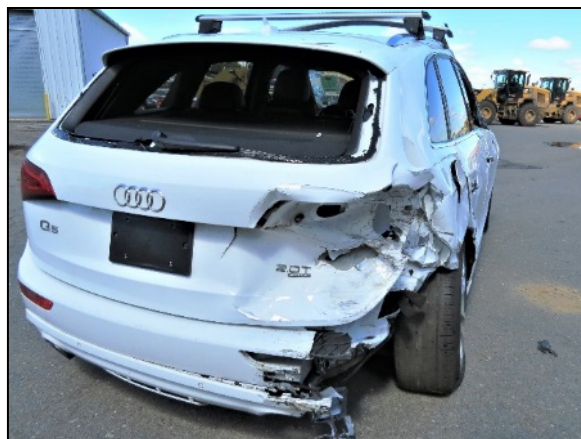
Direct contact began 30 cm (11.8 in) right of center on the tailgate/hatch, and 41 cm (16.1 in) right of center on the bumper. There was a 12 cm (4.7 in) wide black transfer from tire contact by the Acura’s left front tire on the right end of the Audi’s back bumper. Direct contact width on the bumper beam measured only 15 cm (5.9 in) wide, centered 48 cm (18.9 in) right of center (Direct-D). A residual crush profile documented using a Field-L width across the entire 112 cm (44.1 in) back bumper beam of the Audi produced the following resultant measurements: C1 – C4 = 0 cm (0 in), C5 = 1 cm (0.4 in), and C6 = 2 cm (0.8 in). Maximum crush in the profile was observed to the right bumper corner. However, the greatest deformation was observed above the bumper beam to the right rear corner of the vehicle,

**Figure 7.** View of the Audi’s Event 1 damage pattern from impact by the Acura.

in the area of the right taillight (**Figure 7**). The right-rear quarter panel was deformed forward, exposing the rear aspect of the right-rear axle position. The right wheelbase was reduced by at least 3 cm (1.2 in). Based on the observed damage to the Audi, the Collision Deformation Classification (CDC) assigned for the Event 1 impact was 06BREE3. **Figure 8** shows the damage profile to the back of the Audi.

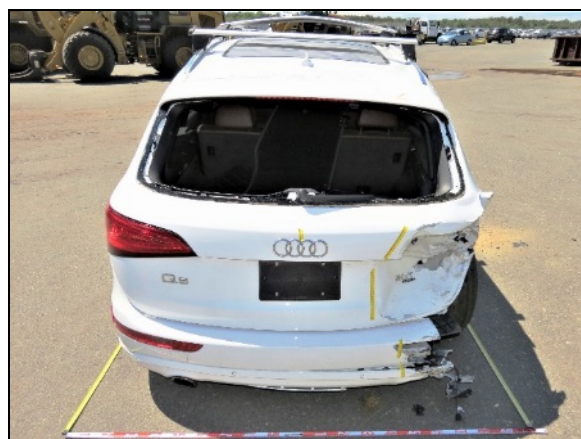
**Figure 8.** Back-plane view of the Audi’s damage profile as documented during the SCI vehicle inspection.

The damage algorithm of the WinSMASH model was used to calculate a vehicle velocity change (delta V) reconstruction of the crash. The calculated total delta V of the Audi for the Event 1 impact with the Acura was 12 km/h (7 mph). Longitudinal and lateral components of the calculated delta V were 12 km/h (7 mph) and 0 km/h (0 mph), respectively. These results were underestimated, due to the narrow overlap of the impact and minor bumper-level crush.

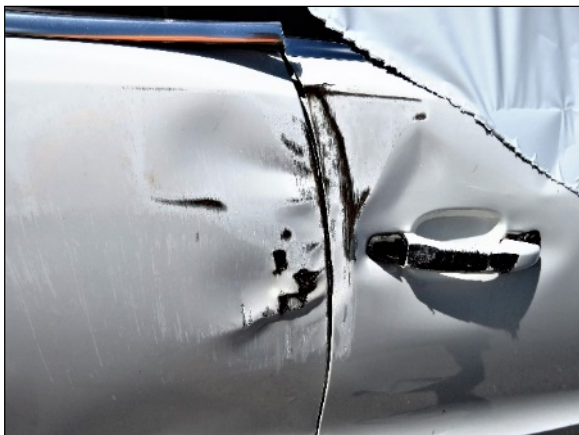
Rollover damage was visible to the right, top, and left planes of the Audi. On the right plane, a distinct pattern of vertically oriented abrasions were observed along the right front fender, right upper A-pillar, right roof side rail, and outermost protrusions of the right doors and right rear quarter panel. The abrasions continued from the right roof side rail and onto the top, with a slight directional shift toward the left rear. The roof was clean across the center aspect, and the roof rack bars were deformed inward with direct contact on both outer surfaces/edges.

**Figure 9.** Close-up of the vertically oriented abrasions to the right doors of the Audi from the rollover.

continuous rollover event that initiated right-side-leading and continued while the vehicle rotated counterclockwise. That is, the Audi completed eight total quarter-turns about its longitudinal axis while it maintained counterclockwise about its vertical axis and rotated an additional 90 degrees. In this manner, the Audi tripped right-side-leading while facing south, and came to final rest on its wheels facing east. **Figure 9** shows a close-up of the vertical abrasions on the right plane, while **Figure 10** shows a close-up of the diagonal abrasions on the left plane. The CDC assigned

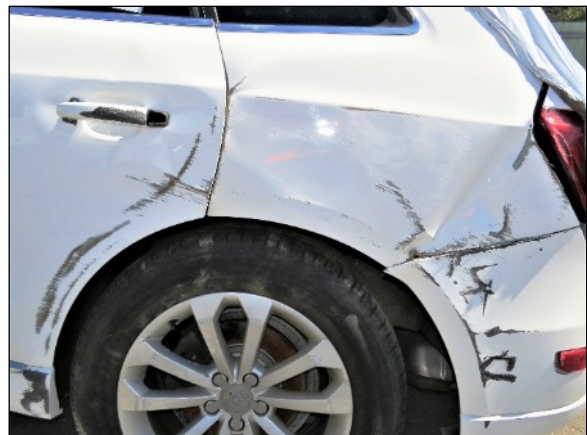
A diagonal pattern of abrasions was observed to the left plane, with an orientation from front/top toward back/bottom. The pattern was most prevalent along the roof side rail at the upper A-pillar/windshield header junction, on the left front fender, and below the beltline on the left rear quarter panel. Combined, the abrasion patterns on the right, top, and left planes exhibited a

**Figure 10.** Close-up view of the diagonally oriented abrasions to the rear left aspect of the Audi.

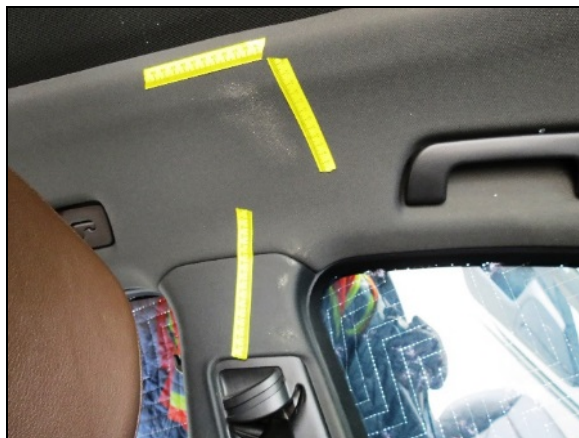
**Figure 11.** Skin transfer from the driver's head on the left roof side rail and upper left B-pillar.

Several areas of occupant contact were identified in the Audi that evidenced the kinematics of its occupants. There was skin transfer on the left roof side rail and left B-pillar from contact by the driver's head during the Event 2 rollover sequence. The driver's left knee contacted the left lower instrument during the rollover as well, producing a scuff to the polymer surface of the component. A skin transfer was also visible on the right roof side rail from contact by the front row right occupant's head during the rollover. Like the driver, an oily residue and possible scuff evidenced contact by her knee. **Figure 11** shows the driver contacts to the left roof side rail, while **Figure 12** shows the front-row right occupant's contact to the right roof side rail. There was no contact evidence associated with the occupants' initial kinematic response to the rear impact (Event 1) by the Acura.

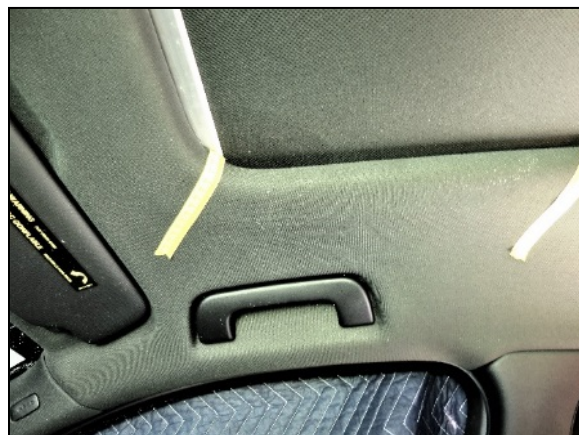
**Figure 12.** Skin transfer from the front-row right occupant's head on the right roof side rail.

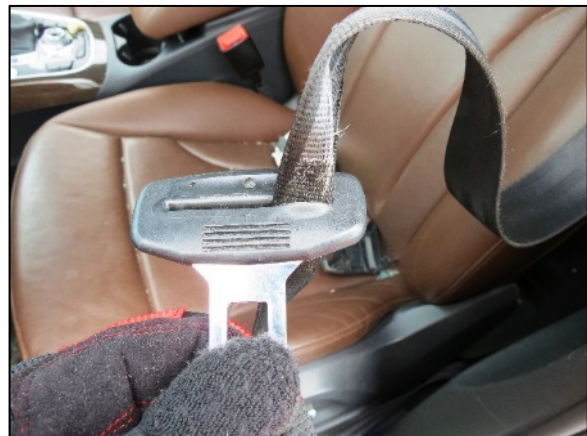
At the time of the SCI inspection, the driver's D-ring was adjusted fully upward. Webbing was extended from the retractor, which was locked in position and did not retract the exposed webbing. The SCI investigator determined that the driver's pretensioner system was actuated. The webbing was observed to be gathered in the forward aspect of the latch plate, a result of occupant loading. The latch plate would not slide along the webbing, and was deformed by the gathered webbing (**Figure 13**). A polymer transfer extended toward the D-ring. The driver's latch plate was stuck in position 87 cm (34.3 in) above the lower anchor and 79 cm (31.1 in) below the D-ring. It was apparent that the driver was belted at the time of the crash.

**Figure 13.** Driver's latch plate in the Audi.

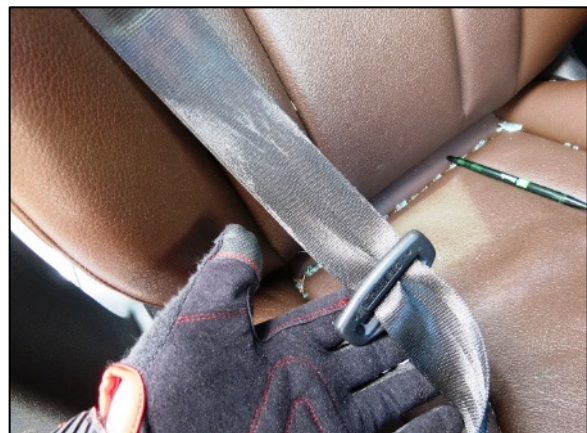
**Figure 14.** Latch plate of the Audi's front-row right seat belt system, with webbing gathered in the belt path.

The front-row right occupant's D-ring was also adjusted fully upward at the time of the SCI inspection. The overall condition of the front right seat belt system was very similar to the driver's with webbing gathered in the belt path of the latch plate (**Figure 14**). Webbing was

extended from the retractor, which was locked in position and did not retract the exposed webbing. The front right seat belt system's retractor pretensioner was also actuated. The latch plate would not slide along the webbing, and was deformed by the gathered webbing. A polymer transfer extended toward the D-ring. The front-row right occupant's latch plate was stuck in position 70 cm (27.6 in) above the lower anchor and 73 cm (28.7 in) below the D-ring. It was apparent that the front-row right occupant was belted at the time of the crash.

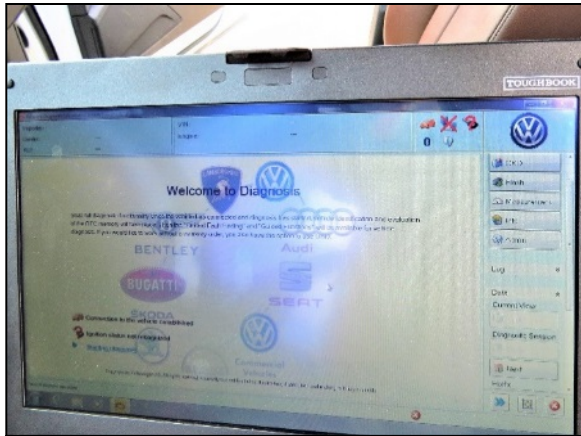
Despite application of multiple power sources to the vehicle at the same time, the manufacturer representative and SCI investigator were unable to energize the instrument cluster, engine, or ignition circuits of the Audi. The only electrical components of the Audi they were able to successfully energize were the low-voltage vanity and interior lights, the radio system, and the center instrument panel controls (climate control system, etc.). As a result of the electrical power issues, the manufacturer representative's proprietary tool and software were unable to communicate with the vehicle, and no data could be retrieved. **Figure 15** shows the proprietary software screen, indicating that the tool was connected to the vehicle, but could not communicate with the ignition system or retrieve its status.

**Figure 15.** Laptop screen view of the manufacturer's software indicating that the system did not recognize ignition status; therefore, the air bags did not deploy.

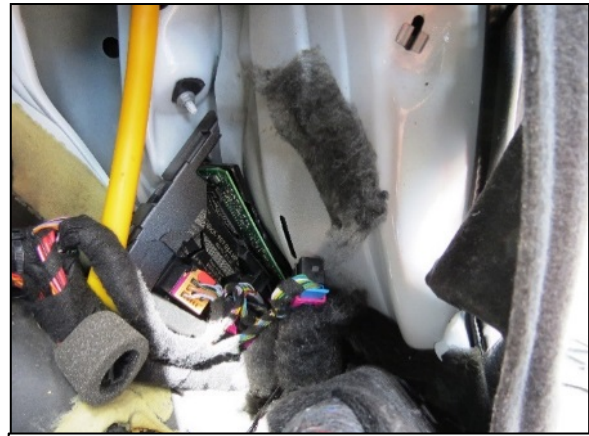
**Figure 16.** Crushed electronic module located in the right rear quarter panel area of the Audi and directly involved in the Event 1 impact deformation.

During the process of diagnosing the electrical power issues, the manufacturer representative and SCI investigator identified an electronic control module adjacent to the battery system in the rear of the vehicle that had become involved in the immediate damage pattern associated with the rear impact (Event 1). This module, which may have been related to the trailer hitch wiring, was entirely crushed (**Figure 16**).

4. The initial rear impact event of the crash sequence (Event 1) involved damage and deformation to the right rear corner area of the Audi. This destroyed an electronic control module and compromised the integrity of the vehicle's low-voltage electrical systems.

7. Due to the damage sustained in relation to the rear impact, the corresponding compromise of the vehicle's low-voltage electrical systems, and the resulting loss of power to the ACM, the Audi's ACM was unable to recognize the rollover (Event 2). Because there was no power to the ACM and it could not recognize the occurrence of the rollover event, it was also unable to command deployment of any of the Audi's inflatable supplemental restraint systems.

Based on the aforementioned circumstances, the lack of deployment of the Audi's supplemental inflatable restraint systems in relation to this crash was determined not to be an anomaly or result of system malfunction. Rather, damage to the vehicle in relation to the initial rear impact event resulted in a loss of power in the vehicle that prevented ACM recognition of subsequent events and the ability to command inflatable supplemental restraint deployment.

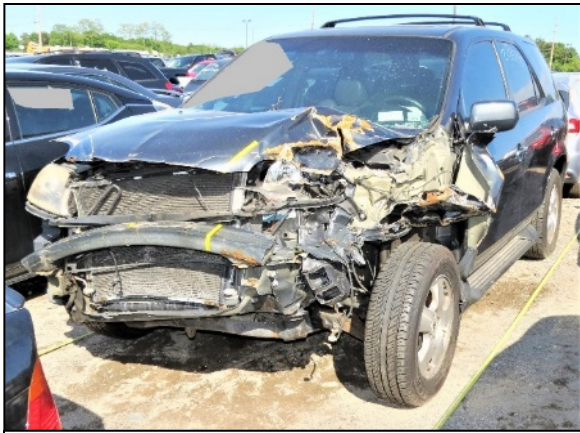
Damage to the exterior of the Acura was located on the front and left planes, associative to the frontal impact event with the back plane of the Audi. Direct contact began 41 cm (16.1 in) left of center on the front bumper beam and extended 23 cm (9.1 in) to the left front bumper corner. In the damage profile was minor crush to and rotation of the front bumper beam, with crush and deformation to the hood and left front fender. The left headlight assembly was disintegrated, the front bumper fascia and grille were separated, and underhood components were displaced.

**Figure 18.** View of the Acura's front plane Event 1 damage pattern.

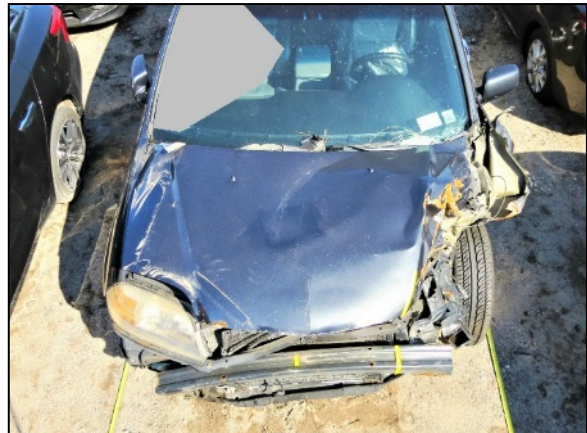
A residual crush profile documented using a Field-L width across the entire 128 cm (50.4 in) front bumper beam of the Acura produced the following resultant measurements: C1 = 8 cm (3.1 in), C2 = 9 cm (3.5 in), C3 = 6 cm (2.4 in), C4 = 6 cm (2.4 in), C5 = 5 cm (2.0 in), and C6 = 4 cm (1.6 in). Maximum crush in the profile was observed to the left front bumper corner. However, the greatest deformation was observed above the bumper beam to the left front fender area, above the left headlight assembly (**Figure 18**). The left wheelbase was shortened by at least 9 cm (3.5 in). The CDC assigned for the Event 1 impact to the Acura was 12FLEE4. **Figure 19** shows the damage profile to the front of the Acura.

**Figure 19.** Overhead perspective view of the damage pattern to the Acura's front plane.
