DOT HS 812 940

**Special Crash Investigations:
On-Site Guardrail End Terminal
Investigation;
Vehicle: 1999 Chevrolet Blazer;
Location: Missouri;
Crash Date: May 2017**

Special Crash Investigations
On-Site Guardrail End Terminal Investigation
Vehicle: 1999 Chevrolet Blazer
Case Number: IN17021
Location: Missouri
Crash Date: May 2017

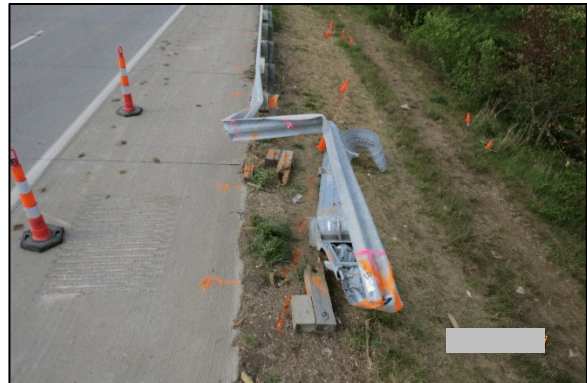
This on-site investigation documents an SUV impact to an ET-Plus 13 cm (5 in) model guardrail end terminal (**Figures 1 and 2**) for the Federal Highway Administration (FHWA). This crash was identified by an engineer with the Missouri Department of Transportation, who submitted images of the damaged guardrail end terminal and vehicle to the FHWA. The FHWA determined that the guardrail end terminal and crash type met their research criteria. This crash investigation was then initiated by the National Highway Traffic Safety Administration in May 2017 and assigned to the Special Crash Investigation team at the Indiana University Transportation Research Center. This single-vehicle crash involved a 1999 Chevrolet Blazer (**Figure 3**). The crash occurred in Missouri in May 2017; the guardrail, crash scene, and vehicle were inspected in the same month.

Figure 1. The damaged ET-Plus and guardrail.

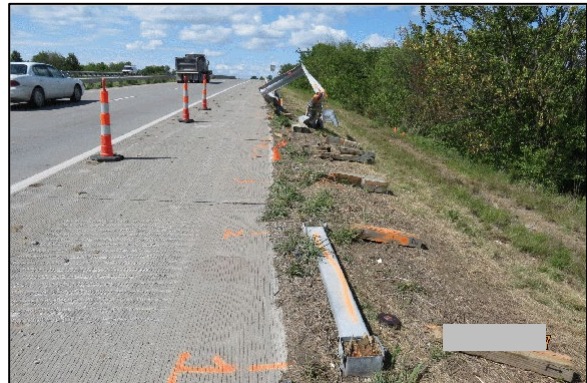
Figure 2. The damaged posts and guardrail, view north.

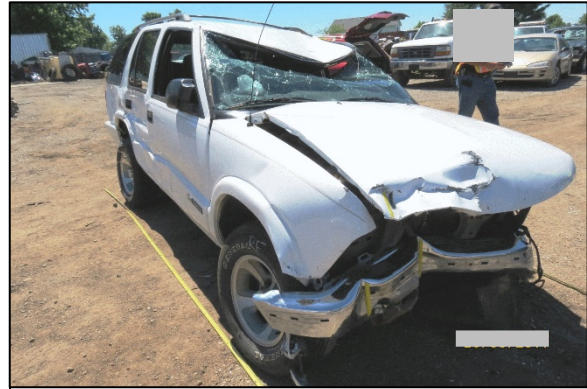
Figure 3. The damaged 1999 Chevrolet Blazer.

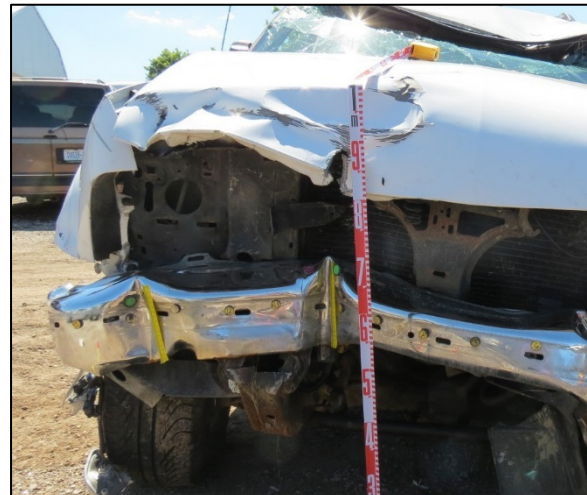
The right aspect of the vehicle's front plane (**Figure 4**) struck the ET-Plus (Event 1) and extruded 5.2 m (17.1 ft) of guardrail to the field side. The speed of the vehicle at impact is not known. The shape of the ET-Plus was stamped into the bumper and hood. The force direction on the Chevrolet was in the 12 o'clock sector and the impact resulted in deployment of both frontal air bags. The vehicle's EDR reported the maximum longitudinal velocity change as -33.2 km/h (20.62 mph). The damage algorithm of the WinSMASH program could not be used to calculate delta V since an impact with a yielding object is out of scope for the program. However, the barrier equivalent speed (BES) algorithm of WinSMASH was used to calculate a velocity change of 34 km/h (21 mph) based on the crush to the front bumper.¹

Figure 4. Damage to the front plane of the Chevrolet from the impact with the ET-Plus.

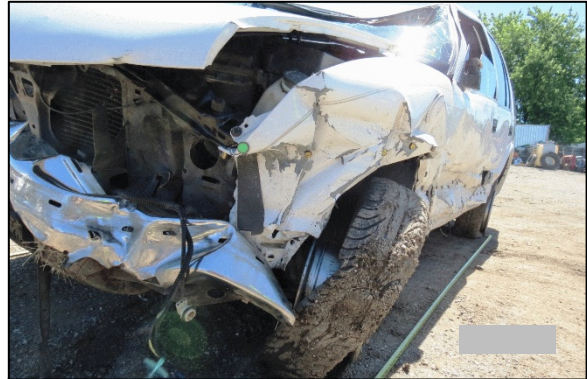
A damaged portion of the guardrail then struck and the left portion of the front plane (Event 2). The damage to the vehicle from this impact continued down the left plane (**Figures 5 and 6**) as the guardrail continued to deform. The exterior sheet metal of the left front door was crushed 18 cm (7.1 in) mid-door and the sheet metal of the left rear door was crushed and torn, but the guardrail did not penetrate into the occupant compartment nor cause intrusion of the interior surfaces of either door. The vehicle separated from the guardrail after traveling approximately 14 m (46 ft) displacing and fracturing eight wood posts and 15.2 m (50.0 ft) of guardrail. The vehicle then traveled an additional 10.5 m (34.4 ft) on the field side of the guardrail, rotated counterclockwise and tripped into a right side leading, two-quarter turn rollover event (Event 3) over a distance of 7.5 m (24.6 ft), coming to final rest on its top plane heading southwest.

Figure 5. Damage to the left corner of the Chevrolet’s front bumper and left plane from the impact with the damaged guardrail.

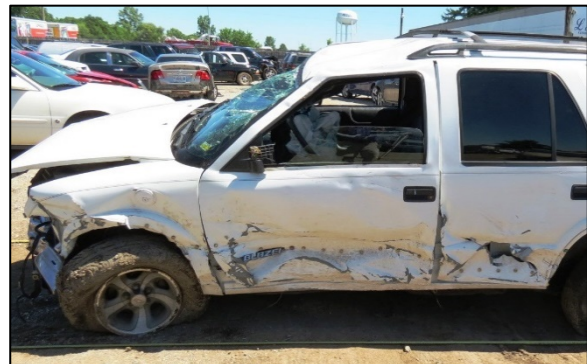
Figure 6. Side view of damage to the Chevrolet’s front bumper and left plane.

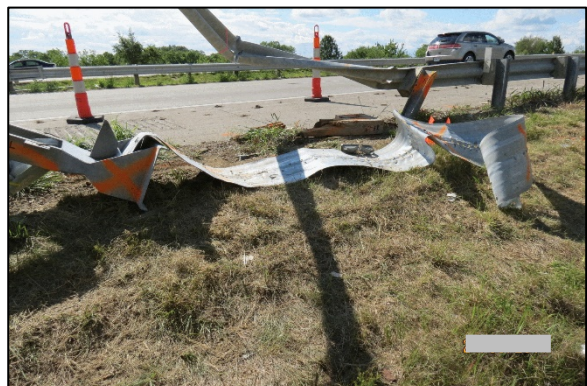
The front plane impact of the Chevrolet to the ET-Plus extruded 5.2 m (17.1 ft) of guardrail to the field side (**Figure 7**) and damaged 15.2 m (50.0 ft) of guardrail and eight posts. The direct damage involved the full height and width (71 cm [28.0 in] and 38 cm [15.0 in]) of the face of the ET-Plus. Posts 1 to 7 were constructed of wood. The remaining posts were constructed of steel. Post 1 and 2 were not equipped with offset blocks. The remaining posts had wood offset blocks. Posts 1 to 7 were fractured and displaced during the crash. The offset blocks were

Figure 7. Extruded guardrail from the ET-Plus.

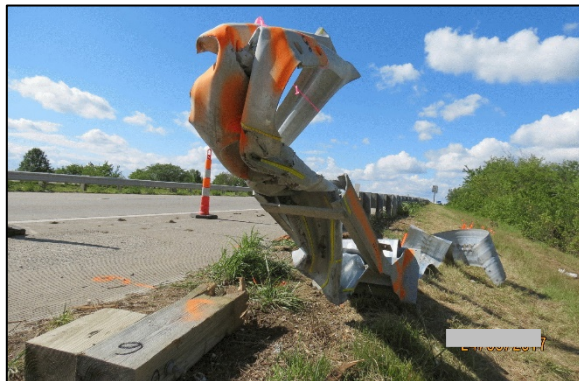
separated from posts 3 and 4 and remained attached to posts 5 to 7. Post 8, which was constructed of steel was bent downstream approximately 30 degrees off vertical. The offset block was slightly damaged but remained attached to the post, and the bolt was pulled through the guardrail. The remaining posts were undamaged. The guardrail was slightly bent and displaced at post 9, but remained bolted to the post. The guardrail was kinked in seven locations (**Figures 1 and 8**) with one kink located at the entrance to the feeder channel, two in the feeder channel, and one each at posts 5 – 8. The width of the feeder channel was 12.7 cm (5.0 in) and the guide chute exit height was 39.4 cm (15.5 in). The connection of the feeder channel to the head was not damaged and no welds were broken. The anchor cable was present but was disconnected from its anchor. It was found during the SCI crash scene investigation on the field side of the guardrail adjacent to post 9 and located 5.2 m (17.1 ft) east of the guardrail. The height of the undamaged guardrail was 70 cm (27.5 in). The In-Service End Terminal Evaluation Data Collection Form is attached to the end of this report as **Appendix A**.

Figure 8. Kinks in guardrail, view north.

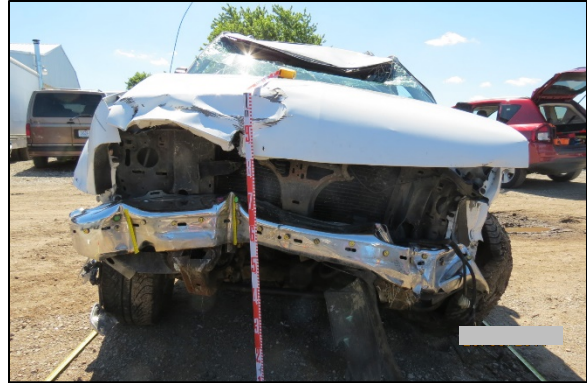
The Chevrolet sustained damage to the front plane (**Figure 9**) during the impact with the end terminal. The bumper, right headlamp/turn signal assembly, grille, and hood were directly damaged and the imprint of the end terminal was stamped in the bumper and hood. The direct damage began 14 cm (5.5 in) left of the right bumper corner and extended 35 cm (13.7 in) to the

left across the bumper. The Field L was 137 cm (53.9 in). Crush measurements were taken at the bumper level and the maximum residual crush was 42 cm (16.5 in) occurring 49 cm (19.2 in) left of the right bumper corner. The crush values were $C_1 = 0$ cm, $C_2 = 0$ cm, $C_3 = 13$ cm (5.1 in), $C_4 = 42$ cm (16.5 in), $C_5 = 35$ cm (13.8 in), and $C_6 = 23$ cm (9.1 in). The Collision Deformation Classification (CDC) was 12FRES2 (0 degree). The severity of the damage was moderate.

Figure 9. Front view of damage to the Chevrolet's front bumper.

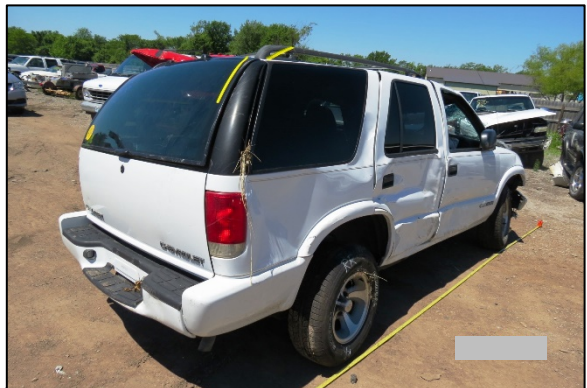
Damage from the rollover involved the right and top planes (**Figure 10**). The direct damage on the right plane extended from the right front door to the back of the quarter panel. The direct damage on the top plane extended from the hood onto the windshield and roof. The maximum vertical and lateral crush occurred at the windshield header and top of the left A-pillar, respectively. The vertical crush was 21 cm (8.3 in) and the lateral displacement was 8 cm (3.1 in). The CDC was 00TYDO3. The extent of the damage was moderate.

Figure 10. Rollover damage to the right and top planes.
