DOT HS 812 943

# **Special Crash Investigations: On-Site Ambulance Crash Investigation; Vehicle: 2016 Ford F-350 Type I Ambulance; Location: Oklahoma; Crash Date: August 2017**

**Special Crash Investigations**  
**On-Site Ambulance Crash Investigation**  
**Case Number: IN17027**  
**Vehicle: 2016 Ford F-350 Type I Ambulance**  
**Location: Oklahoma**  
**Crash Date: August 2017**

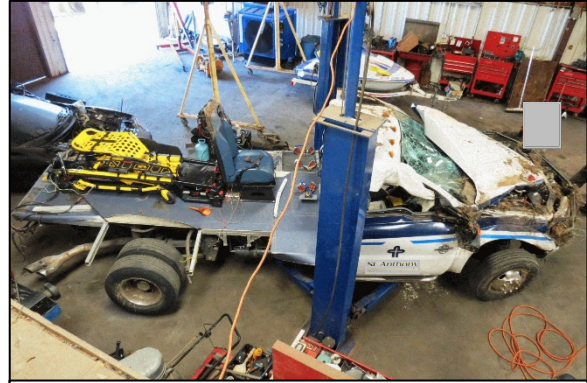
**Figure 1.** The damaged 2016 Ford F-350 Type I ambulance.

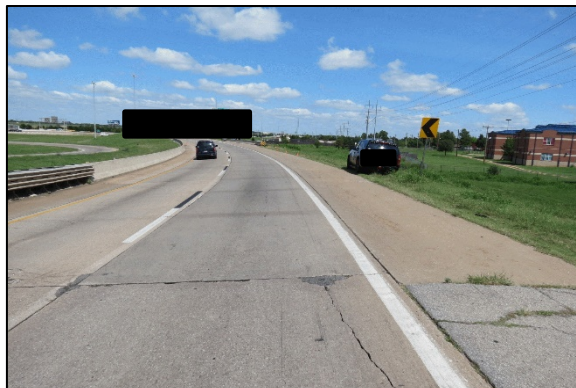
The ambulance was traveling north in the right northbound lane (**Figure 2**) at an Event Data Recorder (EDR) reported speed of 136 km/h (85 mph) at -5.0 sec prior to algorithm enable (AE). The vehicle speed increased to 141 km/h (88 mph) at -2.0 sec and remained at that speed to -0.5 sec with no reported braking. The ambulance departed the right side of the roadway as it entered the left curve. The cause of the roadway departure was possibly due to the driver falling asleep. This factor was based on the paramedic's statements to the police investigators that the driver was unable to stay awake during the overnight shift. It was also reported that witnesses observed the ambulance swerving in the roadway prior to the crash and that the driver had been removed from duty several days prior to the crash for failing to stay awake on the job. The area of roadway departure was evidenced by yaw marks from the right front, right rear, and left rear tires on the shoulder (**Figure 3**) and on the grass roadside during the SCI crash scene inspection. Projecting the path of the yaw marks back along the approach path of the vehicle on the scaled cash diagram indicated that the area of roadway departure was located approximately 89 m

**Figure 2.** Northbound approach of the ambulance to the roadway departure.

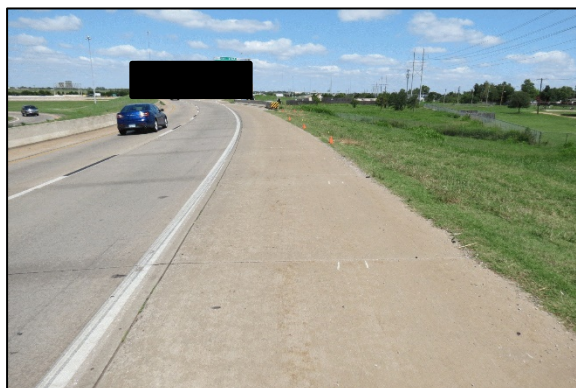
**Figure 3.** Northeasterly view of the yaw marks on the shoulder and grass roadside.

(292.0 ft) prior to the crash attenuator that was located at the end of a concrete Jersey barrier. The yaw marks indicated that the driver initiated a left steering maneuver in an attempt to return the vehicle to the roadway. The vehicle yawed counterclockwise 10 degrees as it approached impact with the Smart Cushion impact attenuator. The-EDR recorded-the service brakes as “On” at AE.

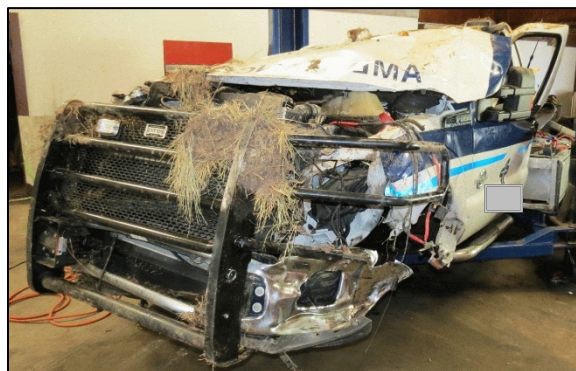
The front plane, left aspect of the ambulance (**Figure 4**) struck the right aspect of the impact attenuator (**Figure 5**). The EDR reported the speed of the vehicle at AE as 125 km/h (78 mph). The force direction on the vehicle was in the 12 o’clock sector and the impact resulted in actuation of the front row retractor pretensioners and stage-one deployments to both the driver’s and passenger’s frontal air bags. The maximum longitudinal and lateral velocity changes were EDR reported as -7.26 km/h (-4.51 mph) and -2.13 km/h (-1.32 mph). The left aspect impact in conjunction with the pre-crash counterclockwise yaw and the slope of the roadside vehicle caused the ambulance to rotate an additional 50 degrees counterclockwise as it traveled 53.4 m (175.2 ft) down the negative 4 percent grade of a grass-covered embankment. The ambulance subsequently tripped into a right-side-leading rollover (**Figure 6**). As the patient compartment struck the ground during the rollover, the unit separated from the floor and the walls and roof collapsed and separated. The ambulance completed an estimated eight quarter turns across a distance of approximately 32 m (105.0 ft), coming to final rest on its wheels facing north.

**Figure 4.** Damage to the left corner of the front bumper from impact with attenuator.

*Exterior Damage Event 1:* The ambulance sustained damage to the front plane during the impact with the impact attenuator. A steel brush guard was mounted on the front of the vehicle and the direct damage began at the left corner of the brush guard and extended to the left corner of the front bumper, and involved the headlamp/turn signal assembly, left fender, and left front tire and wheel. The direct damage length on the bumper was 51 cm (20.1 in). The crush measurements were documented at the bumper level and the maximum residual crush from the attenuator impact was 34 cm (13.4 in) occurring at the left corner of the front bumper. The Field L was 173 cm (68.1 in). The crush values were:  $C_1 = 34$  cm (13.4 in),  $C_2 = 1$  cm (0.4 in),  $C_3 = 0$  cm,  $C_4 = 0$  cm,  $C_5 = 0$  cm, and  $C_6 = 0$  cm. The Collision Deformation Classification (CDC) was 12FLEW2 (10 degrees). The ambulance was out of scope for an analysis with WinSMASH program because the steel brush guard mounted on the front of the vehicle invalidated the vehicle's crush stiffness coefficients, as did its type and weight.

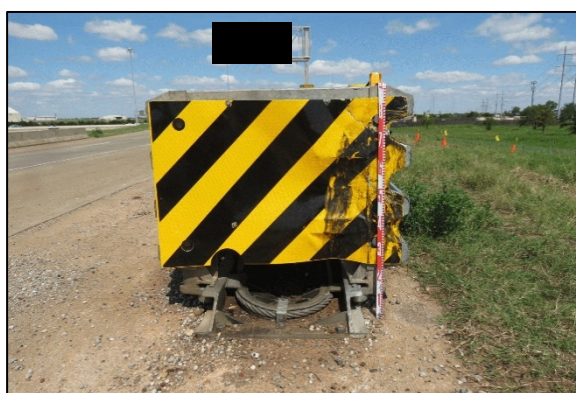
**Figure 5.** Damage to attenuator from impact by the front plane of the ambulance, view north.

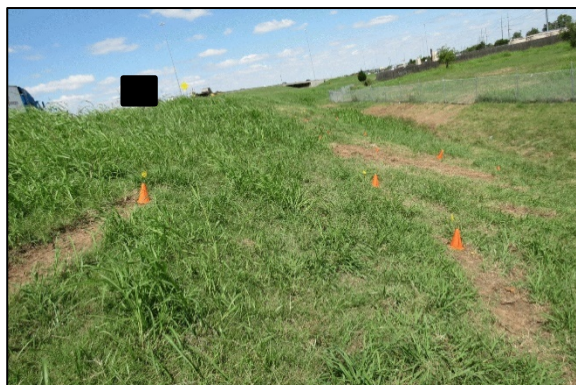
The patient cot remained attached to the cot securement system on the floor of the patient compartment; however, the backrest fractured and separated from the cot and the patient’s legs slid out from under the leg restraints. The patient was then ejected from the patient compartment while still strapped to the backrest (See the “Patient Cot Securement System and Damage” section of this report). The patient came to final rest approximately 26 m (85 ft) beyond the final

**Figure 6.** View northeast to the area where the ambulance tripped and rolled over, and the path of rollover to final rest by the fence.

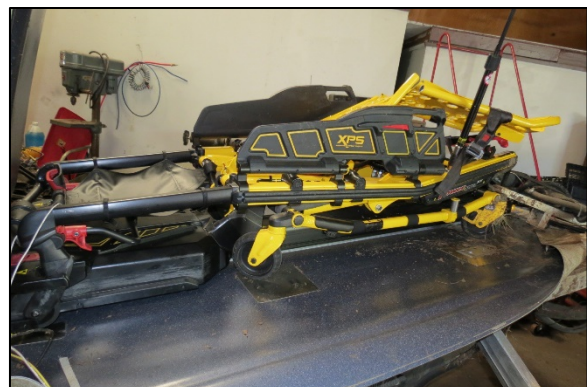
The subsequent fracturing and separation of the patient compartment from the vehicle during the rollover exposed the patient cot and swivel base-mounted bucket seat to direct contact with the ground. Dirt deposits on and deformation to the

**Figure 7.** The damaged Stryker model 6506 Power Pro XT patient cot.

bucket seat and foot-end of the cot indicated that direct contact with the ground did in fact occur during the rollover. See the “Patient Cot Securement System and Damage” section of this report for specific discussion regarding the damage to the cot.

The patient was restrained on the Stryker Model 6506 Power Pro XT cot (**Figure 7**) that was manufactured in March of 2016. The cot was an X-frame design and the manufacturer’s specifications stated the maximum and minimum length were 206 cm (81.1 in) and 160 (63.0 in), respectively. The width was 58 cm (22.8 in), and the height was adjustable from 36 cm (14.2 in) to 105 cm (41.3 in). The weight of the cot with one battery and without the mattress and restraints was 57 kg (125 lb). The cot was powered by an electric motor and a 24-volt NiCad battery. The maximum load capacity of the cot was 318 kg

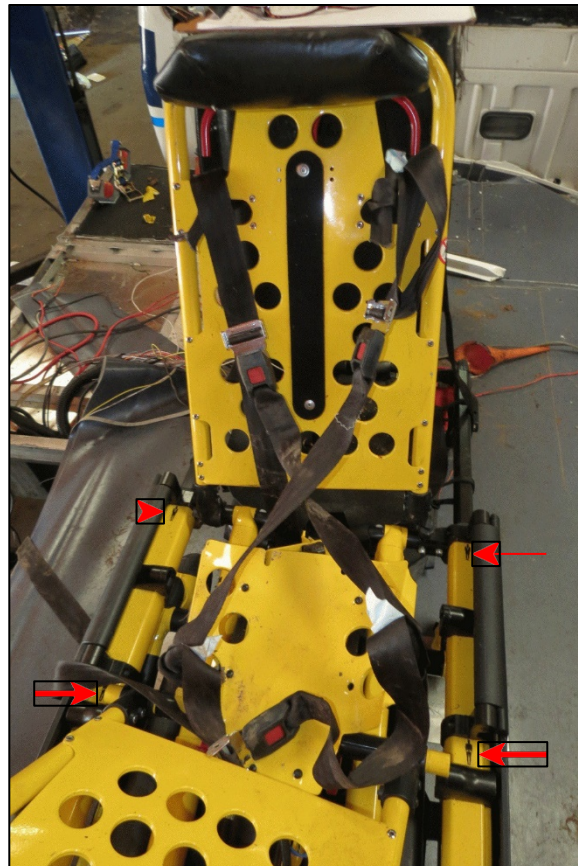
**Figure 8.** Shoulder/chest and waist restraints; arrows show icons for attachment locations on the frame.

The cot was designed to be equipped with shoulder/chest, waist (**Figure 8**), knee, and foot restraint straps. The instructions in the cot operation and maintenance manual described and illustrated how and where the restraint straps were to be attached to the cot. Icons were present on the frame of the cot showing the attachment locations for the shoulder/chest and waist restraint straps and on the frame of the footrest for the attachment locations for the knee and foot restraint straps. The SCI inspection of the cot revealed that the shoulder/chest and waist restraint straps were not attached to the cot frame at the specified locations (**Figure 8**). The shoulder/chest restraint straps were attached to the backrest and the waist restraint straps were attached to the mid-section plate of the cot (**Figures 9 and 10**). The foot restraint straps were attached to the footrest frame at the proper location. The knee restraint straps were missing. It is not known if they were present at the time of the crash. It is possible that they became separated from the footrest frame since each side of the frame was fractured and separated (**Figure 11**) making it possible for the foot restraint straps to slide off the frame. The shoulder/chest restraints were cut by emergency responders to remove the patient from the backrest.

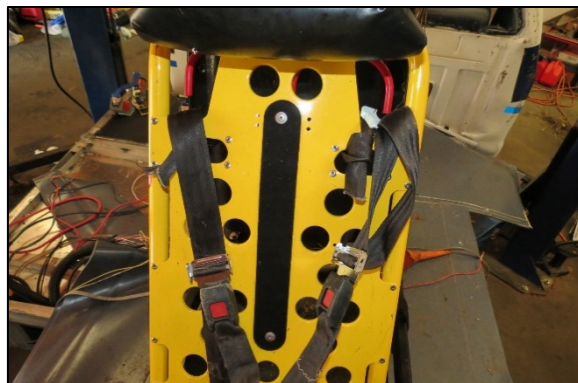
**Figure 9.** Shoulder/chest restraint straps attached to the backrest.

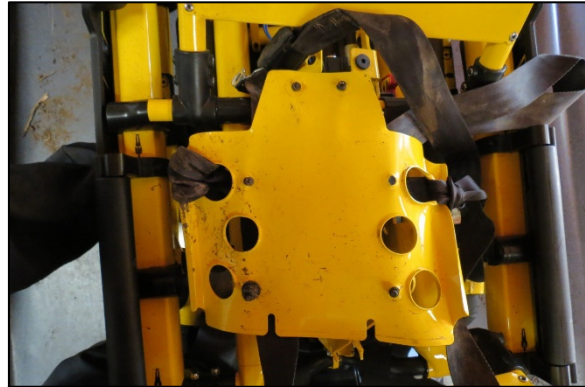
**Figure 10.** Waist restraint straps attached to the mid-section plate.

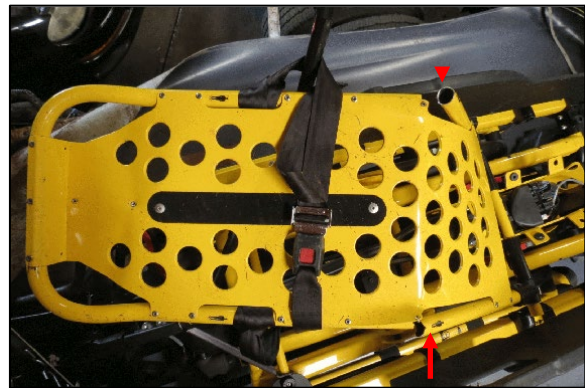
**Figure 11.** Footrest and restraint straps attachment locations; arrows show icons for the knee restraint straps attachment location.

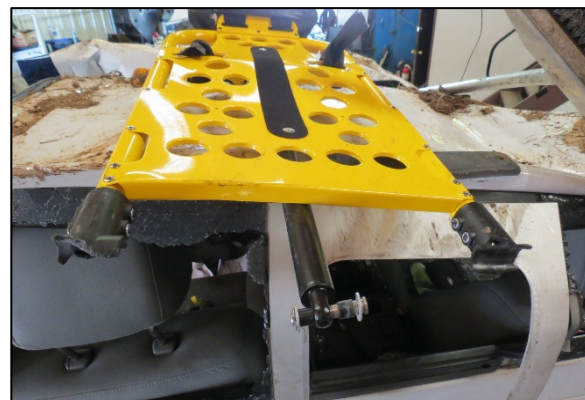
The cot remained secured to the Power-Load system throughout the crash. However, the backrest separated from the cot along with the patient and both were ejected from the vehicle

**Figure 12.** Fractured hinges on the backrest and pneumatic lift cylinder that separated from the yoke.

during the rollover. The backrest separated from the cot as a result of the fracture and separation of the following three components. Both plastic back rest hinges fractured. The yoke for the bottom pivot pin of the backrest pneumatic lift cylinder fractured and the cylinder separated from the yoke (**Figures 12 and 13**). The mid-section plate, on which the waist restraint straps were improperly secured, separated when the six button head cap screws that secured the plate to the cot separated (**Figure 10**). The foot end of the cot made direct contact with the ground during the roller as evidenced by grass and dirt adhering to the cot. The contact fractured the foot end frame.

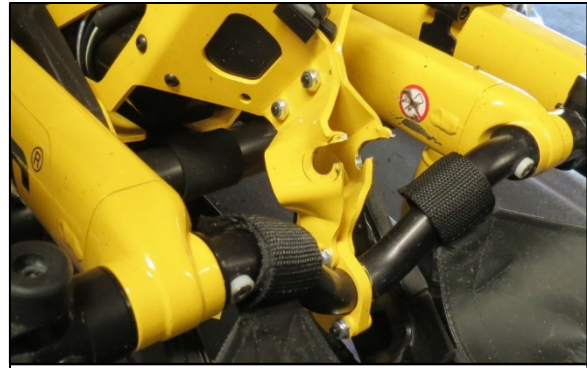
**Figure 13.** Fractured yoke for the backrest pneumatic lift cylinder pivot pin.
