DOT HS 812 950

Special Crash Investigations: On-Site Guardrail End Terminal Crash Investigation; Vehicle: 2002 Kia Optima; Location: Missouri; Crash Date: March 2017

Special Crash Investigations
On-Site Guardrail End Terminal Crash Investigation
Case Number: IN17013
Vehicle: 2002 Kia Optima
Location: Missouri
Crash Date: March 2017

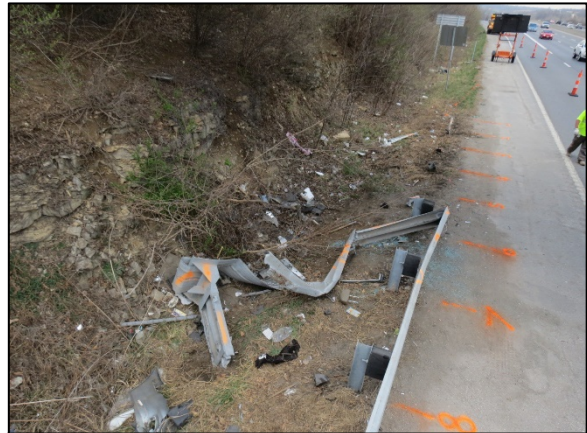
Figure 1. View north to the damaged end terminal and guardrail.

The front plane impact of the Kia to the end terminal extruded 3.0 m (9.8 ft) of guardrail to the field side and damaged seven posts. The height and width of the face of the end terminal was 71 cm (28.0 in) and 38 cm (15.0 in),

respectively, and the direct damage involved the total area of the face of the end terminal. The width of the feeder channel was 10 cm (3.9 in) and the guide chute exit height was 51 cm (20.1 in). The anchor cable disconnected from the guardrail during the crash and was found on the field side of the guardrail between posts 3 and 4 during the SCI crash scene inspection. The guardrail kinked at the entrance to the feeder channel and then tore and separated from the end terminal. The guardrail was also displaced from posts 1 to 7. Post 1 was separated from its base at the bolt hinge and the post was deformed. Post 2 was bent to the ground in the downstream direction. The ground strut remained in place. Posts 3 to 5 were bent in the downstream direction nearly to the ground and the composite offset blocks were displaced from the posts. Post 6 was slightly displaced in the ground. The offset block remained attached to the post but was displaced. The bolt pulled through the guardrail, which was kinked at the post. Post 7 and the offset block were not displaced but the bolt pulled through the guardrail. The guardrail was kinked in five locations (**Figure 9**). There were four kinks in the first section of the guardrail. One occurred at the entrance to the feeder channel where the guardrail tore and separated. Two more occurred in the mid-section of the rail and the fourth occurred at the splice between rails one and two. The fifth kink occurred in rail two at post 6. The “In-Service End Terminal Evaluation Data Collection Form” is attached to the end of this report as **Appendix A**.

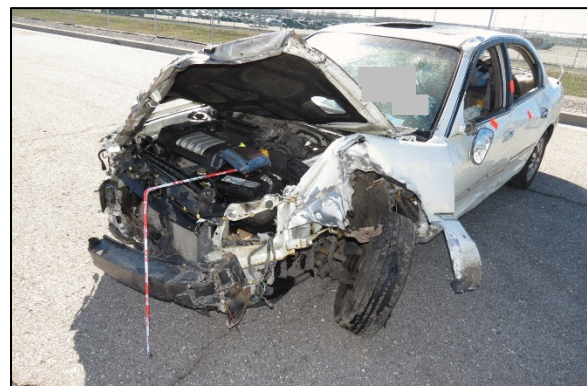
Figure 2. The damaged 2002 Kia Optima.

The Kia sustained direct and induced damage to the front plane from the impact with the end terminal. However, there was also overlapping direct damage across the whole front plane above the bumper level from contact with an embankment that occurred during the rollover. The direct damage from the impact with the end terminal was located at the left corner of the front plane and involved the bumper, left headlamp/turn signal assembly, and left fender. The back of the left front wheel well, lower left A-pillar, sill, and lower front portion of the left front door were also directly damaged when the end terminal separated from the guardrail and the guardrail penetrated through this area into driver's and front row right seating positions. The direct damage to the front plane from the end terminal began at the left corner of the front bumper and extended 38 cm (15.0 in) to the right. A crush profile for this impact could not be determined since the bumper bar was constructed of fiberglass and the left portion of it was fractured and displaced off the vehicle. The bumper bar itself was also partially detached from the vehicle.

The Collision Deformation Classification (CDC) was 12FLEE9 (0 degrees). The extent zone was based on the extent of guardrail penetration into the occupant compartment. The severity of the damage was considered severe, also due to the penetration of the guardrail.

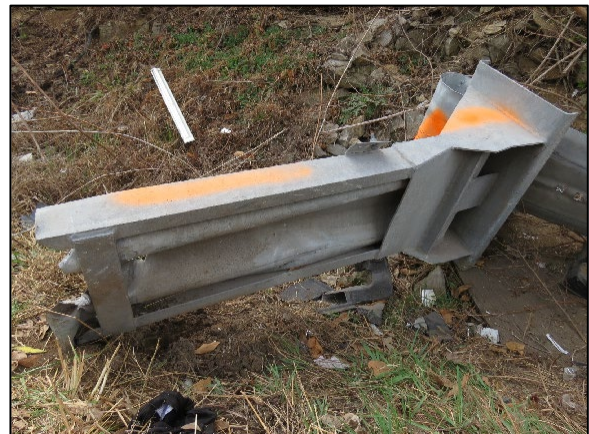
The front plane of the Kia struck the end terminal (**Figure 4**, Event 1) at an unknown speed. The impact occurred to the left corner of the vehicle's front plane resulting in snagging of the end

Figure 4. The damaged end terminal.

terminal on the left front wheel. The end terminal was displaced toward the field side as 3.0 m (9.8 ft) of guardrail were extruded toward the field side. The guardrail kinked at the entrance to the feeder channel and tore and separated from the end terminal (**Figure 5**). The guardrail then penetrated through the cowl behind the left front wheel (**Figure 6**) and into the driver's seating position space (**Figure 7**). The direction of penetration was from the 10 o'clock direction. The guardrail contacted the driver's right leg and hip as evidenced by blood and tissue transfer on the guardrail and continued into the front row right seating position where it contacted and displaced the front right seatback rearward. The vehicle also began to roll over (Event 2), left side leading, as the guardrail was deformed. The vehicle rolled over a total of two quarter turns and the top plane struck the damaged guardrail (Event 3) as the vehicle came to final rest heading west on top of the guardrail (**Figure 8**). The total rollover distance was estimated to be 8 m (26.2 ft). The total distance traveled from impact with the end terminal to the final rest position was 13.6 m (44.6 ft). The crash damaged a total of 12.4 m (40.7 ft) of guardrail and damaged seven posts.

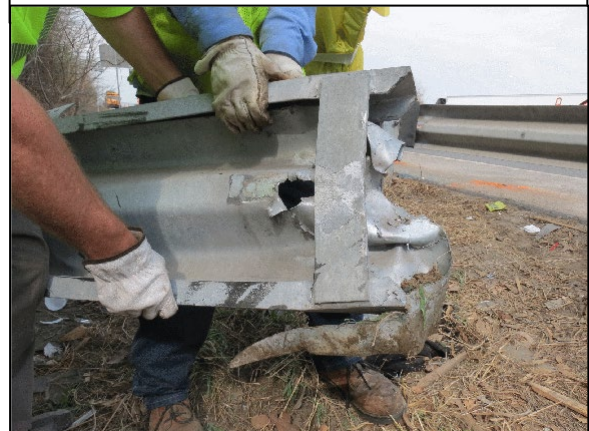
Figure 5. Torn guardrail in feeder channel.

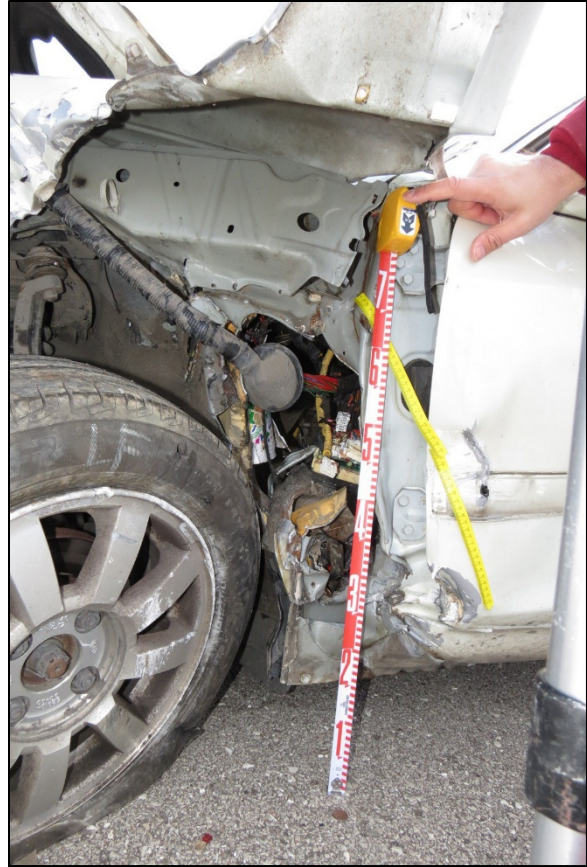
Figure 6. Guardrail penetrated through Kia's left cowl and into the driver's seating position.

The interior of the Kia sustained severe damage as a result of the penetration of the guardrail. The left cowl, lower left instrument panel, driver's seat cushion, floor-mounted gear shift lever, and center console were deformed and displaced. The front passenger's seatback was also directly contacted and displaced by the guardrail. Evidence of occupant contact consisted of a spider web-shaped fracture to the windshield from possible contact by the driver's head. The windshield was also fractured in the same pattern possibly from a head contact of one of the two passengers, whose seating positions are not known. The left front and left rear doors were jammed shut. The right front and right rear doors remained closed and operational. Emergency responders used a hydraulic rescue tool to remove right rear door. The left front, left rear, and sunroof glazing were disintegrated from impact forces. The right front and right rear glazing was disintegrated but this likely occurred during rescue activities. The windshield was cracked due to vehicle damage and occupant contact but remained in place.

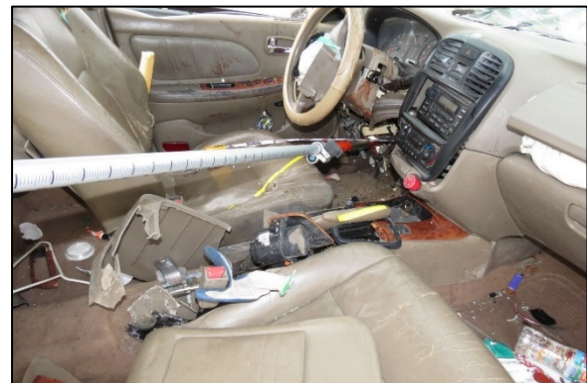
Figure 7. Pole shows path of guardrail penetration through the driver's seating position.

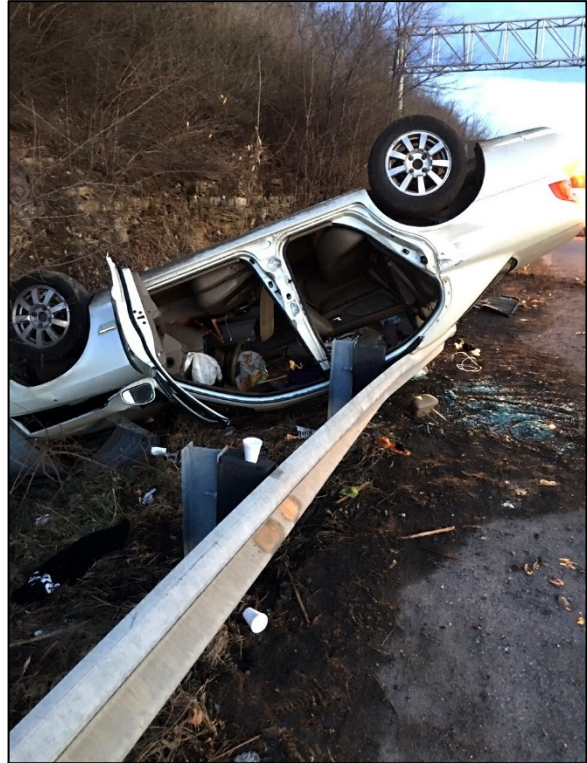
Figure 8. The Kia at final rest on top of the damaged guardrail, view north. Photo provided by local law enforcement agency.

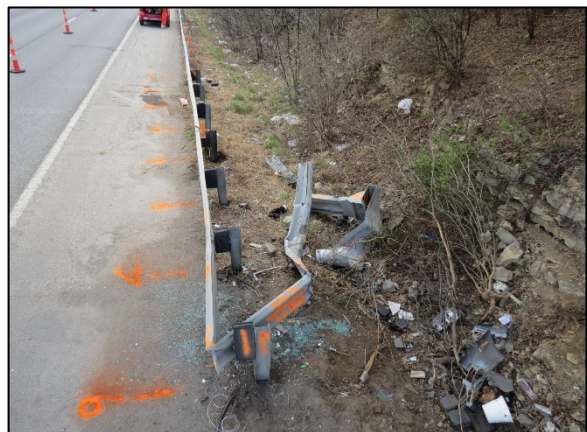
Figure 9. The kinked sections of guardrail, view south.
