DOT HS 812 952

**Special Crash Investigations:
Remote Child Restraint System
Crash Investigation;
Vehicle: 2007 BMW 525i;
Location: Alabama;
Crash Date: June 2012**

Special Crash Investigations
Remote Child Restraint System Crash Investigation
Case Number: CR17001
Vehicle: 2007 BMW 525i
Location: Alabama
Crash Date: June 2012

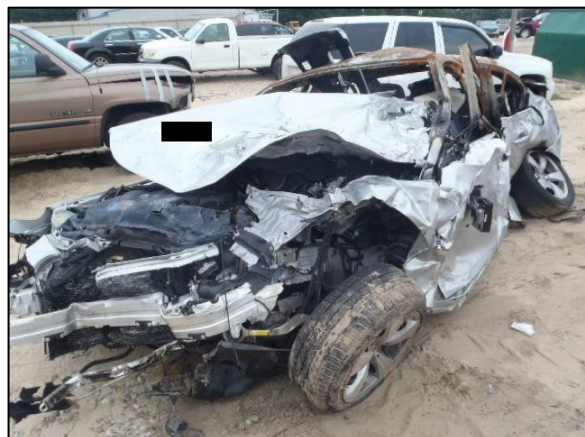
Figure 1. Front-left oblique view of the 2007 BMW. (Image provided by the investigating police department.)

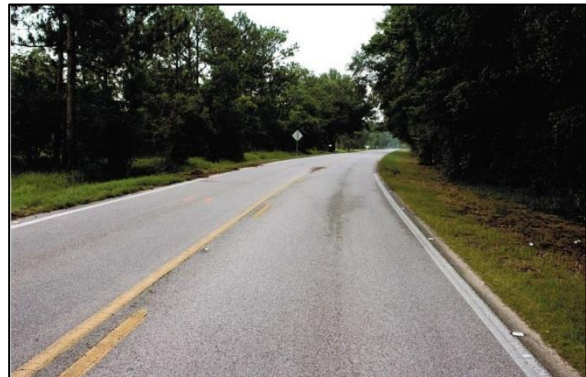
The crash occurred on a two-lane road (**Figure 2**) on a dark night. At the time of the crash, the National Weather Service reported the temperature at 28° C (83° F) with light rain and westerly winds of (6 mph). The asphalt-surfaced roadway curved to the right for northbound traffic and was level. Delineations consisted of a painted centerline that allowed for passing in the northbound direction and painted solid white edge lines. There were no shoulders as the road edges transitioned to cut grass. A tree line bordered the grass roadsides. The posted speed limit was 89 km/h (55 mph). An approximate crash diagram, developed from the police crash report information, is included at the end of this technical report.

Figure 2. North-facing view of the crash site. (Image provided by the investigating police department.)

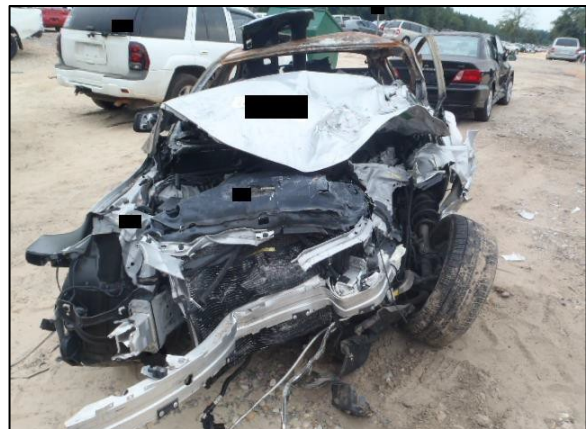
Figure 3. Front-plane damage to the 2007 BMW. (Image obtained from an online VIN source.)

The exterior of the BMW sustained damage to the front and left planes (**Figure 3** and **4**) from the impacts with the Pontiac. The initial contact originated at the front left area and extended across the front plane as the BMW penetrated into the right plane of the Pontiac. The direct contact damage (Event 1) appeared to have spread to the left and center regions of the front plane, crushing the bumper beam to an estimated depth of 51 cm (20 in) at the left corner. Continued crushing into the right plane of the Pontiac caused the left upper A-pillar of the BMW to engage the right upper A-pillar of the Pontiac. The collision deformation classification (CDC) for the Event 1 damage was 11FYAW6.

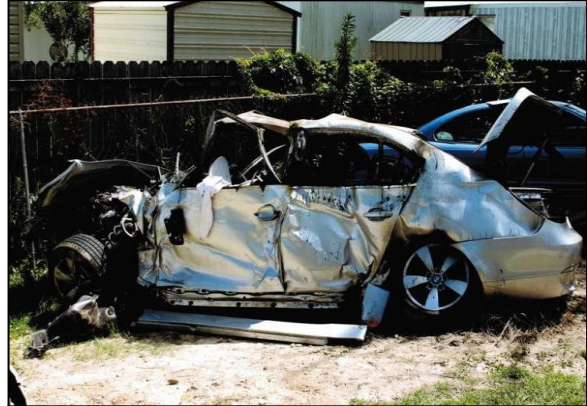
Figure 4. Left plane Event 2 damage to the BMW. (Image obtained from an online VIN source.)

As the vehicles crushed, the Pontiac continued to rotate counterclockwise, causing the left plane of the BMW to engage the right plane of the Pontiac (Event 2). The direct contact damage extended across both left side doors, the left roof side rail, onto the left quarter panel (Figure 4) to the back corner of the left plane. The lateral component of this engagement deflected the left rear axle laterally right. Both left doors were jammed closed and intruded. The CDC for the side-slap Event 2 impact was 09LZAW3.

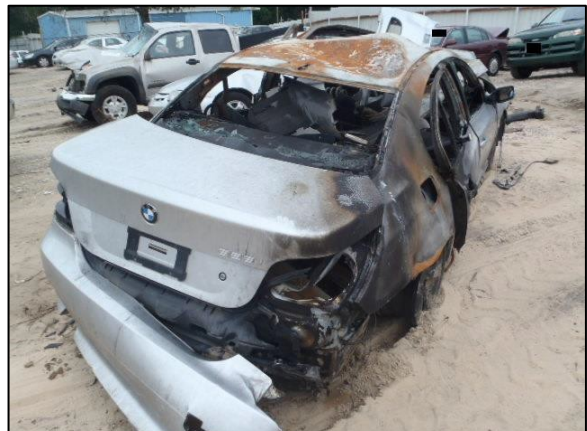
Figure 5. Back-right oblique view of the BMW and the suspected origin of the fire. (Image obtained from an online VIN source.)

The post-crash fire (Event 4) appeared to have originated in the back-right corner of the BMW (**Figure 5**) near the fuel filler. The fire spread forward to the occupant compartment and consumed all combustible materials of the interior, inclusive of the CRS, seats, door panels and air bags. Due to the limited images and the remote nature of this investigation, the specific origin and cause of the fire is undetermined.

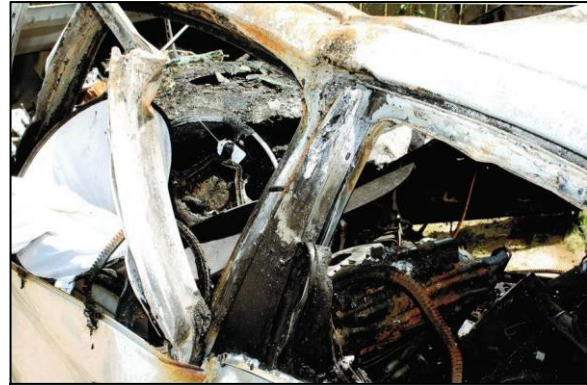
The interior of the BMW sustained intrusion of the occupant compartment from the engagement with the Pontiac. Due to the limited images available to the SCI team, intrusion values were estimated from the police images. The maximum intrusion occurred at the left B-pillar, resulting in approximately 20 cm (8 in) of lateral intrusion into the driver and second row left seat positions. Also intruded in the driver space was longitudinal displacement of the left upper A-pillar 15 cm (6 in). The left front door intruded laterally approximately 15 cm (6 in) with an equal amount of lateral intrusion of the left rear door. The crash-induced fire consumed the interior of the BMW (**Figures 6** and **7**).

Figure 6. Left plane view of the BMW's interior. (Image obtained from an online VIN source.)

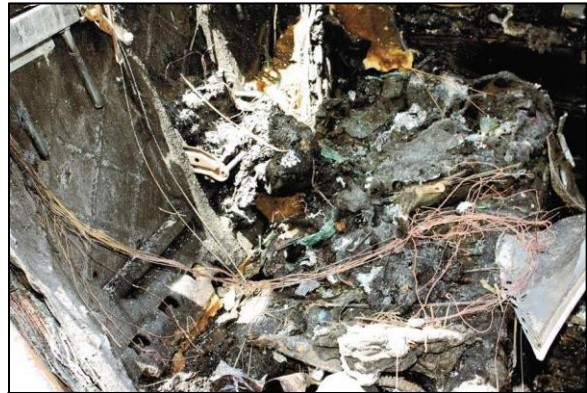
Figure 7. Fire damage to the front row of the BMW. (Image obtained from an online VIN source.)

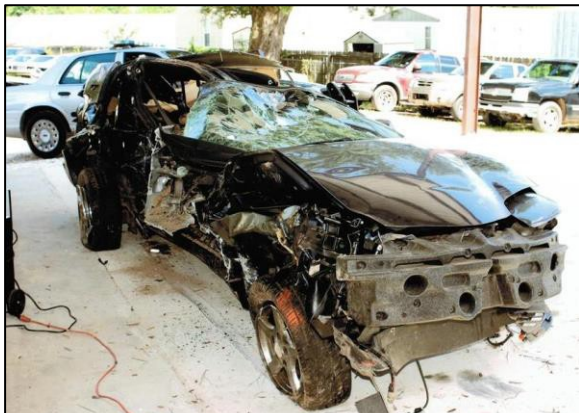
The Pontiac rotated counterclockwise into the path of the BMW and was struck on its right plane by the front plane the BMW (Event 1). Based on the available police images, the damage began at the right A-pillar area of the front fender and right door. Maximum crush was located in the area of the right door and appeared to be uniform from the A-pillar to the B-pillar locations, estimated at 64 cm (25 in). The impact separated the exterior door panel and jammed the right door in the closed position. A-pillar displacement fractured the windshield. The estimated CDC assigned to this damage pattern was 03RYAW4.

Figure 8. Front-right oblique view of the Pontiac. (Image obtained from the investigating police agency.)

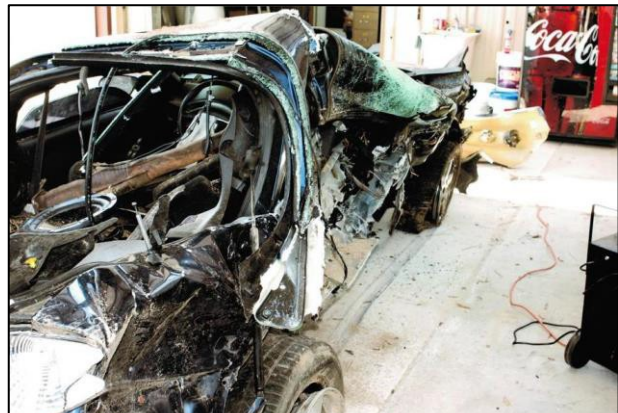
As the vehicles crushed to maximum engagement, the Pontiac continued to rotate counterclockwise and its right plane struck the left plane of the BMW in a side-slap configuration (Event 2). The damage continued rearward involving the B-pillar, the right rear tire and wheel and the right quarter panel. The CDC assigned to this damage was 03RZAW4.

Figure 9. Right-plane deformation to the Pontiac. (Image obtained from the investigating police agency.)
