DOT HS 812 956

**Special Crash Investigations:
On-Site Child Restraint System
Investigation;
Vehicle: 2015 Hyundai Sonata;
Location: Ohio;
Crash Date: December 2016**

**Special Crash Investigations
On-Site Child Restraint System Investigation
Office of Defects Investigation
Case Number: IN17016
Vehicle: 2015 Hyundai Sonata
Location: Ohio
Crash Date: December 2016**

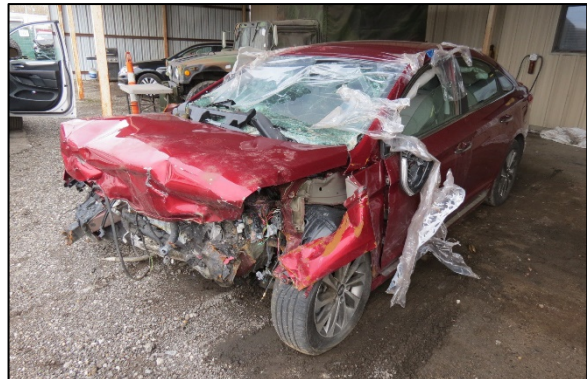
Figure 1. The damaged 2015 Hyundai Sonata.

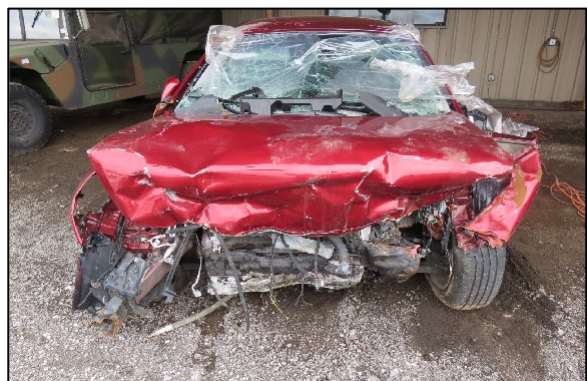
Figure 4. Damage to the front plane of the Hyundai from the impact with the front plane of the Honda.

Exterior Damage: The Hyundai sustained direct damage to the full width of the front plane during the impact with the Honda. The direct damage began at the left corner of the front bumper and extended 160 cm (63.0 in) across the front plane. The Field L was 86 cm (33.9 in). The crush measurements were taken on the bumper bar and the maximum residual crush was 68 cm (26.8 in) occurring 25 cm (9.8 in) left of the vehicle's centerline. The crush values were $C_1 = 60$ cm (23.6 in), $C_2 = 62$ cm (24.4 in), $C_3 = 68$ cm (26.8 in), $C_4 = 66$ cm (26.0 in), $C_5 = 60$ cm (23.6 in), and $C_6 = 55$ cm (21.7 in).

Damage Classification: The Collision Deformation Classification (CDC) was 12FDEW3 (350 degrees).

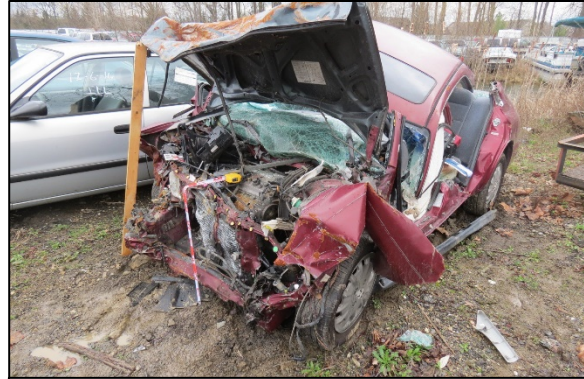
Figure 5. Damage to the front plane of the Honda.

The Honda sustained direct damage to the entire front plane from the impact with the front plane of the Hyundai. The direct damage began at the right corner of the front bumper and extended 159 cm (62.6 in) across the front plane. The Field L was 127 cm (50.0 in). The crush measurements were taken on the upper radiator frame since the bumper was missing from the vehicle. The maximum residual crush was 96 cm (37.8 in) occurring 78 cm (30.7 in) right of the vehicle's centerline. The crush values were $C_1 = 67$ cm (26.4 in), $C_2 = 77$ cm (30 in), $C_3 = 85$ cm (33.5 in), $C_4 = 93$ cm (36.6), $C_5 = 95$ cm (37.4 in), and $C_6 = 96$ cm (37.8 in).

Damage Classification: The CDC was 12FDEW4 (0 degree).

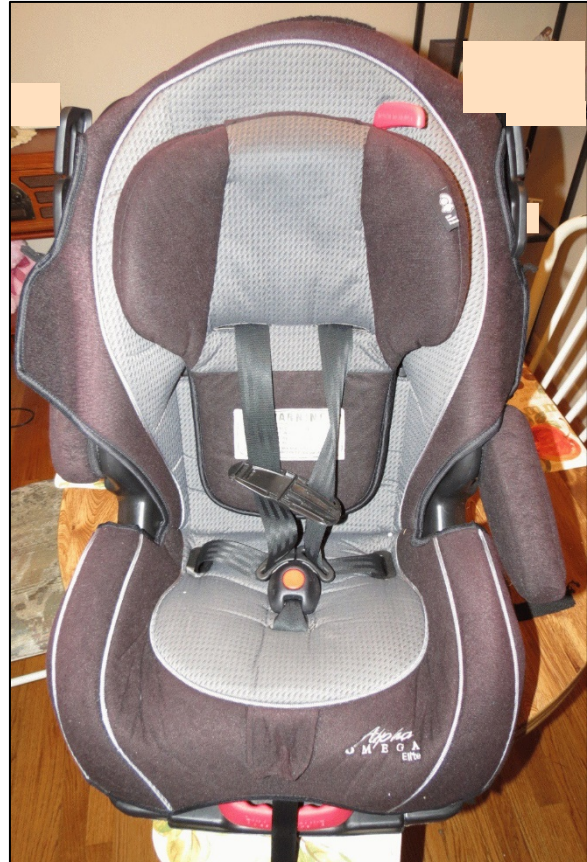
Figure 6. The Dorel Alpha Omega Elite convertible CRS.

The Hyundai's second-row center seating position was occupied by a 4-year-old female in a Dorel Alpha Omega Elite convertible CRS (**Figure 6**). The CRS model number was CC098-BXX and the date of manufacture was February 14, 2013. The CRS was equipped with an internal 5-point harness, harness retainer clip, upper tether, and hardware for the LATCH system. The CRS was designed to be used in the rear-facing position by children under 1-year-old, or in the forward-facing position with the internal 5-point harness, or as a belt-positioning booster seat. The child was seated in the forward-facing position and was secured in the CRS by the 5-point harness. The CRS was designed for children along the following parameters when used in this manner:

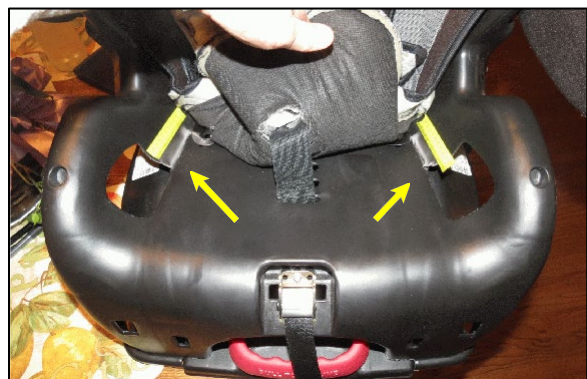
Figure 7. Arrows show the location of tears in plastic on each side of the CRS.

Inspection of the CRS revealed that the harness strap adjustment bar was bent from the child loading the harness straps. The top guide on the plastic harness retaining clip was fractured for each harness strap and the harness strap was out of each guide. The plastic was stressed and torn

on each side of the CRS where the side joined with the bottom (**Figure 7**). The length of the tears was 7 cm (2.8 in) on the left (**Figure 8**) and 8 cm (3.1) on the right (**Figure 9**). The cause of these tears is not known. Their location and appearance suggested the possibility that the vehicle's seat belt may have been improperly routed through the holes in the side of the CRS at this location. However, the driver stated during the interview that the vehicle's seat belt was routed through the forward-facing belt path and load abrasions in the plastic on the edges of the belt path observed during the SCI inspection indicated the seat belt was probably routed in this manner.

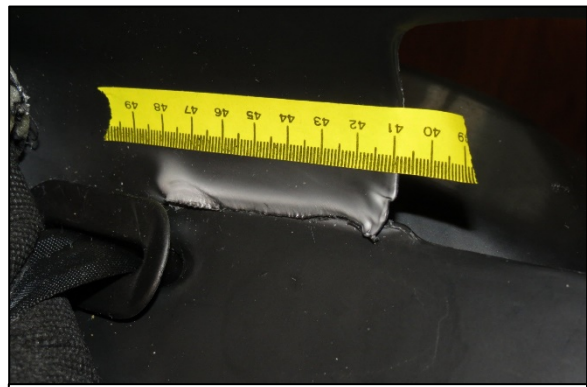
Figure 8. Tear on the left side of the CRS.

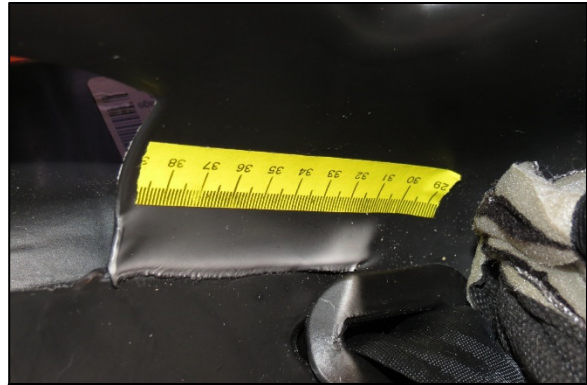
Figure 9. Tear in plastic on the right side of the CRS.
