DOT HS 812 964

**Special Crash Investigations:
Remote Vehicle Fire/Child
Restraint System Investigation;
Vehicle: 2003 Chevrolet Tahoe;
Location: Arizona;
Crash Date: July 2017**

Special Crash Investigations
Remote Vehicle Fire/Child Restraint System Investigation
Case Number: DS19018
Vehicle: 2003 Chevrolet Tahoe
Location: Arizona
Crash Date: July 2017

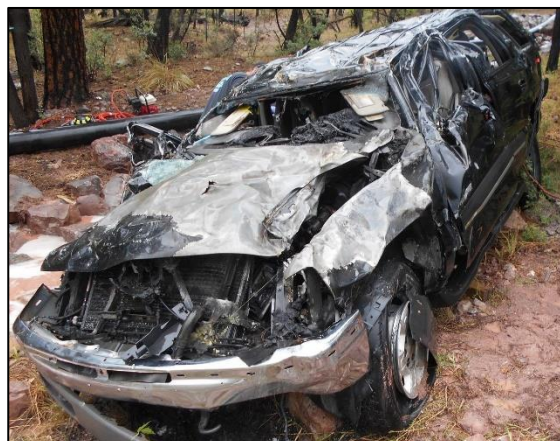
Figure 1. The 2003 Chevrolet Tahoe (police image).

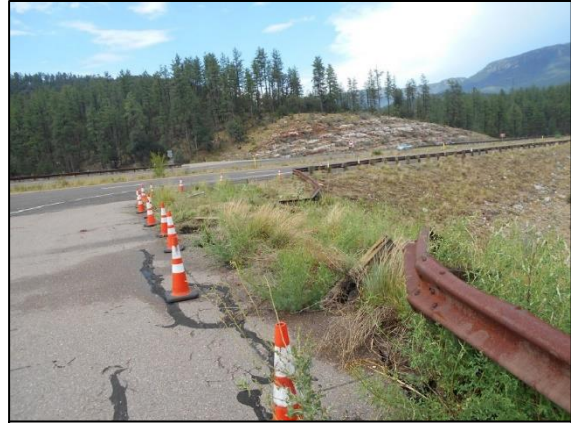
After departing the roadway, the left-rear plane of the Chevrolet struck and penetrated the guardrail (Event 1). A large section of the guardrail was displaced as the vehicle traveled to the east (**Figure 3**). The vehicle continued rotating as it traveled down a very steep embankment and then began a right-side-leading rollover (Event 2). The vehicle rolled four quarter turns before coming to rest in an upright orientation facing north (**Figure 4**). A fire began in the engine compartment shortly after the vehicle came to rest (Event 3).

Figure 3. Guardrail impact, looking north (police image).

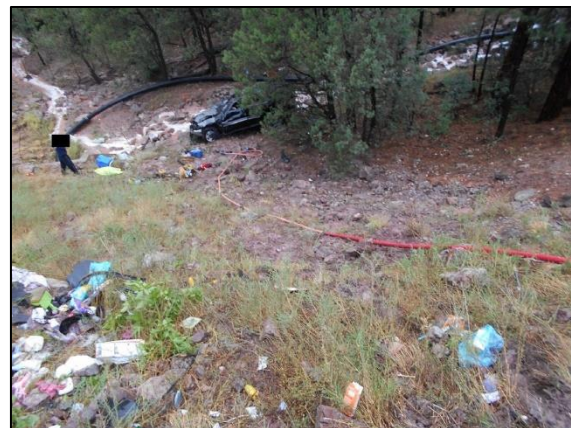
Figure 4. Final rest position, looking east (police image).

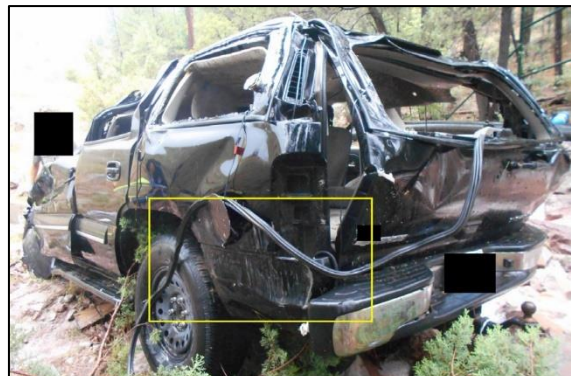
Figure 5. Left-plane damage, the 2003 Chevrolet Tahoe (police image).

The Chevrolet sustained moderate left-plane damage from the impact to the guardrail (**Figure 5**). The damage began at the left rear bumper corner and extended forward. The estimated Collision Deformation Classification (CDC) was 08LBEW2.

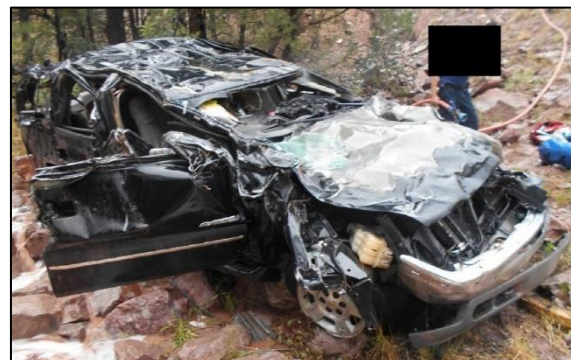
The Chevrolet sustained damage to all planes during the rollover (**Figure 6**). The estimated CDC was 00TDDO3.

Figure 6. Rollover damage, the 2003 Chevrolet Tahoe (police image).

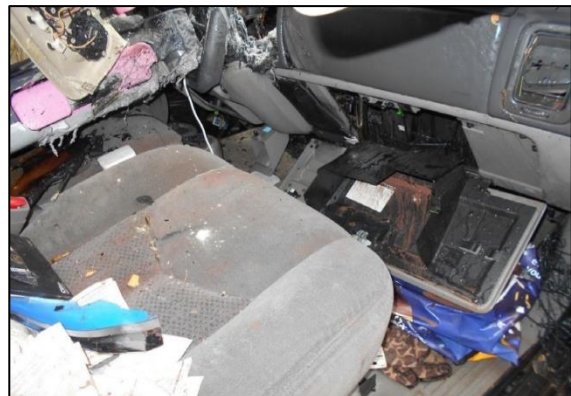
The Chevrolet sustained moderate damage from intrusions and fire. The vehicle sustained intrusions of the roof, roof side rails, windshield header, and both A-pillars. There was burn damage along the center and right instrument panel (**Figure 7**).

Figure 7. Right-front row seating area, the 2003 Chevrolet Tahoe (police image).

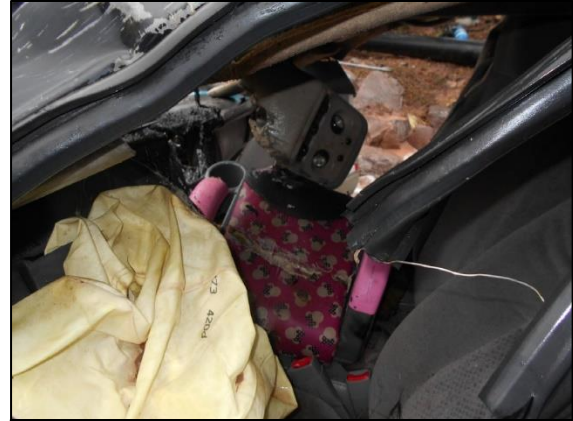
CRS: The 4-year-old in the front-row center position was seated in a Dorel Safety 1st Store'n Go backless booster CRS (**Figure 8**). The CRS was a belt-positioning booster that was designed to be used with a lap and shoulder belt but was being used incorrectly with only the lap belt in this seat position. The seat was designed to be used for children weighing from 18 to 45 kg (40 to 100 lbs) and whose height was from 109 to 144 cm (43 to 57 in). It is not known if the child met the height and weight requirements.

Figure 8. Dorel Safety 1st Store'n Go backless booster CRS (police image).
