DOT HS 812 965

**Special Crash Investigations:  
On-Site Disparate Injury Child  
Restraint System Crash  
Investigation;  
Vehicle: 2007 Chevrolet Malibu;  
Location: Illinois;  
Crash Date: October 2017**

**Special Crash Investigations**  
**On-Site Disparate Injury Child Restraint System Investigation**  
**Case Number: IN17034**  
**Vehicle: 2007 Chevrolet Malibu**  
**Location: Illinois**  
**Crash Date: October 2017**

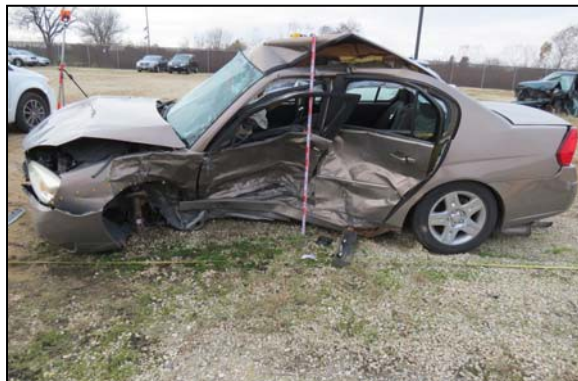
**Figure 1.** The 2007 Chevrolet Malibu.

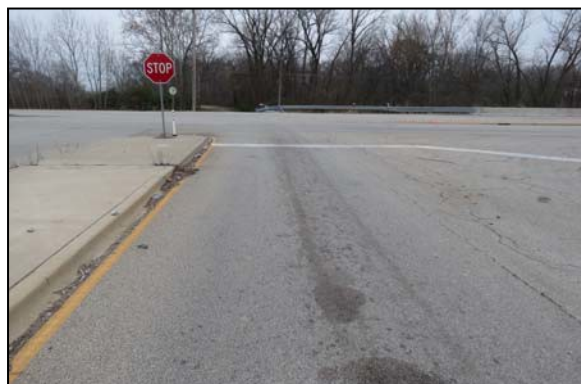
The Chevrolet was southeast-bound and stopped at the intersection (**Figure 2**). The EDR-reported data indicated the vehicle was stopped at the -5.0 to -3.0 second intervals prior to algorithm enable (AE). The driver accelerated at the -2.0 and -1.0 second intervals with corresponding vehicle speeds of 1.6 km/h (1 mph) and 11.3 km/h (7 mph), respectively. The EDR reported no steering input in the 5.0 second recoding prior to AE. The Mitsubishi was traveling southwest in the right through lane (**Figure 3**) approaching the intersection. Based on the crash scene evidence, the Mitsubishi driver steered left to avoid the crash.

**Figure 2.** Southeast view, the Chevrolet approaching the impact area.

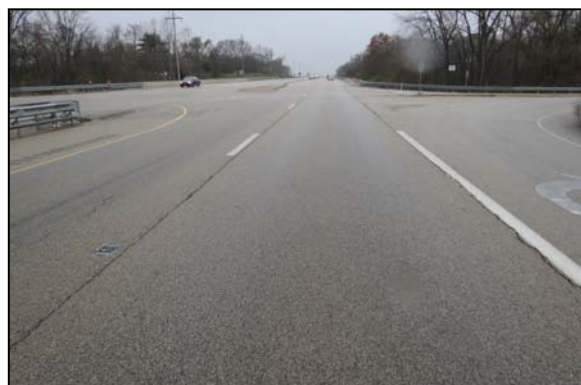
**Figure 3.** Southwest view, the Mitsubishi approaching the impact area.

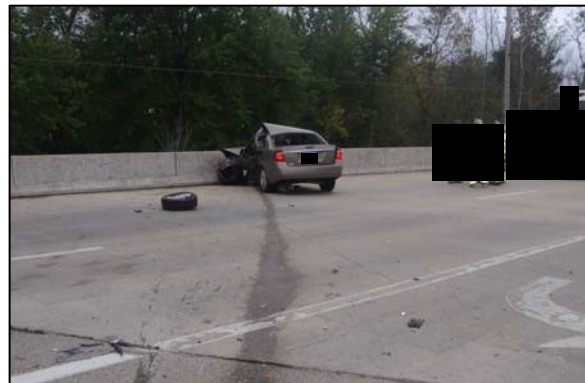
The Chevrolet was redirected to the southwest by the impact. The vehicle traveled 8.5 m (27.9 ft) where the Chevrolet's left-front wheel struck the median curb (Event 2), which was 10 cm (3.9 in) high. The wheel impact was beyond the scope for WinSMASH analysis in order to calculate delta V for this event. The Chevrolet slid 5.5 m (18.0 ft) over the median then continued southwest across the three lanes of travel for 19.5 m (64.0 ft) where the front plane struck the concrete bridge rail (Event 3) on the south side of the roadway. The damage algorithm of the WinSMASH program calculated the Chevrolet's total delta V as 39 km/h (24 mph). The longitudinal and lateral velocity changes were -39 km/h (24 mph) and 7 km/h (4 mph), respectively. The results

**Figure 4.** SW view, the Chevrolet's impact with the bridge rail/final rest. (On-scene police image.)

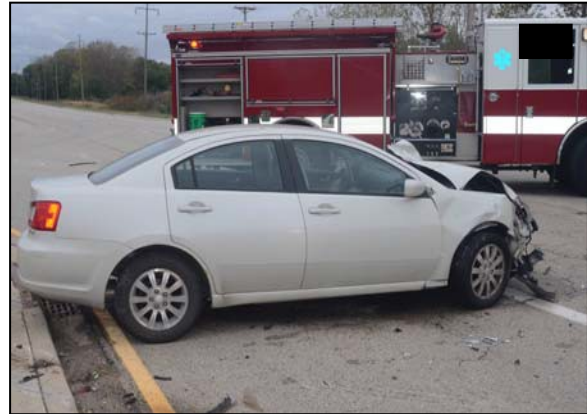
appeared reasonable based on SCI experience. The Chevrolet's EDR reported the maximum velocity change as 24.6 km/h (15.29 mph) and occurred at 180 msec after AE. The maximum longitudinal and lateral velocity changes were reported as -23 km/h (-14.23 mph) and 5.5 km/h (3.39 mph), respectively. These occurred at 170 msec and 100 msec after AE, respectively. The Chevrolet came to final rest facing southeast (**Figure 4**) with the front plane against the bridge rail. The Mitsubishi was also redirected southwest and rotated counterclockwise approximately 70 degrees. It also crossed over the median and came to final rest in the left turn lane of the northeast-bound lanes, facing southeast (**Figure 5**).

**Figure 5.** Northeast view, the Mitsubishi at final rest. (On-scene police image.)

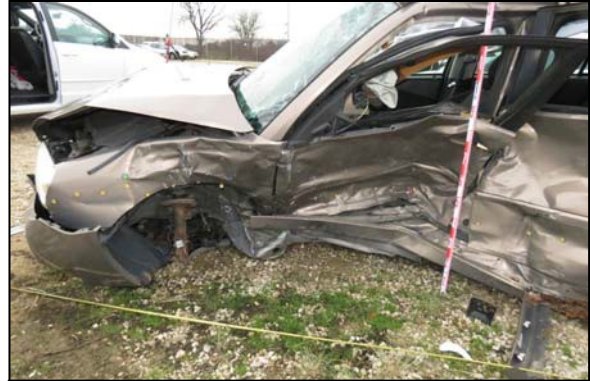
***Exterior Damage Event 1:*** The Chevrolet sustained direct damage to the left plane during the impact with the Mitsubishi. The direct damage began 246 cm (96.9 in) forward of the back plane and extended 215 cm (84.6 in) forward to the left front wheelhouse (**Figure 6**). The Field L was 248 cm (97.6 in). The crush measurements were taken at the lower-door level, and the maximum residual crush was 40 cm (15.7 in) occurring 133 cm (52.3 in) rear of the left-front axle. The sill height was 29 cm (11.4 in) and the height of the maximum crush was 34 cm (13.4 in). The Door Sill Differential was 12 cm (4.7 in). The crush values were  $C_1 = 2$  cm (0.8 in),  $C_2 = 36$  cm (14.2 in),  $C_3 = 40$  cm (15.7 in),  $C_4 = 38$  cm (15.0 in),  $C_5 = 9$  cm (3.5 in), and  $C_6 = 5$  cm (2 in). The Collision Deformation Classification (CDC) was 09LYEW4 (280 degrees).

**Figure 6.** Left plane, front half of the Chevrolet.

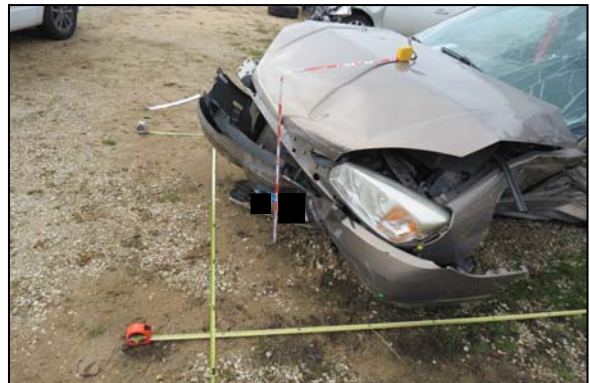
**Figure 7.** Front-plane damage of the Chevrolet. (Note: the vehicle is bowed.)

***Exterior Damage Event 2:*** The Chevrolet sustained direct damage to the front bumper, bumper fascia, grille, hood, and both headlamp and turn lamp assemblies from the impact with the concrete bridge rail (**Figure 7**). The Field L was 120 cm (47.2 in). The crush measurements were taken on the front bumper bar and the maximum residual crush was 51 cm (20.1 in) occurring at the left corner. The crush values were  $C_1 = 51$  cm (20.1 in),  $C_2 = 36$  cm (14.2 in),  $C_3 = 27$  cm (10.6 in),  $C_4 = 17$  cm (6.7 in),  $C_5 = 9$  cm (3.5 in), and  $C_6 = 7$  cm (2.8 in). The CDC was 12FDEW99 (350 degrees). The extent of 99 represented unknown due to the overlapping damage and bowing of the vehicle.

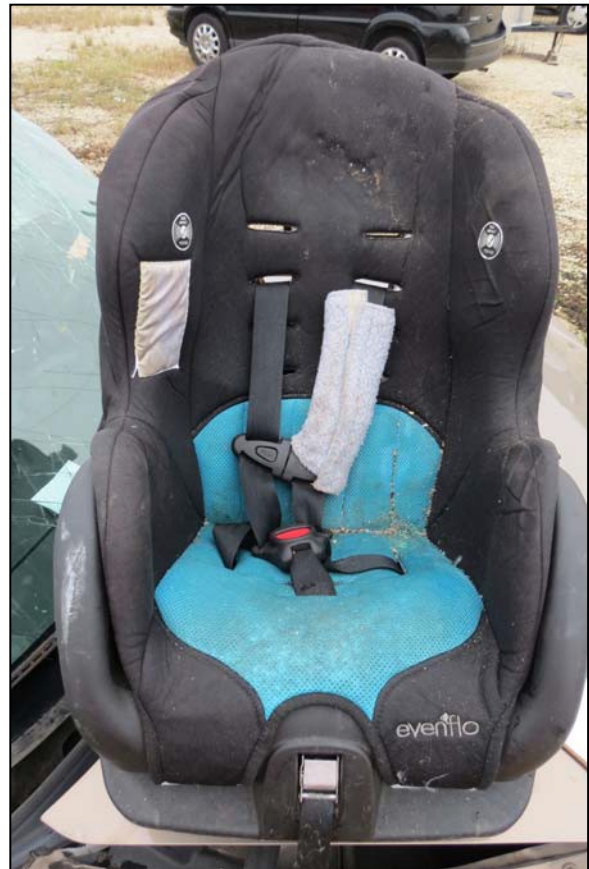
The Chevrolet's second-row right seating position was occupied by a 19-month-old male who was seated in a forward-facing Evenflo Tribute convertible CRS (**Figure 8**). The CRS model number was 38111711 and the date of manufacture was January 5, 2015. The CRS was constructed of a one-piece plastic shell with a cloth cover and a 2 cm (0.8 in) thick Styrofoam liner on the interior of the shell's backrest. The CRS was equipped with a 5-point harness and a harness retainer clip. The CRS was designed to be used for both forward and rear-facing positions by children along the following parameters:

**Figure 8.** Evenflo Tribute CRS, used by the second-row right occupant.

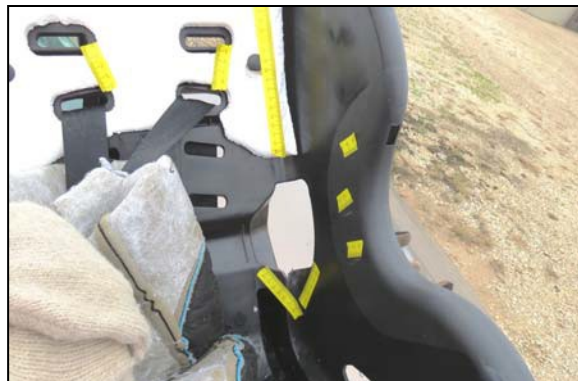
Inspection of the CRS revealed minor stress marks on the interior armrests and lower front corners and at the top right corner of the plastic shell. The CRS loaded the vehicle's seat belt during the crash and resulted in a 1 cm (0.4 in) long cut in left belt webbing guide plastic (**Figure 9**). There were 3 cm (1.2 in) long vertical cracks in the Styrofoam liner between the top and second set of shoulder strap guides and a small portion broken out under the left shoulder strap port. The left side of the Styrofoam liner was completely broken away. The remainder of the CRS was unremarkable.

**Figure 9.** Stress marks/damage to the CRS.

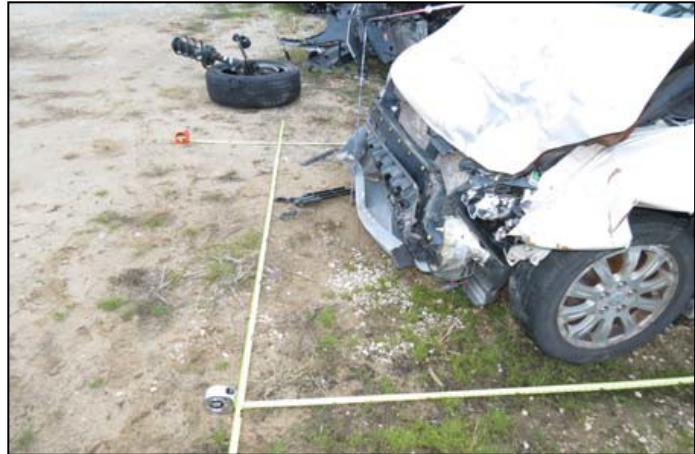
**Figure 10.** Front end of the damaged Mitsubishi.

*Exterior Damage Event 1:* The Mitsubishi sustained direct damage to the entire front plane from the impact with the right plane of the Chevrolet (**Figure 10**). The crush measurements were taken at the bumper level with the maximum residual crush was 45 cm (17.7 in) occurring 31 cm (12.2 in) left of the front center point. The CDC was 12FDEW2 (10 degrees).
