**Special Crash Investigations:  
On-Site Air Bag Non-Deployment  
Crash Investigation;  
Vehicle: 2004 Ford Explorer;  
Location: Ohio;  
Crash Date: July 2017**

**Special Crash Investigations**  
**On-Site Air Bag Non-Deployment Crash Investigation**  
**Office Of Defects Investigation**  
**Case No: IN17025**  
**Vehicle: 2004 Ford Explorer**  
**Location: Ohio**  
**Crash Date: July 2017**

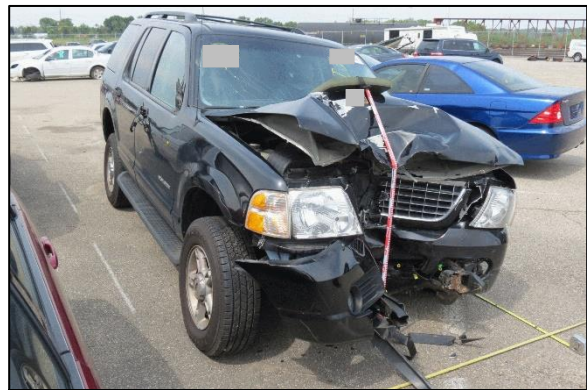
**Figure 1:** The damaged 2004 Ford Explorer.

The driver's frontal air bag did not deploy during the impact with the utility pole. It is possible that the crash sensing algorithm determined that the impact was not sufficiently severe to require air bag deployment due to an elongated crash pulse resulting from fracturing of the utility pole and the impact occurring between the Ford's frame rails in a relatively "soft" area of the front structure.

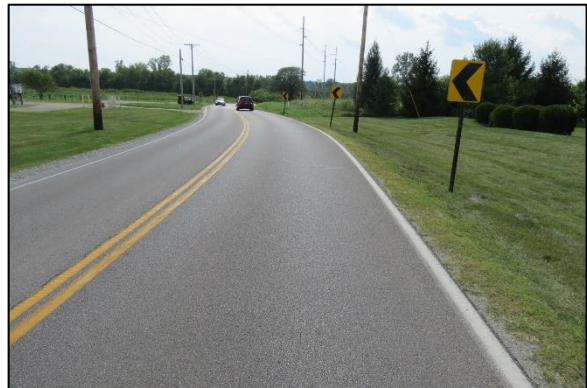
The Ford was traveling west in its lane in a left curve (**Figure 2**) at a driver-reported speed of 64 to 72 km/h (40 to 45 mph). The driver stated during the SCI interview that he had picked up his dog from the veterinarian and was concerned about the poor condition of the dog. The driver took his attention away from the roadway and reached over to the dog, who was located on the front row right seat. The vehicle then departed the right side of the roadway (**Figure 3**). The driver further stated that he did brake without lock-up in an effort to avoid the crash.

**Figure 2:** Westbound approach of the Ford.

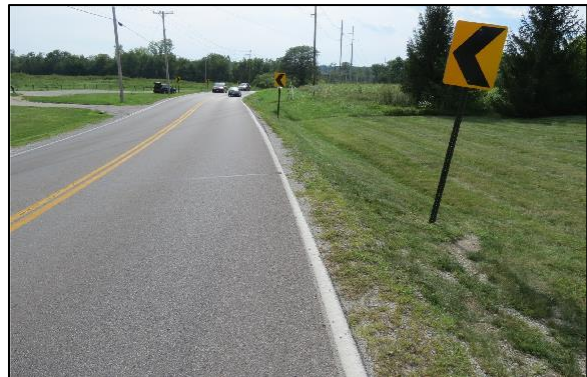
**Figure 3:** Westbound view of the area of roadway departure and approach to impact with two chevron alignment signs.

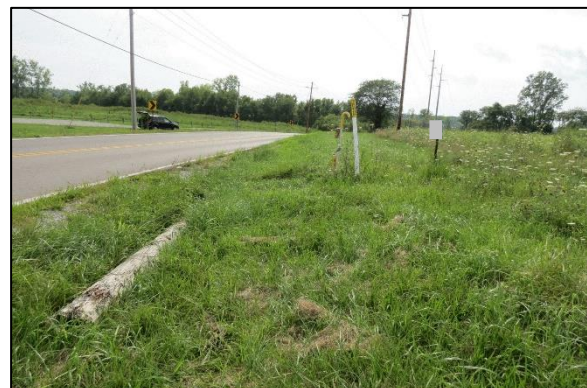
**Figure 4:** Westerly view of the approach to impact with petroleum pipeline marker post (displaced during impact).

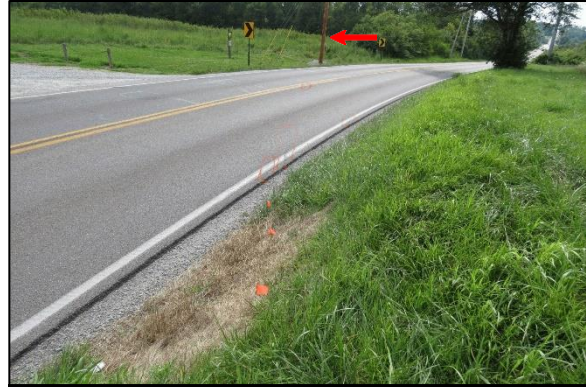
**Figure 5:** Southwesterly view of the vehicle's trajectory across roadway to impact with utility pole (arrow).

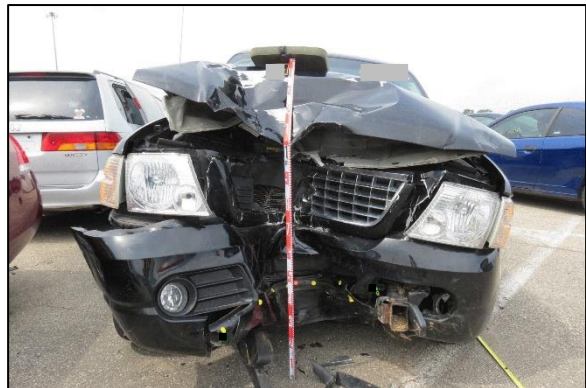
**Figure 6:** Damage to the Ford's front plane from utility pole impact.

*Exterior Damage Event 5:* The front plane sustained direct and induced damaged during the impact with the 30 cm (11.8 in.) diameter wooden utility pole. The bumper, grille, and hood were directly damaged. The direct damage began 55 cm (21.7 in.) left of the front right bumper corner and was 30 cm (11.8 in.) long. The Field L was 59 cm (23.2 in.). Crush measurements were taken on the bumper bar and the maximum residual crush was 49 cm (19.3 in.) occurring 33

*Damage Classification Event 5:* The CDC was 12FCEN2. The severity of the damage was moderate.

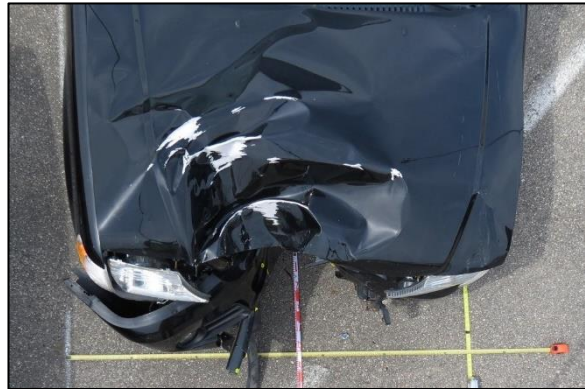
cm (13.0 in.) left of the right bumper corner (**Figure 7**). The crush values were: C1 = 11 cm (4.3 in.), C2 = 31 cm (12.2 in.), C3 = 48 cm (18.9 in.), C4 = 49 cm (19.3 in.), C5 = 20 cm (7.9 in.), C6 = 0 cm.

**Figure 7:** Front crush to the Ford from impact with the utility pole.

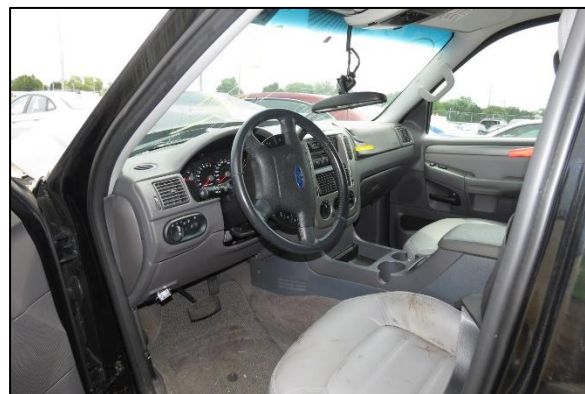
The interior of the Ford (**Figure 8**) sustained minor damage resulting from 10 cm (3.9 in.) of longitudinal intrusion of the left toe pan. Evidence of occupant contact consisted of the fractured ignition key from contact by the driver's right knee. The driver's head contacted the steering wheel rim, although there was no evidence of contact other than sustained injury. He loaded the seat belt system evidenced by frictional abrasions on the latch plate and webbing from the D-ring. The passenger mid-mount air bag module cover was dented and the glove box door scuffed from contact by the driver's dog. The windshield-mounted rear view mirror separated from the windshield from possible driver arm contact, or the crash forces. The AS1 laminated windshield was fractured vertically from exterior deformation. All other glazing was undamaged. All the doors remained closed and operational.

**Figure 8:** Oblique view of Ford's front row/non-deployed air bags.
