DOT HS 812 970

# **Special Crash Investigations: On-Site Guardrail End Treatment Crash Investigation; Vehicle: 2012 Ford Escape; Location: Missouri; Crash Date: July 2016**

**Special Crash Investigations**  
**On-Site Guardrail End Treatment Crash Investigation**  
**Case Number: CR16018**  
**Vehicle: 2012 Ford Escape**  
**Location: Missouri**  
**Crash Date: July 2016**

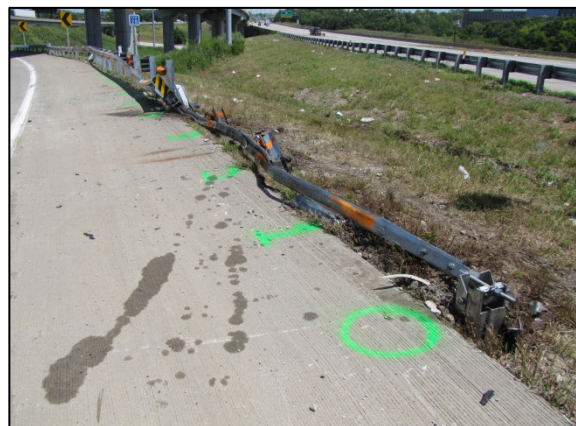
**Figure 3.** North-facing view of the crash site and the damaged guardrail during the SCI inspection.

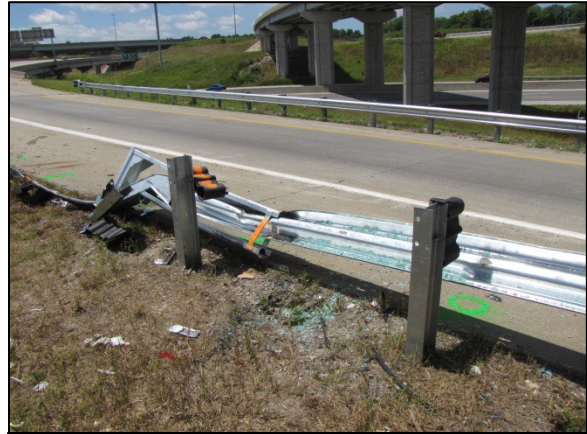
As the Ford displaced the end terminal to the north, its counterclockwise rotation was accentuated. The vehicle achieved a right-side-leading attitude and the lateral forces at the tire/ground interface resulted in an instability, which tripped the vehicle into a right-side-leading rollover (Event 4) as its front plane separated from the end terminal. The Ford rolled two-quarter turns and its roof struck the post 5 I-beam support (Event 5). This impact punctured and tore the sheet metal of the roof, deformed the lateral load bar of the roof rack, and disintegrated the backlight glazing. The overturned vehicle came to rest facing south on top of the guardrail. Its roof remained engaged with post 5. The disintegrated backlight glazing was captured in the concave profile of the W-beam between post 5 and 6 (**Figure 7**). During a review of an on-scene image supplied by MoDOT, it was observed that the glazing was also sprayed onto the roadway adjacent to this location. The location of the disintegrated glazing in these areas was indicative of the impact dynamics. The vehicle dynamics were also captured in the recorded EDR data.

**Figure 7.** Southwest-facing image depicting the final rest location of the Ford between posts 5 and 6, evidenced by the disintegrated glazing.

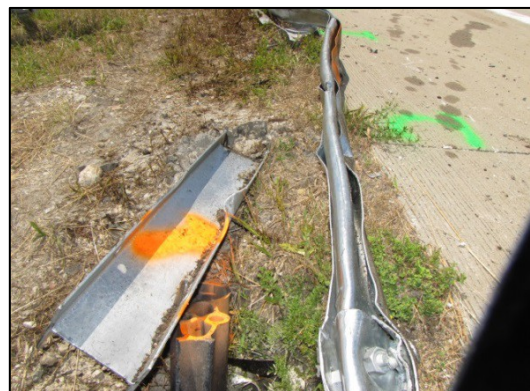
Post 2 was also a yielding 15 x 10 cm (5.9 x 3.9 in) I-beam. Based on the pattern of the dirt, it appeared that these holes were also approximately at ground level. This post deformed approximately 90 degrees by bending and fracture of the beam at the weakening holes. Based on the observations of the inspection, the W-beam was bolted to this post through a composite block-out. The carriage bolt was deformed, and the composite block-out was fractured and separated (**Figure 9**) from the W-beam. The installation directions indicated that this post should have a block-out; however, the W-beam was not supposed to be attached to the post.

**Figure 9.** South-facing image depicting the post 2 deformation and the displaced block-out.

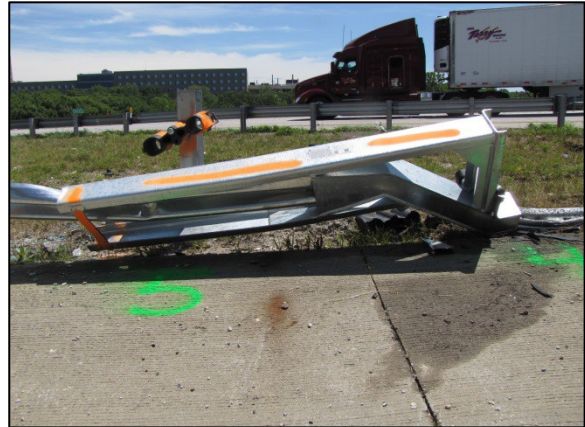
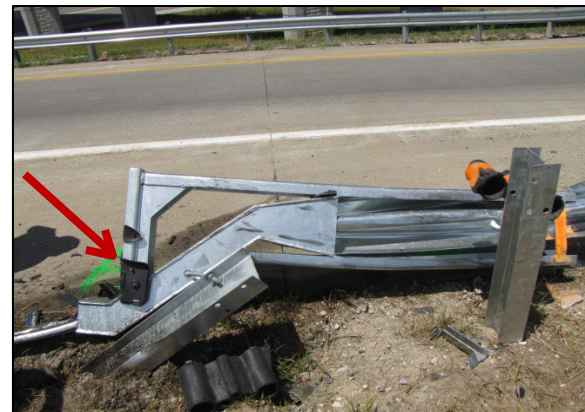
The end terminal (**Figures 10 and 11**) was displaced approximately 8.1 m (26.3 ft) to the north by the Ford to the area of posts 4 and 5. Inspection of the end terminal was unremarkable. No welds were broken and it was relatively undeformed. At inspection, the deformed license plate and hood emblem of the Ford were wrapped around the impactor face (highlighted by the arrow in **Figure 11**). This physical evidence was indicative of the vehicle's alignment at the time of the crash. At impact, the centerline of the Ford was 5 cm (2.0 in) right of the centerline of the impact face.

**Figure 10.** East-facing image depicting the location and condition of the displaced end terminal adjacent to posts 4 and 5.

**Figure 11.** West-facing image depicting the location and condition of the displaced end terminal adjacent to posts 4 and 5.

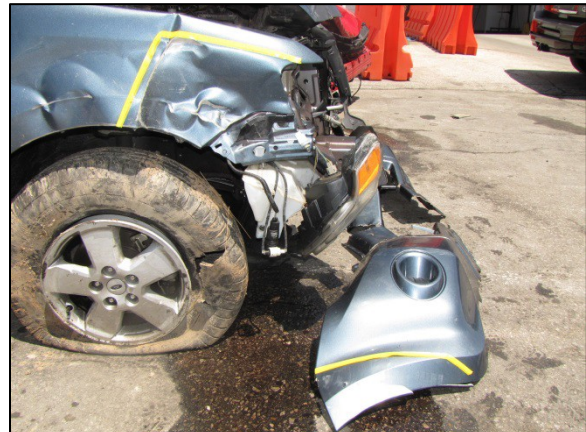
The Ford sustained direct impact damage to its front, undercarriage, right, and top planes consistent with the events of the crash. Induced damage due to the forces of the crash was also observed on the left and back planes. The direct contact damage relative to the sign post impact (Event 1) began on the front plane on the front right corner and consisted of abrasions to the right wraparound of the bumper fascia. This pattern extended rearward 41 cm (16.0 in) along the right plane with lateral crush to the fender (**Figure 13**). The direct damage ended 15 cm (6.0 in) forward of the right-front axle position. The maximum lateral crush measured 8 cm (3.2 in). The Collision Deformation Classification (CDC) associated with this damage was 12FREE3.

**Figure 13.** Right side view of the Ford depicting the Event 1 impact damage.

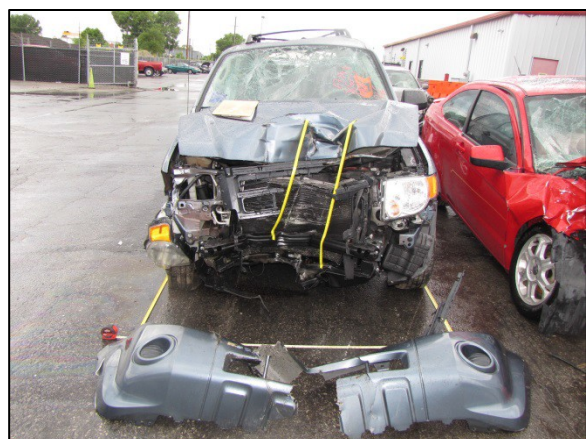
The direct damage from impact with the end terminal (Event 2) was located near the centerline of the front plane and measured 18 cm (7.0 in) in width (**Figure 14**). At the bumper elevation, the direct contact began 9 cm (3.5 in) left of center

**Figure 14.** Front view of the Ford depicting the Event 2 impact damage.

and ended 9 cm (3.5 in) right of center. The combined width of the direct and induced damage extended across the entire 109 cm (43.0 in) width of the front bumper reinforcement bar. The front bumper cover was fractured and separated during the impact.

The frontal impact involved the forward components of the engine compartment. Crush was noted to the grille and radiator core, and it extended vertically onto the hood face. There was no change in the wheelbase dimensions. A residual crush profile documented by the SCI Investigator using the total station produced the following measurements: C1 = 0, C2 = 22 cm (8.7 in), C3 = 33 cm (13.0 in), C4 = 29 cm (11.4 in), C5 = 15 cm (5.9 in), and C6 = 0. The CDC assigned to this damage pattern was 12FCEN2. This crash type was not in the scope of analysis by the WinSMASH program due to the yielding property of the guardrail end treatment. A borderline analysis of the crash severity (delta V) was calculated using the WinSMASH model's damage algorithm for comparison purposes only. The total calculated delta V was 36 km/h (22 mph) with longitudinal and lateral components of -36 km/h (-22 mph) and 0 km/h, respectively. The results of the borderline reconstruction appeared reasonable.

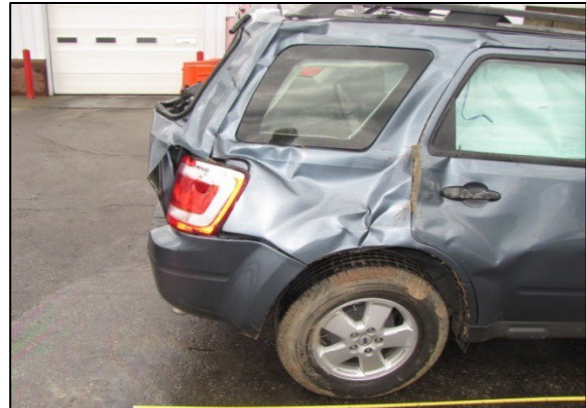
Rollover damage (Event 4) was present on the right and top planes, and consisted of body panel deformation and surface abrasions. The right outside mirror mount was fractured and the mirror was missing. Dirt and debris was embedded in the right rear door seam from ground contact (**Figure 15**). The right D-pillar area struck the ground and was buckled and abraded over an 84 x 91 cm (33.0 x 36.0 in) area, width by height. The maximum vertical deformation measured 3 cm (1.0 in) at the right

**Figure 15.** Right-side view of the Ford depicting the rollover damage at the D-pillar.

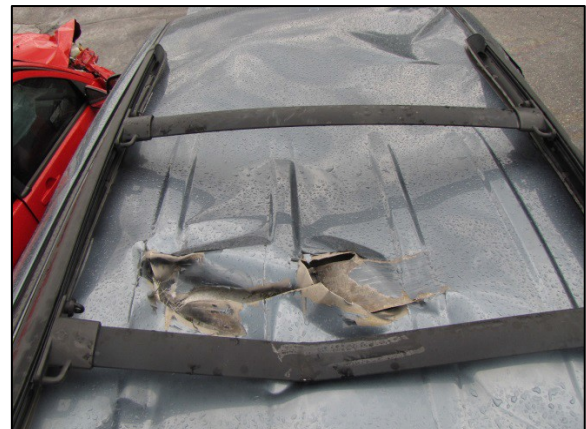
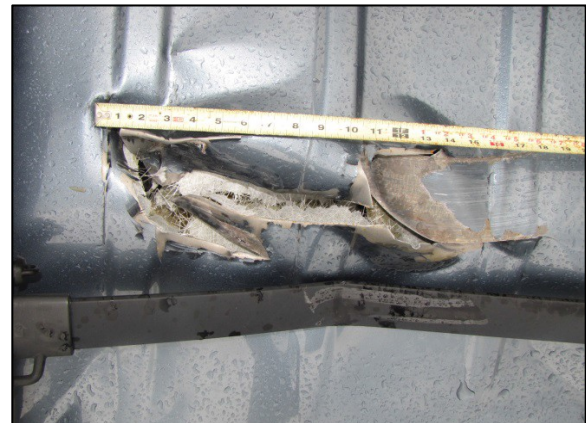
**Figure 16.** Overhead image of the Ford depicting the roof puncture. Front of the vehicle is toward the top of the image.

**Figure 17.** Close-up overhead view of the roof puncture to the Ford with a measuring tape reference.

**Figures 16 and 17** depict the damage associated with the Event 5 roof impact that consisted of a puncture to the roof, deformation of the rearmost lateral load bar of the luggage rack, and the disintegration of the backlight glazing. The roof puncture (Event 5) measured 15 x 48 cm (5.9 x 18.9 in). The size, shape, and orientation of the puncture were consistent with an impact to an I-beam support post of the guardrail. The deformation of the load bar was consistent with contact to the W-beam. The disintegrated backlight glazing was captured in the concave profile of the W-beam between guardrail post 5 and 6. The reconstruction of the crash dynamics determined that the roof puncture had occurred from post 5, due to its location and orientation. The CDC of this impact was 00TPCW2.

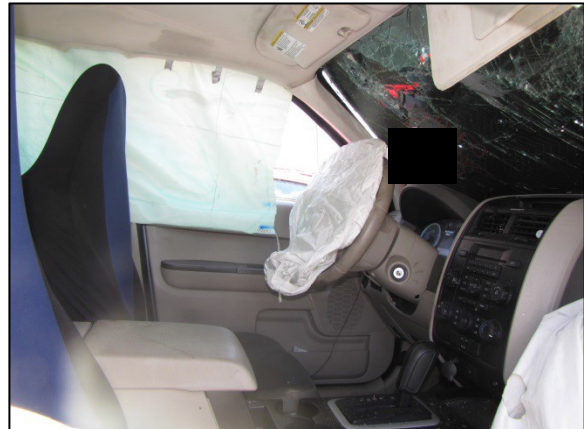
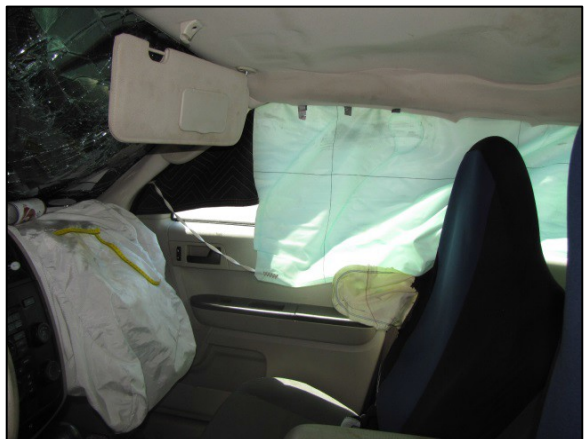
The front row of the Ford's interior (**Figures 18 and 19**) sustained minimal damage, which consisted of air bag deployment and occupant contacts. There was no intrusion at these seat positions. The driver seat was adjusted fully rear and the seatback was upright. The horizontal distance from the seatback to the center hub of the steering wheel measured 61 cm (24.0 in). A 6 x 4 cm (2.5 x 1.5 in) scuff mark was observed on the headliner directly above the driver seat. This mark was consistent with contact to the headliner from the driver's head during the rollover. The front row right seat was also adjusted fully rear. This seatback was reclined 10 degrees aft of

**Figure 18.** Left-front interior of the Ford.

**Figure 19.** Front-right interior image of the Ford.

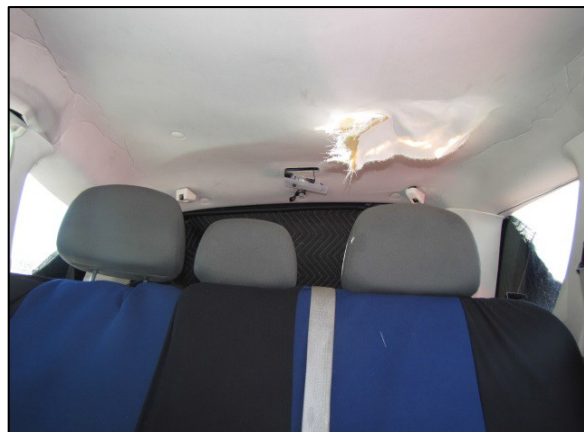
**Figure 20.** Second-row interior view of the Ford and the puncture to the roof.

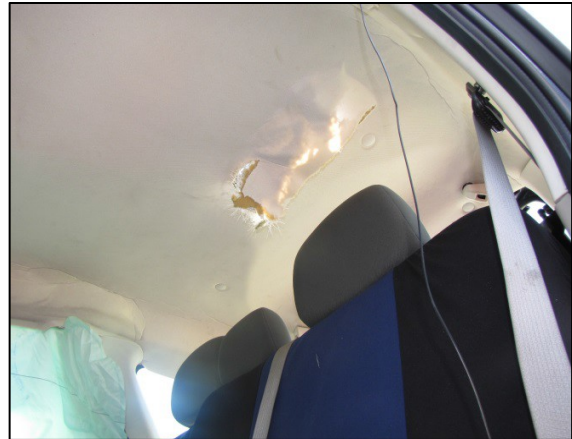
**Figure 21.** Oblique view of the Ford depicting the roof puncture.

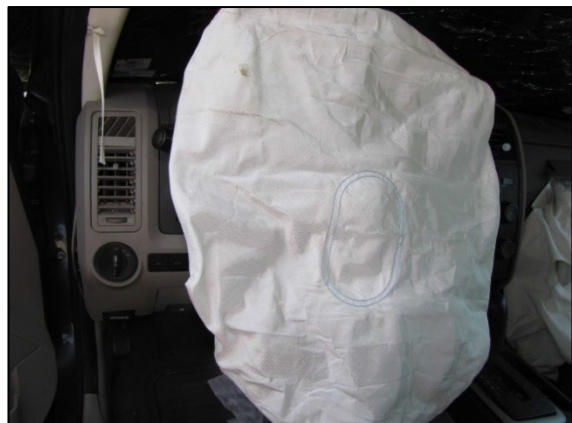
During the guardrail end terminal impact, the driver's frontal air bag deployed from its module located in the center hub of the steering wheel rim. In its deflated state, the driver air bag measured 48 cm (19.0 in) in diameter, was tethered by internal straps and was vented by two 5 cm (1.2 in) ports on the back side of the back in the 11 and 1 o'clock positions. There was no damage or evidence of occupant contact to the module cover flaps or the air bag. Examination of the deployed driver air bag (**Figure 22**) was unremarkable.

**Figure 22.** View of the Ford's deployed driver air bag.

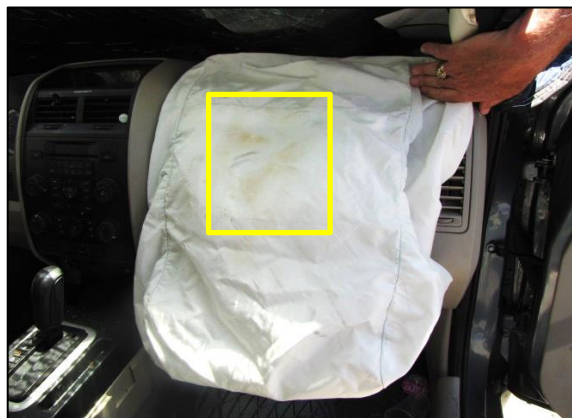
**Figure 23.** View depicting the make-up transfer to the face of the Ford's passenger frontal air bag.

on the air bag and was related to contact from the front-right occupant's face (**Figure 23**). In the make-up transfer were smaller transfers related to the occupant's eyebrows. A post-crash blood transfer was noted on the top surface/center aspect of the air bag.

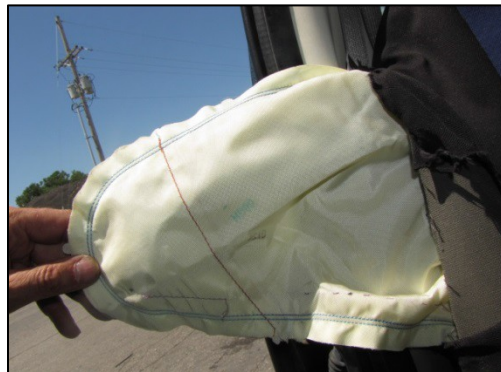
The front-row, right-seat-mounted air bag deployed forward from the outer aspect of the seatback bolster. The air bag tore through the after-market seat cover as it inflated and expanded forward. The air bag was oblong in shape (**Figure 24**) and measured 25 x 20 cm (10.0 in x 8.0 in), length by height, in its deflated state. The bottom edge of the air bag measured 28 cm (11.0 in) above the seat bight. It was not tethered and was vented by a 3 cm (1.0 in) port on its outer surface. The air bag was devoid of occupant contact evidence.

**Figure 24.** Right-seat-mounted, side-impact air bag of the Ford.

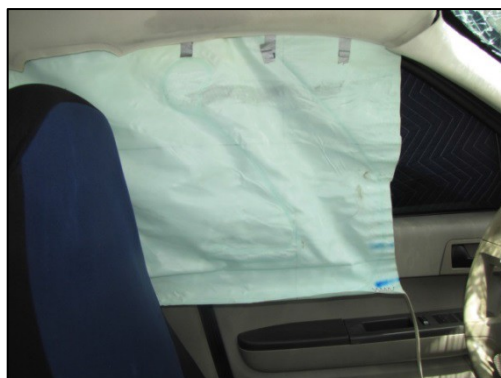
The IC air bags deployed from the roof-side rails and extended 53 cm (21.0 in) downward. In their deflated states, the air bags extended approximately 8 cm (3.0 in) the They were tethered to the A-pillars by a 41 cm (16.0 in) strap. These air bags were rectangular in shape with a void in coverage along the rake angle of the A-pillar (**Figure 25**). The IC air bags measured 142 cm (56.0 in) in overall length. Each IC provided 46 cm (18.0 in) of longitudinal coverage forward of the B-pillar along the side glazing of the first row and 97 cm (38.0 in) of coverage along the second row glazing to the C-pillar area. There was no evidence of occupant contact to either IC air bag.

**Figure 25.** Interior view of the Ford's left IC air bag at the driver's position.
