**National Highway
Traffic Safety
Administration**

DOT HS 812 985

**Special Crash Investigations:
On-Site Child Restraint System
Crash Investigation;
Vehicle: 2005 Honda Accord;
Location: Maine;
Crash Date: May 2016**

Special Crash Investigations
On-Site Child Restraint System Crash Investigation
Case Number: CR16014
Vehicle: 2005 Honda Accord
Location: Maine
Crash Date: May 2016

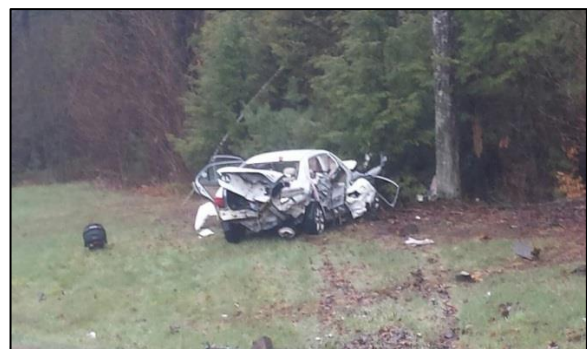
The back plane of the Honda struck the end terminal of the guardrail installation (Event 1). The vehicle's back plane deformation was consistent with the geometry of the end terminal. **Figure 4** is a view of the end terminal and guardrail along the approximate trajectory of the Honda. The impact displaced the end terminal to the south along the W-beam and fractured (wooden) post 1. The sudden deceleration of the initial impact accentuated the clockwise rotation of the Honda, and the vehicle's right plane struck the guardrail installation (Event 2). The force of this impact fractured wooden posts 2 to 7 and displaced the W-beam to the west. The Honda penetrated through the guardrail along its southwest trajectory and entered the roadside. The vehicle continued 31.3 m (102.7 ft) through a swale, evidenced by rolling tire impressions, and came to rest facing southwest near the tree line (**Figure 5**).

Figure 5. Looking to the southwest of the Honda at final rest. (Image provided by an internet news source.)

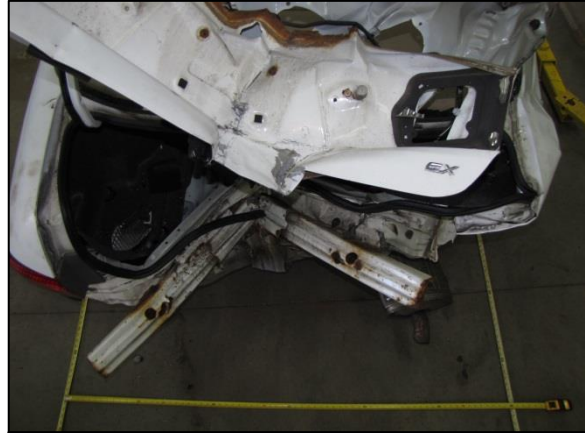
The back plane of the Honda (**Figure 8**) struck the end terminal of the guardrail system, resulting in a direction of force in the 5 o'clock sector. The direct contact damage began 8 cm (3.0 in) right of the vehicle's centerline and extended 51 cm (20.0 in) to the left. The impact deformed

the entire back plane and compressed the trunk space into a V-pattern. The combined length of the direct and induced damage spanned the vehicle's entire 147 cm (58.0 in) end width. The lateral component of the impact force displaced the back-right frame rail 17 cm (6.5 in) laterally to the left. The maximum crush measured 39 cm (15.3 in) and was located at the centerline of the bumper beam. The deformation was documented at the level of the bumper beam with a Field L 90 cm (35.0 in). Residual crush measurements were as follows: C1 = 4 cm (1.6 in), C2 = 19 cm (7.5 in), C3 = 37 cm (14.7 in), C4 = 39 cm (15.3 in), C5 = 12 cm (4.7 in), and C6 = 0. The Collision Deformation Classification (CDC) assigned to this damage pattern was 05BYEW3.

Figure 8. Overhead view of the Honda's back plane deformation.

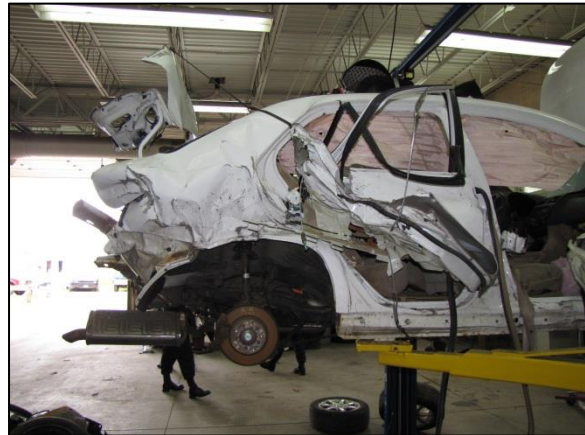
As the Honda continued to rotate CW, the right plane engaged the deformed guardrail, fractured the wooden posts, and penetrated through the installation. This Event 2 impact involved the entire length of the right plane (**Figures 9 and 10**). A residual crush profile was measured along the plane beginning on the fender, 37 cm (14.6 in) forward of the right-front axle, and extending rearward 378 cm (148.8 in) to a point 64 cm (25.2 in) aft of the right-rear axle on the deformed quarter panel. The documented residual crush profile was C1 = 21 cm (8.3 in), C2 = 10 cm (3.9 in), C3 = 4 cm (1.6 in), C4 = 6 cm (2.4 in), C5 = 6 cm (2.4 in), and C6 = 0. The crush profile under-represented the overall damage severity due to the wooden post construction of the guardrail and its yielding properties.

Figure 9. Right view depicting the deformation of the rear half of the Honda.

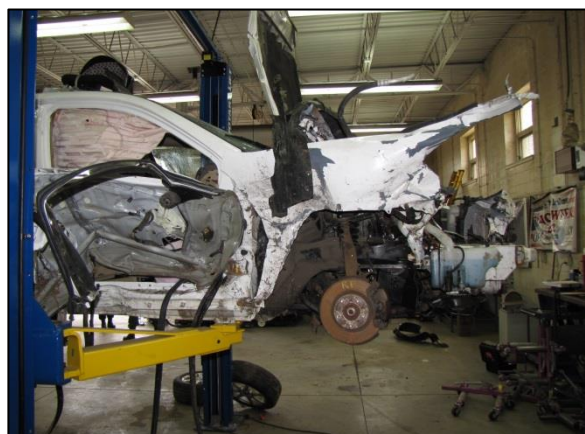
Figure 10. Right view depicting the deformation of the forward half of the Honda.

Impact damage from contact with the W-beam during the vehicle's penetration through the guardrail system was noted on the right plane from the radiator support plane rearward to the rear corner. Isolated impact damage from contact with wooden posts was noted at multiple locations along the right plane. At the right-front axle, a narrow fracturing of the right-front wheel rim with the fracture of the lower control arm of the right-front suspension was observed. Focused deformation was located on the fender at the A-pillar and at the mid-aspect of the front door. The outer sheet metal of the right-front door had separated, which revealed a fractured door beam with consistent deformation of the right sill 150 cm (59.0 in) forward of the rear axle. The right-rear door intruded laterally during the engagement and was holed 20 x 38 cm (8.0 x 15.0 in). The magnitude of the dynamic intrusion was great enough to cause the door to impact and fracture the left side of the CRS that was secured at second-row right seat position. The door's outer sheet metal was snagged and pulled up and forward. The latches for both right doors remained engaged. The CDC assigned to this damage pattern was 03RDEW3. Analysis of this event was outside the scope of the WinSMASH program due to the yielding nature of guardrail and the rotational dynamics of the vehicle during the impact.

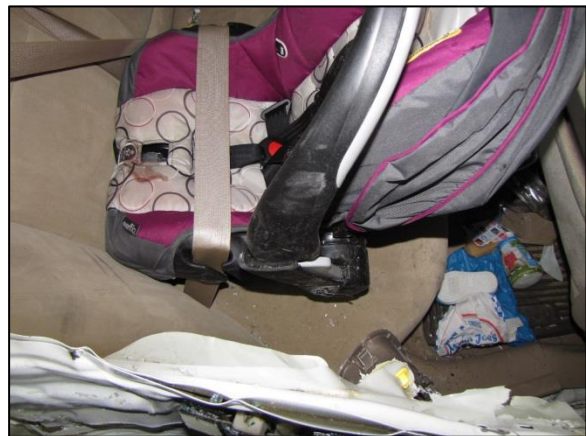
The intrusion was associated with the lateral engagement of the guardrail system as the vehicle rotated counterclockwise. The right-rear door panel intruded laterally and fractured the polymer shell (left aspect) of the Evenflo rear-facing CRS (**Figure 11**). This residual intrusion measured 10

Figure 11. Overhead view through the right-rear window of the Honda depicting the second-row intrusion and the contact to the Evenflo CRS.

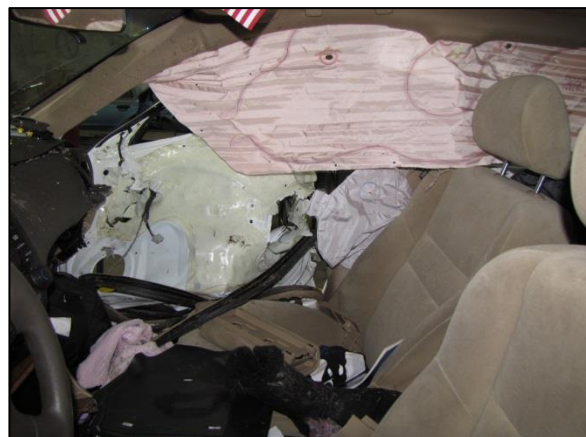
Figure 12. Lateral view of the front row depicting the intrusion of the right-front door.

cm (4.0 in). The residual lateral right-front door intrusion measured 20 cm (8.0 in) at the door's rear lower quadrant (**Figure 12**). Right B-pillar intrusion measured 8 cm (3.0 in). The front-row right seat was displaced laterally fracturing the center console. Compression of the door panel displaced the right lower A-pillar laterally 8 cm (3.0 in) into the right aspect of the instrument panel. Due to compression of the instrument panel, the mid-aspect of the instrument panel intruded longitudinally 10 cm (4.0 in). The kick panel forward of the lower right A-pillar intruded 8 cm (3.0 in) laterally into the floor space of the front-row right occupant position.

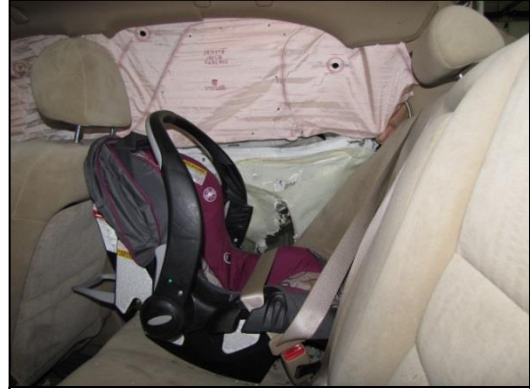
Figure 13. Lateral view across the second row depicting the deployed IC and its relationship to the Evenflo CRS.

The right IC air bag deployed from the roof-side rail/headliner juncture (**Figure 13**). The overall length of the air bag measured 173 cm (68.1 in) which extended from the right A-pillar to the right C-pillar. Vertically, the IC air bag extended downward 41 cm (16.1 in) to the level of the beltline. There was a triangular void at the right A-pillar, as the IC air bag was not configured with a sail panel. There was no damage or occupant contact to the deployed IC air bag, which was located in the plane of the exterior deformation.

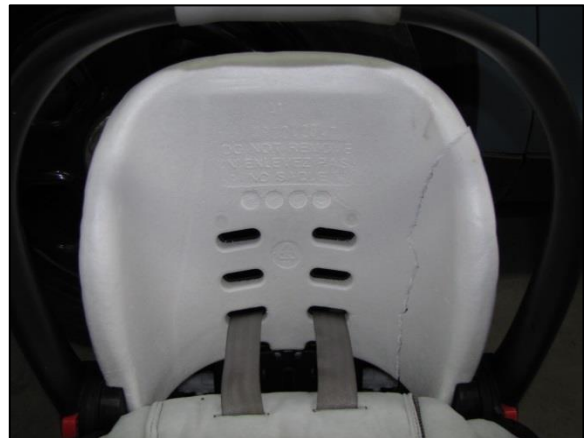
Figure 16. Front view depicting the fractured Styrofoam filler of the Graco CRS.

The continued CW rotation of the vehicle caused the second-row center occupant to translate to her left, where she contacted the left wing of the rear-facing CRS in the second-row left position. This contact with her upper body fractured the Styrofoam of this CRS.

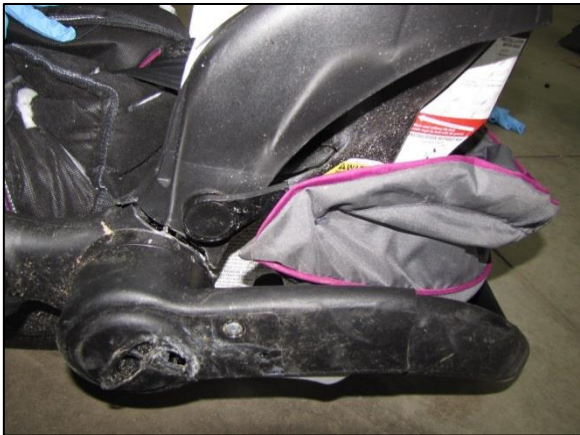
The force of the right-plane/guardrail impact caused the right-rear door to intrude. The intruded door struck the left side of the Evenflo CRS. The CRS shell was fractured adjacent at the pivot point (**Figure 20**) with a complete fracture/separation of the carrying handle 10 cm (3.9 in) above the pivot. The left aspect of the

Figure 20. Close-up, left-side view of the CRS and the fractured shell attributed to the intruding right-rear door of the Honda.

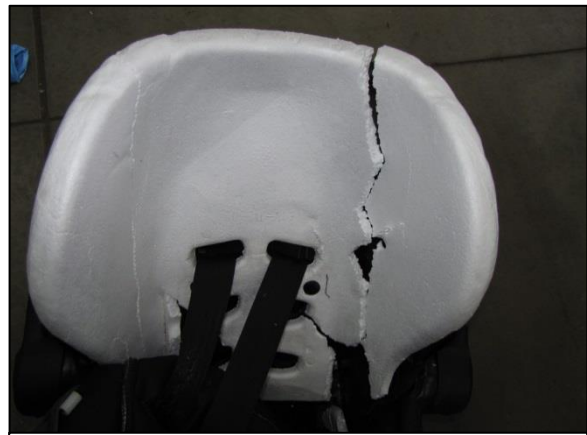
shell was abraded with associated stress marks in the polymer. After removal of the padded fabric covering, it was observed that the Styrofoam filler was fractured vertically on both sides of the CRS in the areas of the child's head and shoulders (**Figure 21**). The left-side fracture was attributed to the loading of the intruding right-rear door while the right-side fracture line was attributed to the loading by the second-row center occupant.

Figure 21. Front view depicting the fractured Styrofoam filler of the Evenflo CRS.

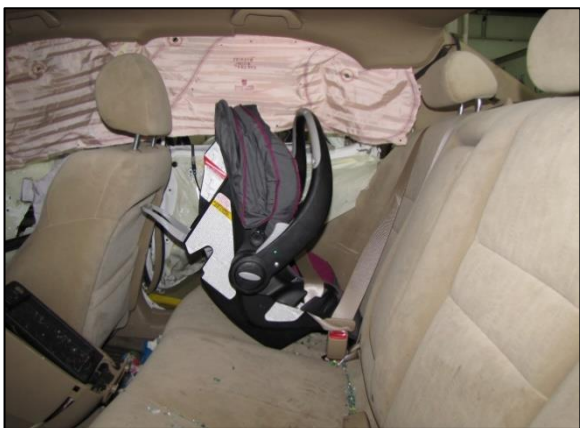
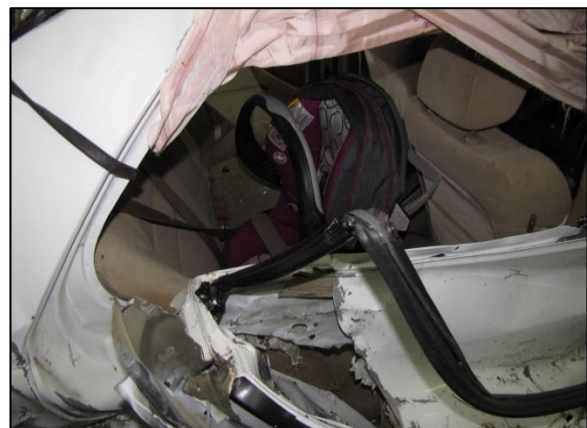
It was reported to the police investigator that the first responders to the crash found the Evenflo CRS tipped up and rotated rearward in the second-row right position. **Figure 22** and **23** are images depicting the reconstructed post-crash position of the Evenflo CRS. It was theorized that the combination of the kinematic response to the back-plane impact and the right-plane impact force and intrusion caused the displacement of the CRS.

Figure 22. Left lateral view of the reconstructed post-crash position of the Evenflo CRS in the second row of the Honda.

Figure 23. Right lateral view of the reconstructed post-crash position of the Evenflo CRS in the second row of the Honda.
