DOT HS 812 986

**Special Crash Investigations:  
Air Bag Non-Deployment Crash  
Investigation;  
Vehicle: 2014 Toyota Avalon;  
Location: Kansas;  
Crash Date: January 2019**

**Special Crash Investigations  
Air Bag Non-Deployment Crash Investigation  
Office of Defects Investigation  
Case Number: DS19011  
Vehicle: 2014 Toyota Avalon  
Location: Kansas  
Crash Date: January 2019**

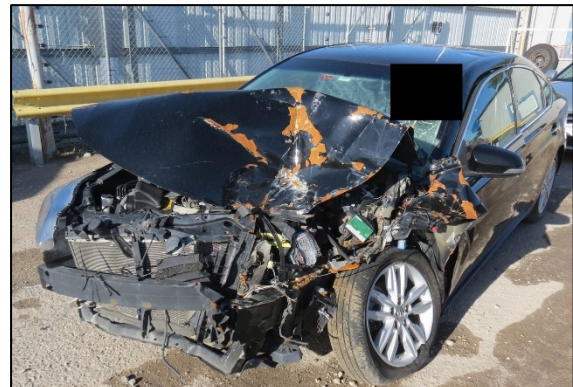
This report documents the on-site investigation of an air bag non-deployment crash involving a 2014 Toyota Avalon (**Figure 1**). The frontal air bags did not deploy. This investigation was initiated by NHTSA’s Office of Defects Investigation. Special Crash Investigations (SCI) assigned the case to Dynamic Science, Inc., in May 2019. The Toyota was located at an auction lot, and the SCI team obtained permission to inspect the vehicle. The inspection was completed in May 2019. The Toyota had previously been inspected by NHTSA’s Vehicle Research and Test Center (VRTC) staff. The Toyota was supported by the Bosch Crash Data Retrieval (CDR) system, and the vehicles’s ACU was imaged during their inspection. No events were recorded by the Bosch tool. The vehicle’s ACU was removed and was in the custody of the VRTC. The vehicle was being inspected in connection with ODI investigation EA19-001.

**Figure 1.** The 2014 Toyota Avalon.

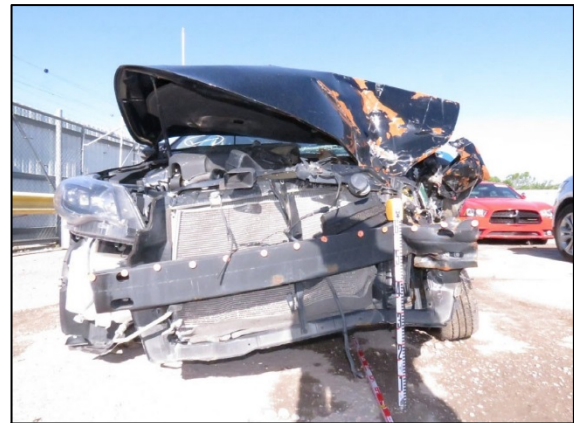
The Toyota sustained moderate front plane damage from the impact to the rear plane of the Lexus (**Figure 3**). The direct damage began at the left front bumper corner and extended 31 cm (12.2 in) to the right. The Field L extended from bumper corner to bumper corner. Thirteen measurements were taken at bumper backing bar level by the Nikon Total Station and the Faro Blitz program computed crush measurement in six increments as follows:  $C_1 = 10$  cm (3.9 in),  $C_2 = 22$  cm (8.6 in),  $C_3 = 18$  cm (7.0 in),  $C_4 = 13$  cm (5.1 in),  $C_5 = 6$  cm (2.3 in), and  $C_6 = 1$  cm (0.4 in). The maximum crush was located 23 cm (9.0 in) from the left front bumper corner. The direct damage extended 84 cm (33.0 in) down the left plane. The Collision Deformation Classification (CDC) was 12FLEE3.

**Figure 3.** Frontal damage, the 2014 Toyota Avalon.

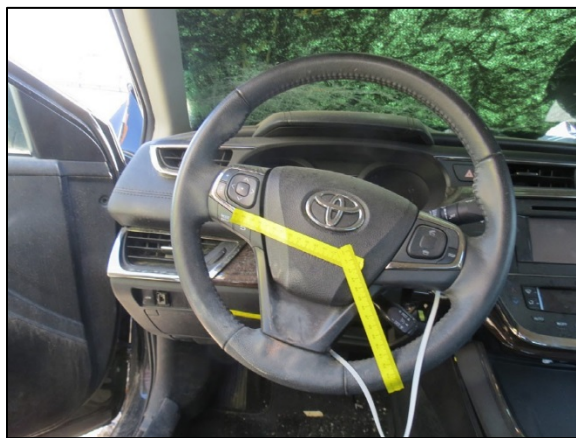
The Toyota sustained minor interior damage as a result of this crash. There was slight longitudinal intrusion at the base of the left A-pillar. The windshield was fractured from hood contact. There was no other glazing damage. There were scuff occupant contacts to the left lower instrument panel and make-up contacts to the steering wheel hub (**Figure 4**). All the doors remained closed and operational.

**Figure 4.** Steering wheel hub/lower instrument panel contacts, the 2014 Toyota Avalon.

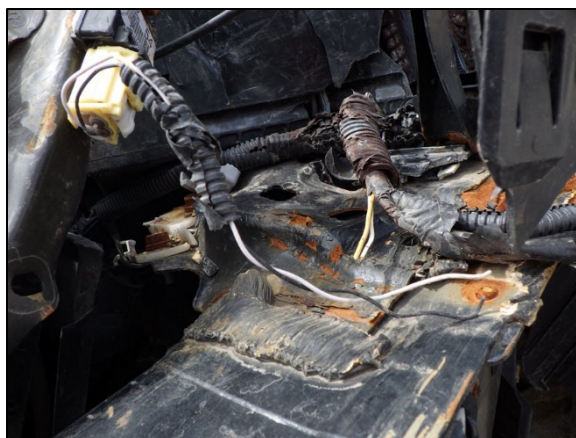
The Toyota was equipped with 10 air bags for supplemental restraint: dual-stage frontal air bags for the driver and front right passenger positions; front row seat-mounted side air bags; front row knee air bags; second row seat-mounted side air bags; and side-impact inflatable curtain (IC) air bags for the front and second row seats. There were no air bag deployments. The vehicle was configured with an air bag sensor assembly, front impact sensors, side-impact sensors (front doors), and side-impact sensors (front and rear). The dual front impact sensors were located on the vehicle body above the backing bar on the frame rails. The left sensor wiring was damaged during the crash (**Figure 5**).

**Figure 5.** Left frontal air bag sensor, the 2014 Toyota Avalon.

The driver's frontal air bags did not deploy and the pretensioner did not actuate. The owner's manual indicated that the frontal air bags would deploy in impacts that exceed the set threshold level. The threshold level was reported to be the level of force corresponding to an approximately 20 to 30 km/h (12 to 18 mph) collision with a fixed wall that does not move or deform. This threshold might be higher in the case of underride collisions or impacts against deformable objects and vehicles. In this crash, the WinSMASH algorithm calculated a total delta V of 25 km/h (16 mph). The crash severity and vehicle crash configuration suggest that the driver's frontal air bag should have deployed in this crash. The damage was outside of the left frame rail, possibly causing a longer delta T and a late deployment. Regardless, a non-deployment event should have been recorded.

ODI opened an engineering analysis (EA19-001) in April 2019. The subject was air bag ACU electrical overstress. The issue was that an internal component of the ACU that monitors signals from crash signals may fail that may disable the ACU and cause a non-deployment of needed air bags. It has been reported that the disablement occurs in certain types of frontal crashes. A condition known as electrical overstress may affect the internal components of the ACU. It is not known if this was the issue in this crash.
