**Special Crash Investigations:  
On-Site Air Bag Inflator Rupture  
Crash Investigation;  
Vehicle: 2004 Honda Civic;  
Location: Louisiana;  
Crash Date: July 2017**

<b>16. Abstract</b> This report documents the on-site investigation of the driver air bag inflator rupture in a 2004 Honda Civic that resulted in the fatality of a belted 60-year-old male driver. The Honda was involved in an inline, front-to-rear crash with a 2015 Toyota Camry. The crash occurred when the Toyota, driven by a belted 28-year-old female, was stopped in traffic on an east/west multi-lane roadway. The Honda's front plane then struck the Toyota's back plane. Dual-stage frontal air bags in the Honda deployed during the crash. During deployment, the Honda driver's frontal air bag inflator ruptured, projecting multiple metallic fragments rearward. These fragments contacted the Honda's driver and produced severe neck injuries. Emergency medical services personnel transported the Honda's driver to the hospital while providing trauma and resuscitative care, but he succumbed to his injuries and was pronounced deceased upon arrival at the hospital.

**Special Crash Investigations**  
**On-Site Air Bag Inflator Ru

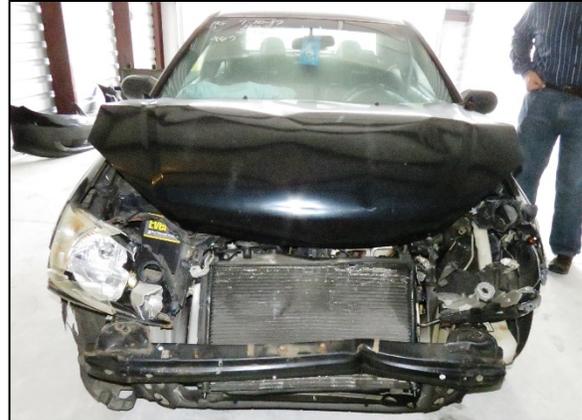
Damage to the exterior of the Honda was distributed across the front plane, attributable to the crash event with the Toyota. In the damage pattern was moderate front plane deformation, with longitudinal displacement of the bumper beam, hood, radiator support, and underlying front plane components. Both headlight assemblies were disintegrated, and the bumper fascia was fractured and separated from the vehicle. Direct contact spanned the entire 150 cm (59.0 in)

undeformed end width (UEW). Using a direct and induced damage length of 118 cm (46.5 in) across the entire bumper beam, a residual crush profile was obtained. Due to the underride characteristics of the damage pattern, residual crush was also documented at the level of the upper radiator support on the deformed hood. The averaged resultant crush profile consisted of the following measurements: C1 = 19 cm (7.5 in), C2 = 20 cm (7.9 in), C3 = 18 cm (7.1 in), C4 = 14 cm (5.5 in), C5 = 18 cm (7.1 in), and C6 = 17 cm (6.7 in). Maximum crush on the bumper beam was observed 30 cm (11.8 in) right of the left front bumper corner. The collision deformation classification (CDC) assigned to the Honda Civic for the frontal damage pattern was 12FDEW2. **Figure 4** depicts a horizontal view of the frontal damage and crush profile, while **Figure 5** depicts the damage profile from overhead.

The damage with CDC algorithm of the WinSMASH model was used to calculate a reconstruction of the frontal impact for analysis purposes. The calculated delta V of the Honda Civic for its impact with the Honda Accord was 31 km/h (19 mph). Longitudinal and lateral components of the delta V were -31 km/h (-19 mph) and 0 km/h (0 mph), respectively. These results seemed reasonable.

**Figure 4.** Front damage profile to the 2004 Honda Civic.

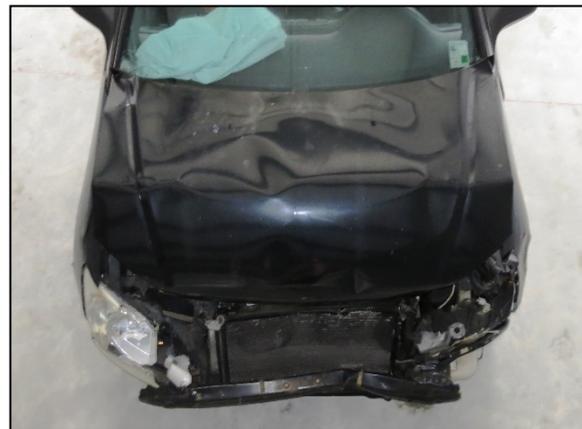
**Figure 5.** Overhead view of the Honda's damage profile.

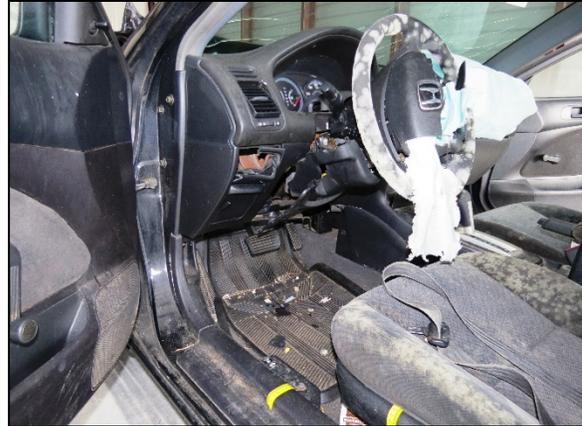
The interior of the Honda Civic was inspected for crash-related damage and occupant contact. There was no intrusion of the occupant compartment space associative to the exterior crash force. At the time of the SCI inspection, the majority of the interior surfaces surrounding the driver's area were covered in a visible white/gray discoloration. This was bacteria/mold that had developed over the course of time since the crash. A powdery residue, one metallic object, and several polymer fragments were observed to be scattered on the floor space in front of the driver's position. The polymer fragments were from fractured trim components surrounding the steering column, while the residue had fallen out of the driver's air bag module. There was no damage to the roof/headliner associated with any fragments from the air bag inflator, and no

fragments were found anywhere else in the vehicle's interior. **Figure 6** depicts the driver's area in the Honda at the time of inspection.

Occupant contact in the Honda's interior was identified to the left instrument panel. A heating, ventilation, and air conditioning (HVAC) louvre on the left aspect of the left instrument panel was fractured and displaced, likely from contact by the driver's left hand. There were also areas of scuffing to the lower instrument panel beneath the steering wheel/column and deformation at the left aspect of the panel, attributable to contact from the driver's knees.

**Figure 6.** View of the driver's area in the Honda.

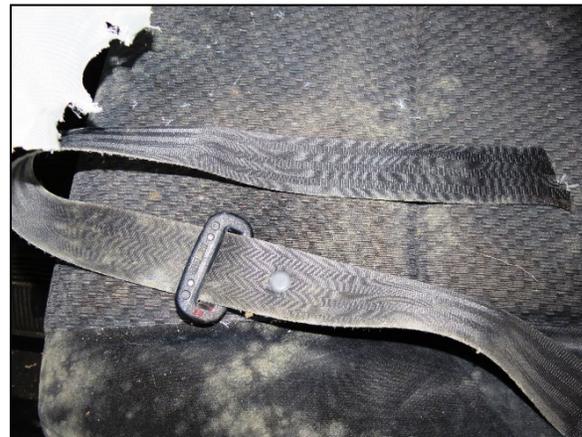
At the time of the SCI inspection, the driver's seat belt system was observed to have been cut in two locations. These cuts were the result of the actions of emergency responders to remove the driver from the Honda. A 105 cm (41.3 in) long section remained attached to the lower anchor, and contained the sliding latch plate (**Figure 7**). Minor loading evidence abrasions were observed in the belt path of the latch plate. A second section was loose, and measured 76 cm (29.9 in) in length. This section had two areas of tears to the webbing (likely from metallic fragments from the ruptured inflator) and was covered in the driver's blood. The final section measured just 9 cm (3.5 in) in length, and was protruding from the D-ring. Based on the post-crash condition of the driver's seat belt system, it was apparent that the driver was belted at the time of the crash.

**Figure 7.** Lower portion of the driver's seat belt webbing and latch plate in the Honda.

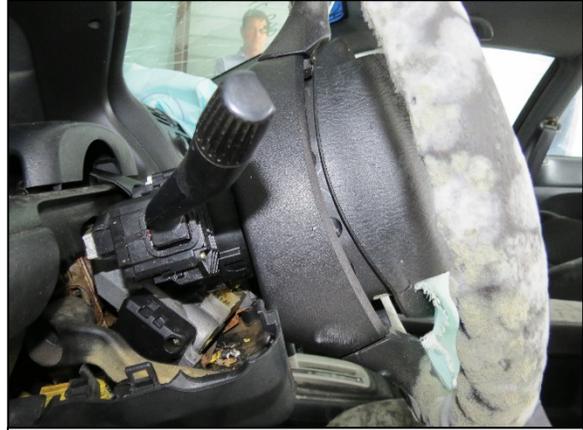
The driver's frontal air bag had deployed from the steering wheel-mounted module. There was no damage to the H-configuration cover flaps, though the module housing itself appeared deformed. The entire module/assembly was partially separated from the steering wheel spokes (**Figure 8**). The SCI investigator observed that the fabric of the driver's air bag was separated entirely from the module. It was revealed that the investigating law enforcement agency had cut the fabric circumferentially adjacent to the cover flaps during the investigation process as they sought to determine the source of the driver's penetrating injuries. The air bag fabric was retained as evidence and remained in possession of the law enforcement agency at the time of the SCI vehicle inspection.

**Figure 8.** Damaged steering column trim in the Honda as a result of driver air bag inflator rupture.

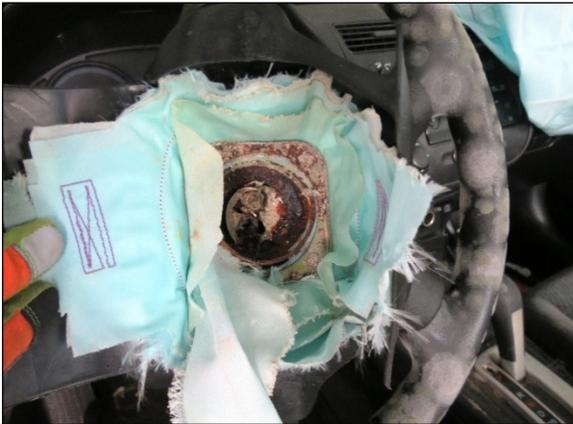
The SCI investigator observed the driver's air bag module with its internal components exposed (**Figure 9**). It was visually apparent that the inflator had ruptured, as only the rear half of the housing remained. A large portion of the inflator was found loose in the vehicle (**Figure 10**). This fragment had been discovered in the vehicle post-crash (exact location unknown) by a family member of the driver and secured in the vehicle by the attorney. A label on the front of this inflator fragment contained the serial nomenclature JBAN4736344.

**Figure 9.** View of the Honda's driver air bag module and exposed internals at the time of the SCI inspection.

Based on a preponderance of the evidence, the SCI investigator determined that the driver's frontal air bag inflator in the 2004 Honda Civic ruptured during the deployment sequence, producing multiple fragments. These fragments were projected rearward and cut through the air bag's fabric, then continued into the occupant compartment. Several of these fragments contacted the driver's seat belt webbing and the driver, partially cutting the seat belt webbing and inducing severe lacerations to the driver's neck. The driver's injuries ultimately led to his death.

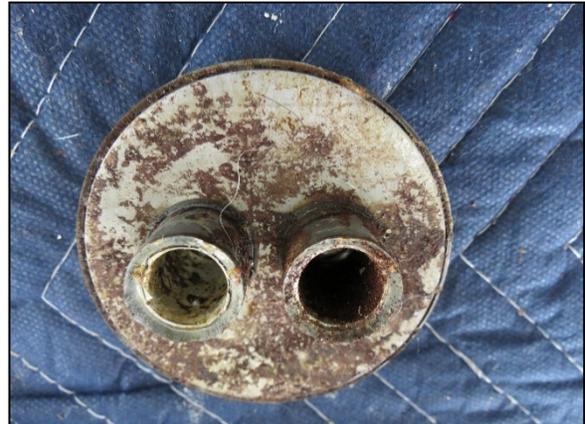
**Figure 10.** Separated portion of the Honda's air bag inflator that remained in the vehicle.

the ruptured inflator could induce occupant injury. The recall remedy was replacement of the inflator by the vehicle's manufacturer. No remedy had been reported for this specific 2004 Honda Civic in regard to this specific driver air bag inflator, either prior to the crash or at the time of the SCI investigation.

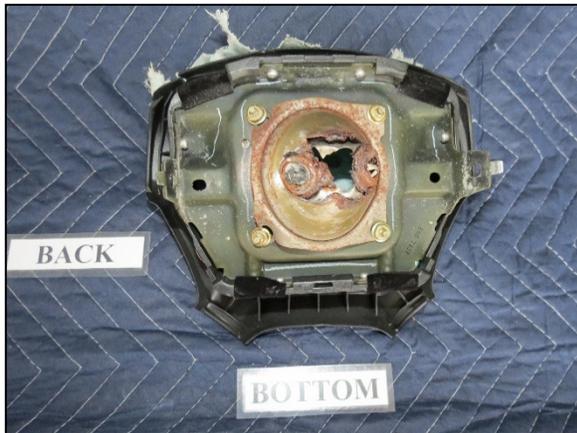
The driver's air bag module was removed from the steering wheel hub by extracting two torx screws and disconnecting the wiring harness. This process was performed by the Honda manufacturer's representative during the joint inspection process. **Figure 11** depicts the back aspect of the module following its removal from the vehicle. Warning labels were visible on the sides of the module. There also were markings identifying the Honda manufacturer on the module's components. However, there were no labels affixed to the air bag module housing that provided serial numbers or manufacturer part numbers. Found loose in the hub of the steering wheel was the label from the backside of the inflator (**Figure 12**). The serial nomenclature on the label matched the nomenclature from the front of the separated portion of the inflator, and also identified the year of manufacture as 2002.

**Figure 11.** View of the driver's air bag module following its removal from the 2004 Honda Civic.

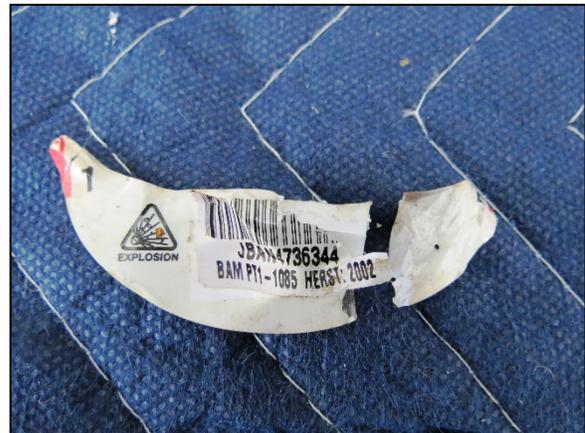
**Figure 12.** Label found in the hub of the Honda's steering wheel following removal of the air bag module.

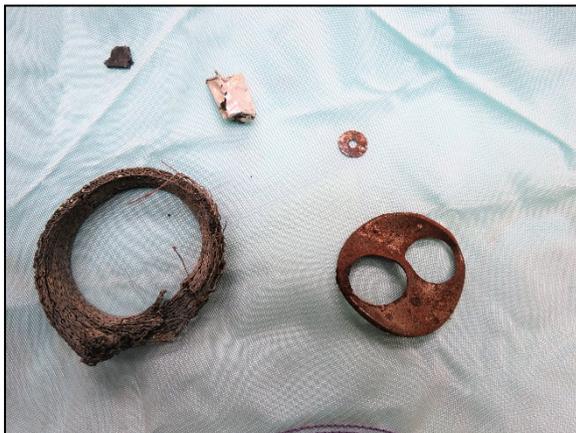
**Figure 13.** Fragments from the Honda's air bag inflator retained by the investigating law enforcement agency.

The SCI investigator met with the law enforcement agency after completing the vehicle inspection to examine the remnants of the driver's air bag that had been retained as evidence. Among these components were two washers, the wire mesh filtering agent, and an aluminum

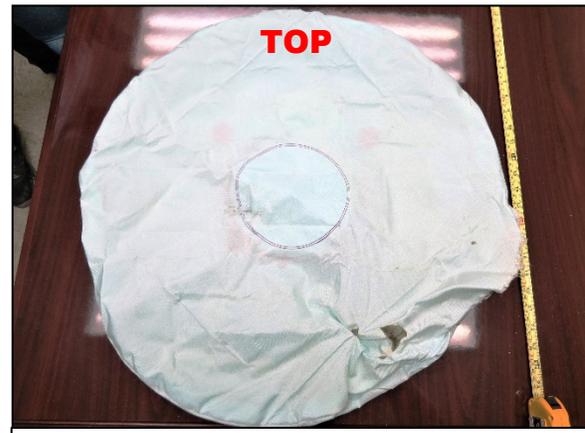
**Figure 14.** View of the 2004 Honda Civic's driver air bag fabric.

fragment (**Figure 13**). In its deflated state (**Figure 14**), the overall diameter of the air bag was 62 cm (24.4 in). A 16 cm (6.3 in) long burst of the fabric was identified on the right aspect of its circumference.

There was an area of melted fabric at the right lower quadrant of the air bag's face, where a hot metallic object (wire mesh) had come to rest following deployment/rupture. Last, a 7 cm (2.8 in) long jagged perforation was observed to the left aspect of the center stitch pattern (**Figure 15**). It was determined that the tear resulted from a fragment of the ruptured inflator being expelled outward and through the fabric during the deployment/rupture. Nomenclature on the back of the driver's frontal air bag module identified that it had been assembled in Mexico on September 17, 2002.

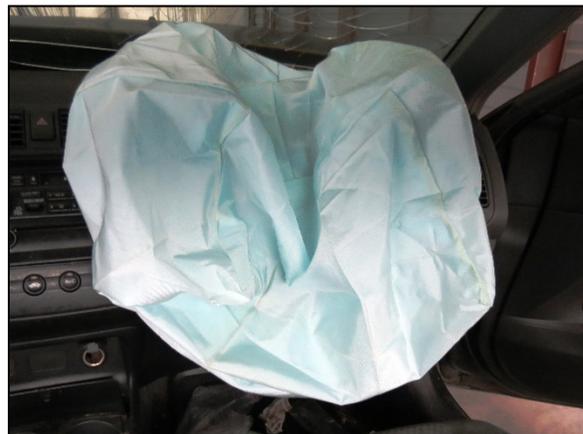
The passenger's frontal air bag (**Figure 16**) deployed from the module in the top of the instrument panel through the cover flaps without damage. In its deflated state, the air bag measured 66 cm (26.0 in) wide and 73 cm (28.7 in) tall. It extruded 50 cm (19.7 in) rearward from the module. The air bag was vented on both sides by 5 cm (2.0 in) vents. There was no damage or occupant contact discernable during the SCI inspection to the front right occupant's frontal air bag.

**Figure 16.** Deployed passenger's air bag in the 2004 Honda Civic.

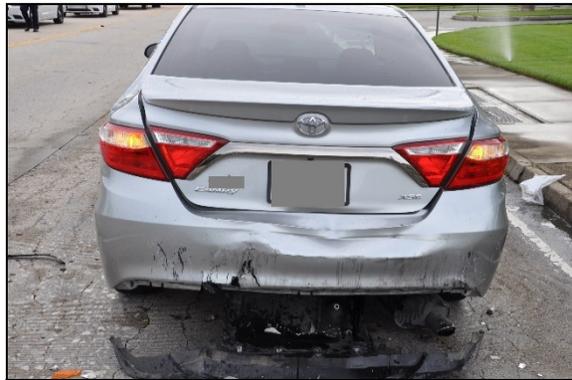
**Figure 18.** Back plane damage to the Toyota (on-scene image provided by the investigating law enforcement agency).

The following damage assessment was based on a review of on-scene images of the Toyota provided to the SCI investigator by the investigating law enforcement agency (**Figure 18**). The damage to the Toyota from the crash consisted of minor deformation to the rear bumper fascia.

The lower trim of the bumper fascia was fractured and separated from the vehicle. With the bumper fascia in place, there was no visible structural damage to the Toyota. The estimated CDC for the Toyota's damage profile was 06BDLW1. The damage CDC algorithm of the WinSMASH model was used to calculate the severity of the crash for the Toyota. The total delta V was 24 km/h (15 mph), with respective longitudinal and lateral components of 24 km/h (15 mph) and 0 km/h (0 mph). These results seemed reasonable.
