DOT HS 813 006

# **Special Crash Investigations: On-Site Air Bag Inflator Rupture Crash Investigation; Vehicle: 2002 Honda Civic; Location: Arizona; Crash Date: June 2018**

**Special Crash Investigations  
On-Site Air Bag Inflator Rupture Crash Investigation  
Office of Defects Investigation  
Case Number: DS19004  
Vehicle: 2002 Honda Civic  
Location: Arizona  
Crash Date: June 2018**

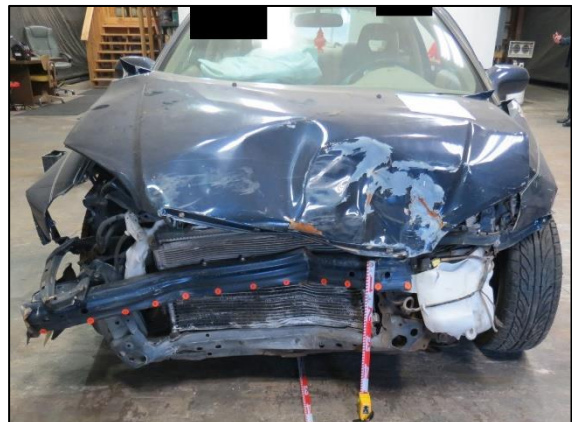
This report documents the on-site investigation of an inflator rupture of a frontal air bag module in a 2002 Honda Civic (**Figure 1**). The inspection documented the ruptured driver air bag inflator, the air bag, and the steering wheel/column assembly. It was determined that the inflator did rupture. This investigation was initiated by the Office of Defects Investigation (ODI) in response to notification by an attorney. The Special Crash Investigations (SCI) group of the National Highway Traffic Safety Administration assigned the case to Dynamic Science, Inc., in March 2019. The Honda was held by the plaintiff's attorney at a private facility. The vehicle was inspected in March 2019. Parties associated with the attorney and Honda were present during the inspection. The vehicle was not supported by the Bosch Crash Data Retrieval (CDR) system.

**Figure 1.** The 2002 Honda Civic.

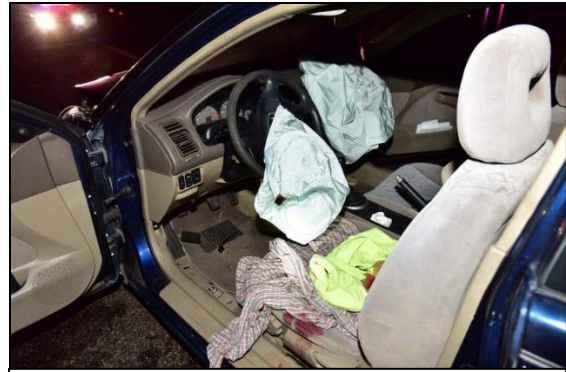
**Figure 2.** Frontal air bag deployments, the 2002 Honda Civic (police image).

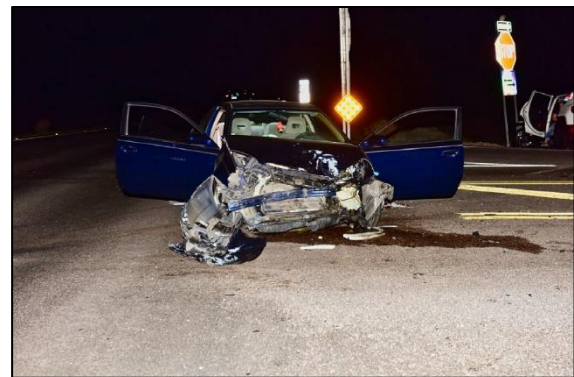
**Figure 5.** The 2002 Honda Civic at final rest, looking north (police image).

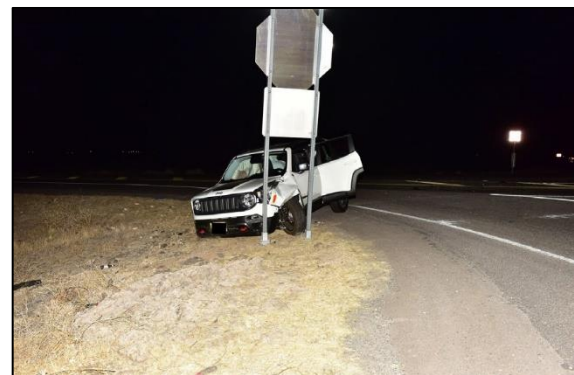
As the Jeep entered the intersection, it was struck in the right plane by the Honda (Event 1). The “missing vehicle” algorithm of the WinSMASH program calculated a total delta V of 50 km/h (31 mph) for the Honda. The longitudinal and lateral components were -47 km/h (-29 mph) and 17 km/h (11 mph), respectively. The collision fit the model and the results appear reasonable. The WinSMASH program calculated a total delta V of 35 km/h (22 mph) for the Jeep. The longitudinal and lateral components were -12 km/h (-7 mph) and -33 km/h (-21 mph), respectively. The results appear borderline. The Honda was displaced in a northeast direction and came to rest in the intersection facing south (**Figure 5**). The Jeep was displaced in a northeast direction, entered the right shoulder of the westbound lane, and struck a stop sign pole (Event 2) before coming to rest facing northwest next to the pole (**Figure 6**).

**Figure 6.** The 2017 Jeep Renegade at final rest/event 2, looking east (police image).

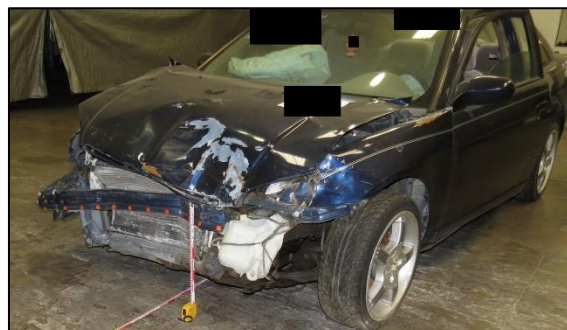
The Honda sustained moderate front plane damage from the impact to the right side of the Jeep (**Figure 7**). The direct damage began at the left front bumper corner and extended from bumper corner to bumper corner. The backing bar had been shifted 40 cm (15.6 in) to the right. The Field L extended from bumper corner to bumper corner. Twelve measurements were taken at the bumper backing bar level by the Nikon Total Station, and the Faro Blitz program computed crush measurement in six increments as follows:  $C_1 = 23$  cm (9.0 in),  $C_2 = 29$  cm (11.4 in),  $C_3 = 35$  cm (13.7 in),  $C_4 = 30$  cm (11.8 in),  $C_5 = 20$  cm (7.8 in), and  $C_6 = 10.0$  cm (3.9 in). The Collision Deformation Classification (CDC) was 11FDEW2.

**Figure 7.** The 2002 Honda Civic.

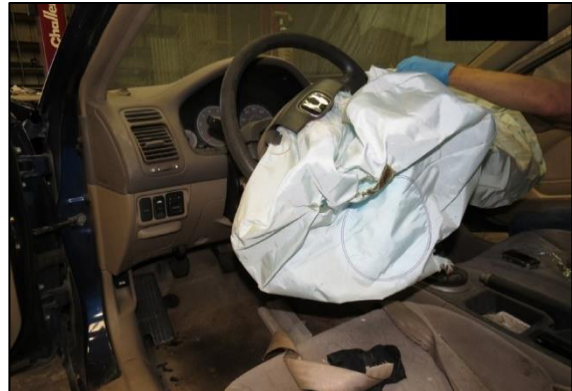
**Figure 8.** Driver's frontal air bag, the 2002 Honda Civic.

The driver's air bag deployed from an H-configuration module cover located in the hub of the steering wheel rim (**Figure 8**). The air bag was circular and measured 46 x 43 cm (18.1 x 16.9 in) in diameter in its deflated state (**Figure 9**). The air bag was configured with rear panel vent ports and was tethered. The air bag inflator ruptured during the air bag deployment. The air bag face was holed at the 12 and 6 o'clock positions. The upper hole was measured 7 x 4 cm (2.7 x 1.5 in). There was an area of melting adjacent to this hole. The lower hole measured 6 x 4 cm (2.3 x 1.7 in).

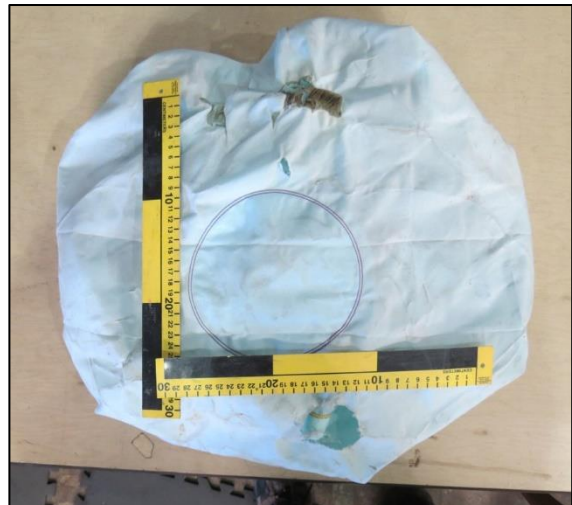
**Figure 9.** Driver's air bag, the 2002 Honda Civic.

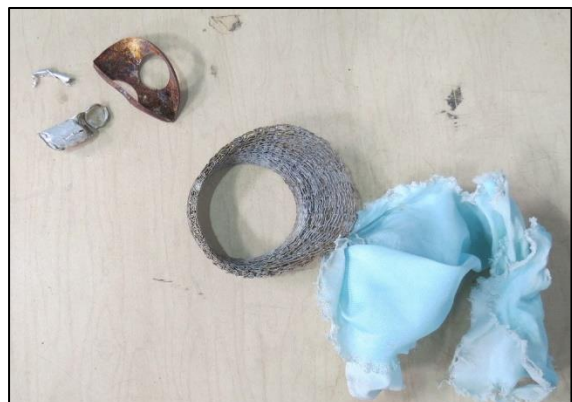
**Figure 10.** Components found inside the air bag, the 2002 Honda Civic.

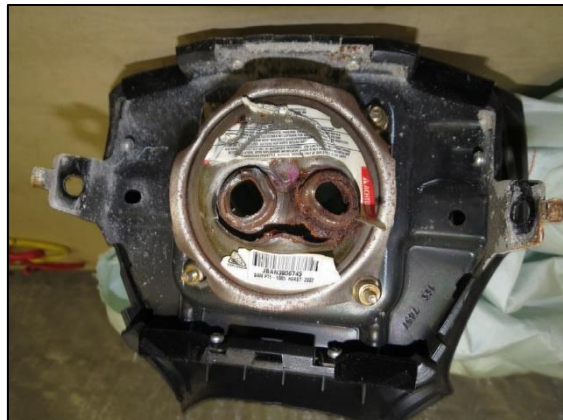
The driver's air bag inflator was manufactured by Takata in 2002 and appeared to be original to this vehicle, per Honda. At the time of the inspection, the bottom portion of the module was still attached to the vehicle. The top of the module and other pieces were found in the vehicle by a relative of the driver and placed in a bag. The module was unbolted from the steering wheel and further torn down for inspection. Multiple fragments were recovered from in the air bag (**Figure 10**). The back of the inflator housing was damaged with three of the four attachment bolts torn (**Figures 11-12**).

**Figure 11.** Back view of ruptured inflator housing, the 2002 Honda Civic.

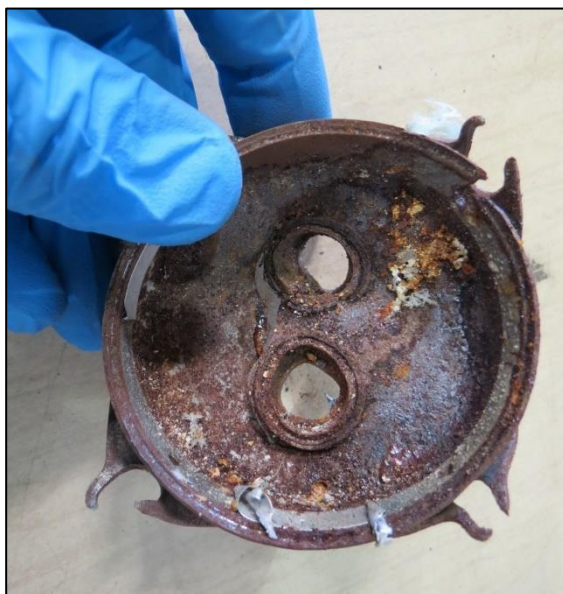
**Figure 12.** Interior surface of the ruptured inflator housing, the 2002 Honda Civic.

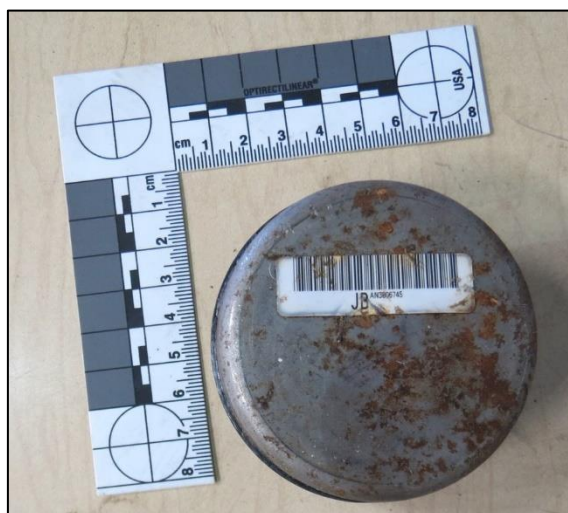
The Stage 2 cap, both squibs, and a metal fragment were found in the vehicle (**Figures 13-15**). The top surface of the cap was labeled JBAN3806745. It weighed 318 grams (11.2 ounces). The metal fragment weighed 4 grams (0.1 ounces) and each initiator weighed 10.9 grams (0.38

ounces). Based on available evidence, it was determined that the driver's frontal air bag inflator ruptured during its Stage 1 deployment and displaced the Stage 2 inflator cap rearward toward the driver. The cap holed the air bag's fabric and struck the driver on the left side of his face and neck resulting in fatal injuries.

**Figure 13.** Stage 2 inflator cap, the 2002 Honda Civic.

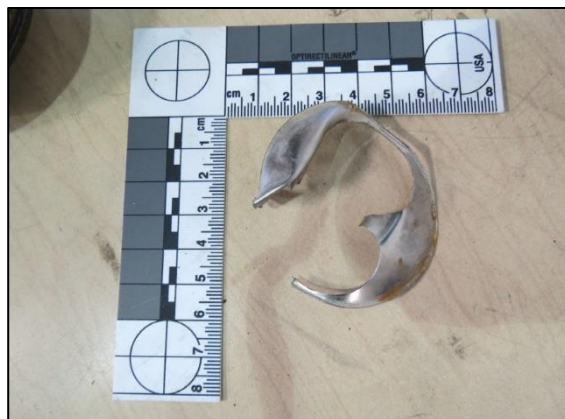
**Figure 14.** Inflator metal fragment, the 2002 Honda Civic.

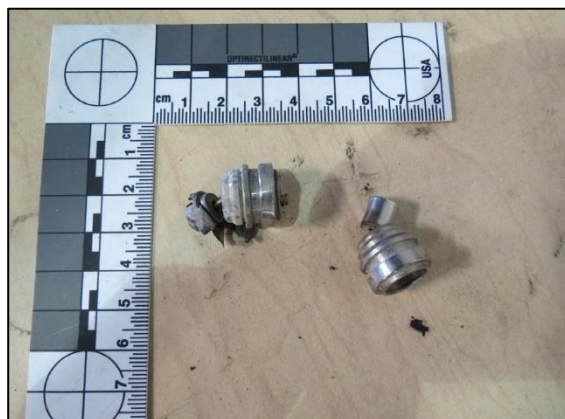
**Figure 15.** Inflator squibs, the 2002 Honda Civic.

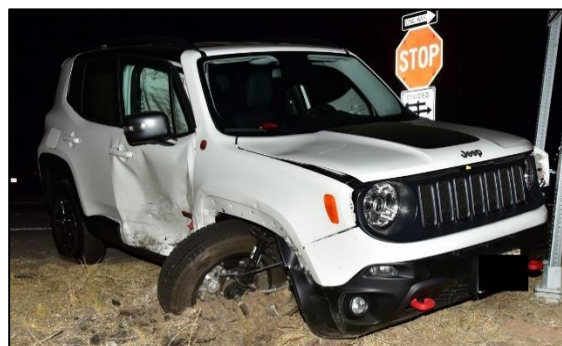
**Figure 16.** The 2017 Jeep Renegade, right plane damage (police image).

The Jeep sustained moderate damage to the right plane from the impact with the Honda (**Figure 16**). The direct contact began near the B-pillar and extended to the front right bumper corner. The front right axle was displaced. The CDC for this impact was 02RYEW2. The vehicle sustained moderate damage to the front plane from the

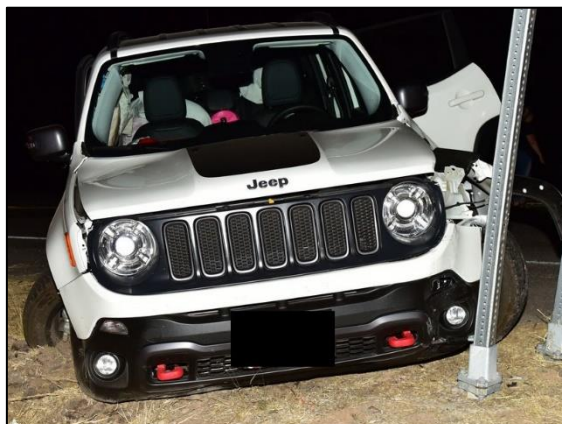
**Figure 17.** The 2017 Jeep Renegade, frontal damage (police image).

impact with the stop sign support pole (**Figure 17**). The damage began at the front left bumper corner. The CDC was 12FLEE2.
