DOT HS 813 017

**Special Crash Investigations:
On-Site Inadvertent Air Bag
Deployment Crash Investigation;
Vehicle: 2010 Nissan Frontier;
Location: Texas;
Crash Date: March 2017**

Special Crash Investigations
On-Site Alleged Inadvertent Air Bag Deployment Crash Investigation
Office of Defects Investigation
Case Number: IN17020
Vehicle: 2010 Nissan Frontier
Location: Texas
Crash Date: March 2017

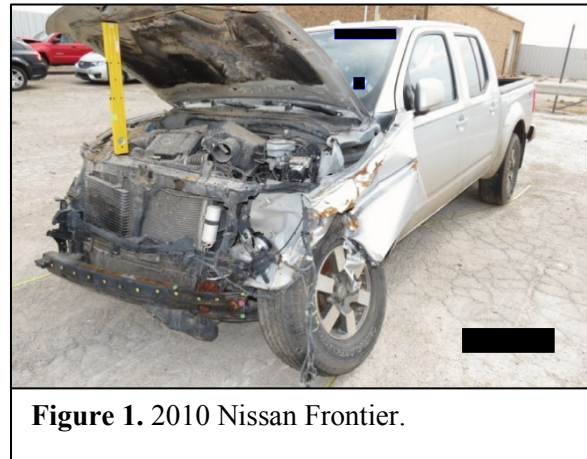
Figure 1. 2010 Nissan Frontier.

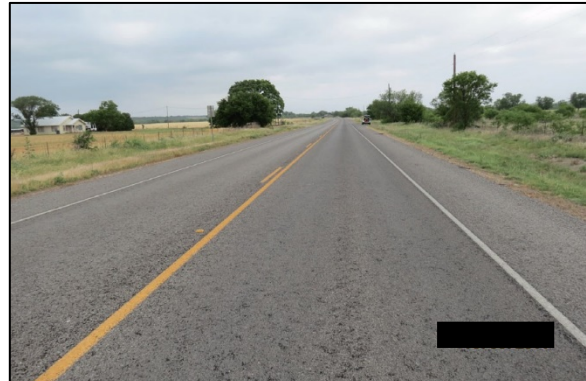
The Nissan was traveling north in the northbound lane (**Figure 2**). The driver stated during the SCI interview that she was traveling with the cruise control set to 97 km/h (60 mph). According to the driver, the front air bag deployed while the vehicle was in motion on the roadway and she tried to reach around it to re-grasp the steering wheel. The driver lost control of the vehicle and it departed the west edge of the roadway (**Figure 3**). The vehicle traveled northwest down an 8 percent grade into a ditch, then up the 12 percent backslope of the ditch and across a gravel driveway.

Figure 2. Nissan's northbound approach.

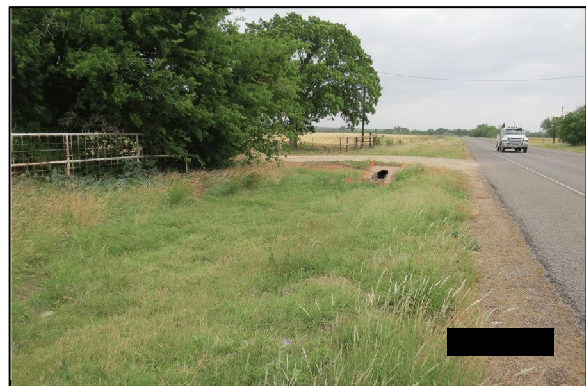
Figure 3. Roadway departure, northwest.

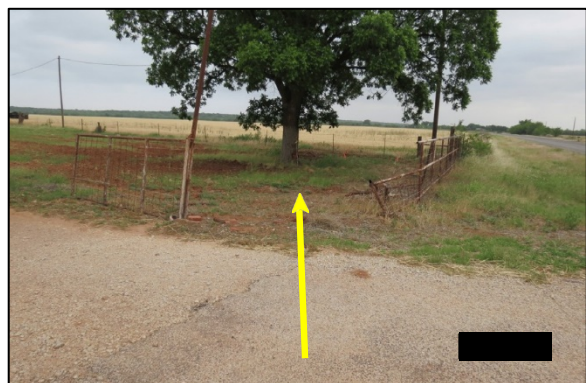
Figure 4. Northwest view, fence impact.

The front plane of the Nissan struck a fence (Event 1) constructed of steel pipe and heavy gauge wire (**Figure 4**). The impact damaged and displaced the fence. The severity of the damage to the front plane was minor. The Nissan continued northwest for 12.5 m (41.0 ft) and the front left corner struck a 76 cm (29.9 in) diameter tree (Event 2, **Figure 5**), resulting in a force direction on the vehicle in the 12 o'clock sector. The damage algorithm of the WinSMASH program calculated the total delta V as 29 km/h (18 mph). The longitudinal and lateral velocity changes were -29 km/h (-18 mph) and 0 km/h, respectively. The results were considered borderline since there was overlapping damage from the fence impact. The tree impact caused the Nissan to rotate counterclockwise and the right end of the back bumper struck a 21 cm (8.3 in) diameter wooden fence post (Event 3, **Figure 6**), displacing the fence post in the ground (**Figure 7**). The WinSMASH program could not be used to calculate delta V or a barrier equivalent speed for this event since yielding objects are out of scope for the program. However, WinSMASH was used to calculate a barrier equivalent speed (BES) of 11 km/h (4.3 mph), based on crush to the back bumper. The vehicle came to final rest approximately 6m (19 ft) north of the tree impact, heading southwest and traveled approximately 52m (171 ft) from the point of roadway departure to final rest.

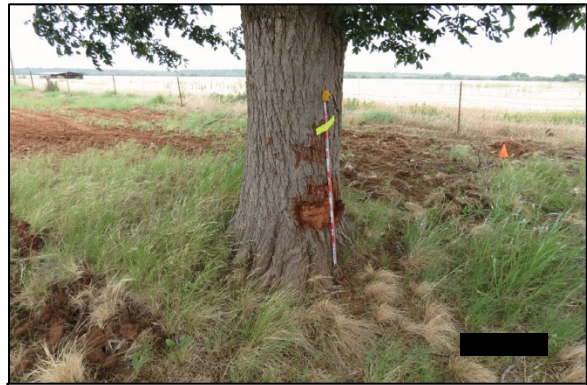
Figure 5. Tree impact.

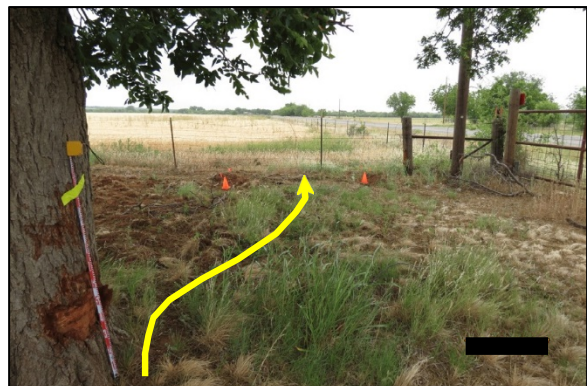
Figure 6. North view, trajectory from tree impact to fence line.

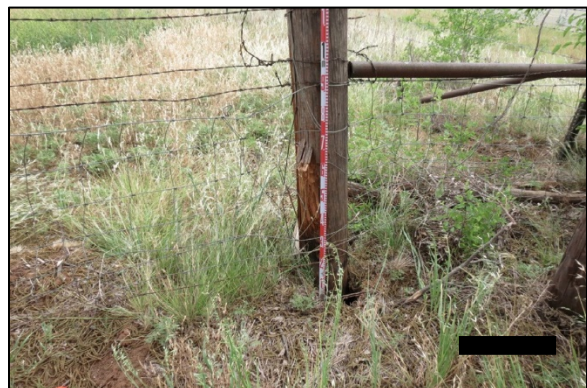
Figure 7. Fence post impact.

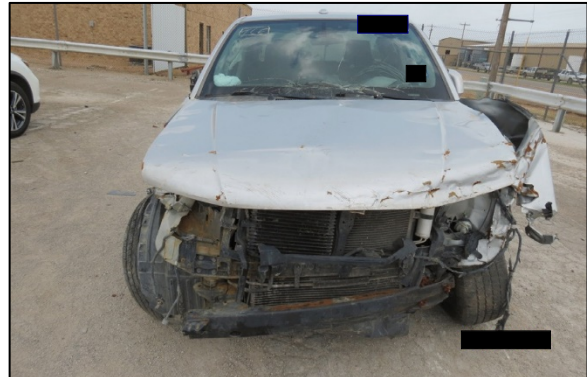
The Nissan sustained damage to the front plane (**Figure 8**) during the impact with the fence that was constructed of steel pipes and heavy-gauge wire. There was direct damage to the front bumper fascia, grille, hood, upper radiator support, right headlamp/turn signal assembly, and the right fender. Direct damage began at the left edge of the hood and extended 167 cm (65.7 in) across the front plane. No crush measurements were taken since there was overlapping damage from the subsequent tree impact.

The collision deformation classification (CDC) was 12FDEW1 (0 degrees). The severity of the damage was minor.

Figure 8. 2010 Nissan Frontier, front plane impact with fence.

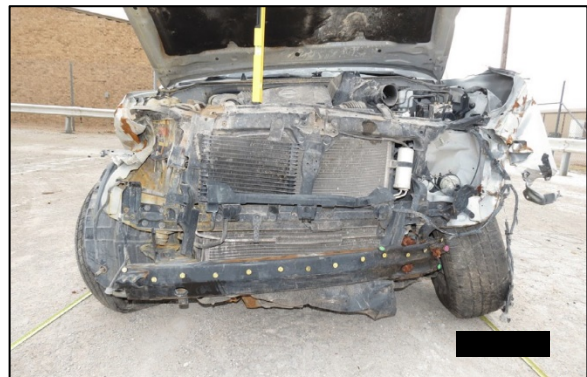
Figure 9. 2010 Nissan Frontier, front plane damage from tree impact.

The front plane (**Figure 9**) was damaged during the impact with the tree. There was direct damage to the left portion of the front bumper, bumper fascia, upper radiator support, left headlamp/turn signal assembly, and the left fender. Direct damage began at the left front bumper corner and extended 30 cm (11.8 in) across the front plane. Crush measurements were taken on the bumper bar and the Field L 135 cm (53.1 in). The crush values were $C_1 = 21$ cm (8.3 in), $C_2 = 26$ cm (10.2 in), $C_3 = 28$ cm (11 in), $C_4 = 14$ cm (5.5 in), $C_5 = 10$ cm (3.9 in), and $C_6 = 0$ cm. The maximum residual crush was 28 cm (11 in), occurring 10 cm (3.9 in) left of the center of the front plane.

The CDC was 12FLEE2 (0 degrees). The severity of the damage was moderate.

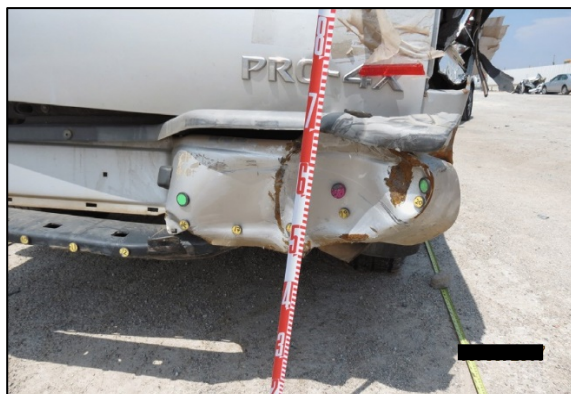
The Nissan sustained damage to the back plane (**Figure 10**) during the impact with the 21 cm (8.3 in) diameter wooden fence post. There was a previous crash to this portion of the vehicle that damaged the bumper and right rear tail lights. In this impact, only the back bumper was directly contacted. Direct damage to the back bumper began at the right rear bumper corner and extended 42 cm (16.5 in) to the left. Crush measurements were taken on the back bumper and the Field L was 164 cm (64.6 in). The crush values were $C_1 = 0$ cm, $C_2 = 1$ cm (0.4 in), $C_3 = 1$ cm (0.4 in), $C_4 = 2$ cm (0.8 in), $C_5 = 7$ cm (2.8 in), and $C_6 = 3$ cm (1.2 in). The maximum residual crush was 7 cm (2.8 in), occurring 70 cm (27.6 in) right of the center of the bumper.

Figure 10. 2010 Nissan Frontier, Rear bumper damage from tree/previous impacts.

The CDC was 05BRLW1 (160 degrees). The damage severity was minor.
