DOT HS 813 020

October 2020

# **Special Crash Investigations: Ambulance Crash Investigation; Vehicle: 2011 Chevrolet Express 3500 Type III Ambulance; Location: California; Crash Date: May 2018**

**Special Crash Investigations  
Ambulance Crash Investigation  
Case Number DS18014  
Vehicle: 2011 Chevrolet Express 3500 Type III Ambulance  
Location: California  
Crash Date: May 2018**

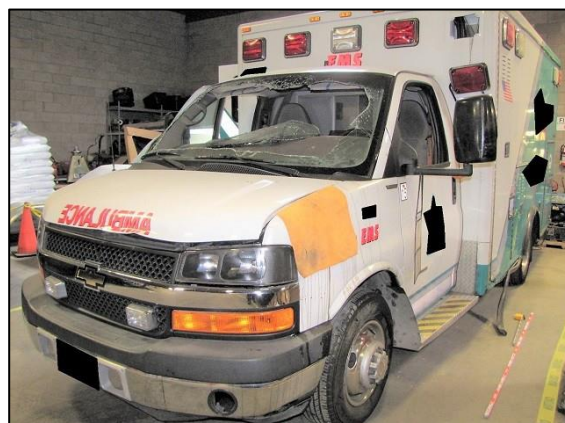
This report documents the investigation of a 2011 Chevrolet Express 3500 American Emergency Vehicles Type III ambulance (**Figure 1**) involved in a crash with a 2002 Audi A6 3.0 Quattro and the ambulance's subsequent rollover. The investigation was intended to determine what role the manual restraints may have played in the injury mechanisms for the patient, driver, and passengers of the ambulance. The Special Crash Investigations (SCI) group of the National Highway Traffic Safety Administration initiated the investigation in May 2018 in response to an online news report of the crash. Permission to inspect the two involved vehicles was obtained through the state police department, whose multidisciplinary accident investigation team officers attended the SCI vehicle inspections in June 2018. The Chevrolet's Event Data Recorder (EDR) was supported by the Bosch CDR system, and the vehicle's EDR was imaged during the vehicle inspection. For unknown reasons, the EDR report did not capture any events or contain any crash data, likely due to the relatively low delta V caused by the vehicle-to-vehicle impact.

**Figure 1.** The 2011 Chevrolet Express 3500 Type III Ambulance.

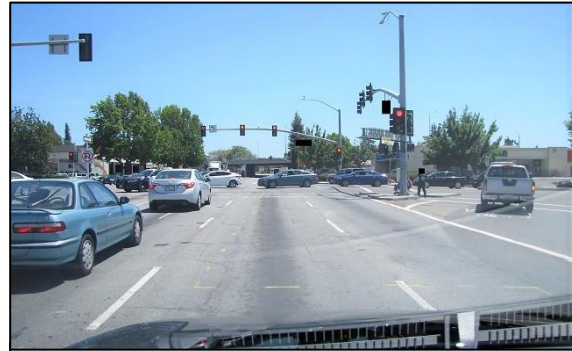
The crash site was the four-way intersection of a divided north/south roadway and a divided east/west roadway in a mixed-use urban area in California (**Figure 2**). The southbound roadway included a right raised curb measuring 15 cm (6.0 in) high, a right-turn lane measuring 4.2 m (13.8 ft) wide, three through lanes each measuring 3.3 m (11.0 ft) wide, a left-turn lane measuring 3.3 m (11.0 ft) wide and a raised concrete median measuring 1.7 m (5.5 ft) wide and 15 cm (6.0 in) high. The turn lanes were bordered by solid white painted stripes and the through lanes were bordered by dashed white painted stripes. The three northbound lanes were configured similarly, measuring 3.3 m (11.0 ft) in width and separated by dashed white painted stripes. The posted speed limit for this roadway was 56 km/h (35 mph).

**Figure 2.** Crash site, southbound approach for the 2011 Chevrolet Express 3500 Type III Ambulance.

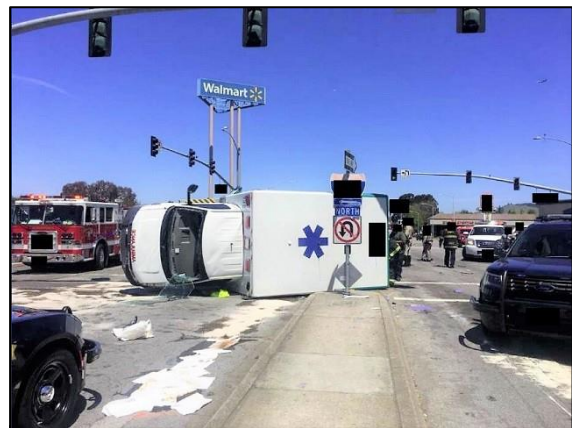
**Figure 3.** Final rest position of the 2011 Chevrolet Express 3500, looking north (police photo).

The ambulance was at rest on its left side at the center median ending at the south aspect of the intersection (**Figure 3**). Police, fire, and EMS responders arrived within 11 minutes of the crash. All occupants of both vehicles were transported by ambulances to local hospitals. Both vehicles were towed due to damage and placed on hold. The patient was declared deceased at the hospital and the other occupants of both vehicles were treated and released.

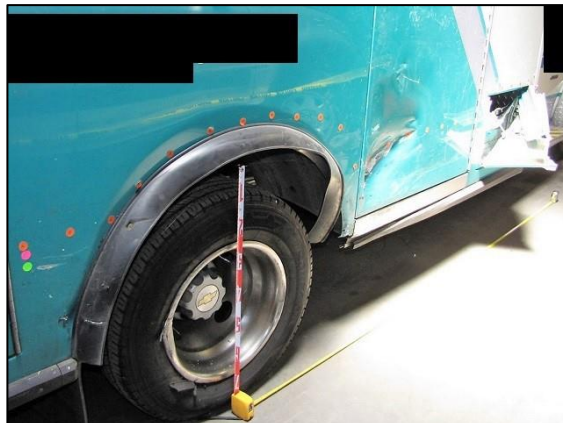
The ambulance sustained minor severity damage to the right plane caused by the vehicle-to-vehicle impact. Direct damage began 55 cm (21.6 in) aft of the right rear wheel and extended 180 cm (70.9 in) forward. The damage was confined to the right side of the patient compartment. The CDC for the ambulance in Event 1 was 02RBEW1 (**Figure 4**).

**Figure 4.** Right plane damage, the 2011 Chevrolet Express 3500.

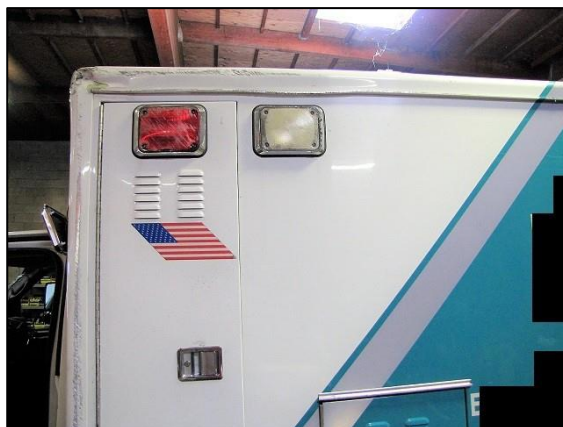
The vehicle sustained minor damage to the left plane caused by the rollover. Direct damage to the left plane began at the lower aspect of the box and extended vertically 220 cm (86.6 in) upward ending at the roof rail. The damage extended longitudinally from the leading edge of the roof rail 80 m (31.5 in) rearward causing minor crush and the CDC for the ambulance in Event 2 was 00LYAO1 (**Figure 5**).

**Figure 5.** Left plane damage, the 2011 Chevrolet Express 3500.

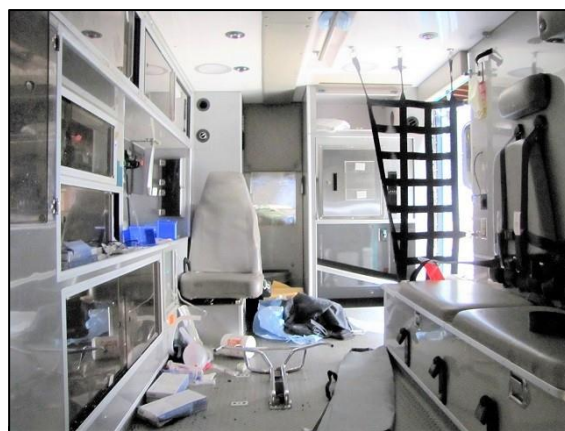
The patient compartment was a walk-through design with interior dimensions of 366 cm (144.0 in) long, 180 cm (70.9 in) wide, and 178 cm (70.1 in) high (**Figure 6**). Double rear doors served for the loading and unloading of the cot, as well as entry for the crew. The right wall was configured with a single door located on the forward aspect and a squad bench on the middle and rear aspects. A squad bench safety net separated the right door from the squad bench. The left wall was configured with metal and glass storage cabinets extending from floor to ceiling. The floor area was configured with a cot fastener system using a Stryker rail clamp and an antler style stabilizer.

**Figure 6.** Patient compartment, the 2011 Chevrolet Express 3500.

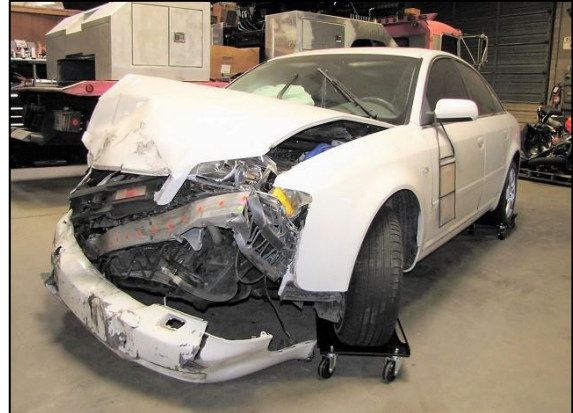
The Audi sustained direct damage to the front plane and induced damage extending to the left, right, and top planes. The front bumper fascia, backing bar, and grille were displaced (**Figure 7**). The hood and right front fender were crumpled and the right front tire was restricted. Direct damage to the bumper fascia extended from bumper corner to bumper corner and measured 160 cm (63.0 in). The damage extended vertically from frame level to belt line. The backing bar was used to measure crush. Thirteen measurements in 10.0 cm (3.9 in) increments were taken at bumper level by the Nikon Total Station and the Faro Blitz program computed crush measurement in six increments as follows:  $C_1 = 17$  cm (6.7 in),  $C_2 = 21$  cm (8.3 in),  $C_3 = 24$  cm (9.5 in),  $C_4 = 27$  cm (10.6 in),  $C_5 = 33$  cm (13.0 in), and  $C_6 = 35$  cm (13.8 in). Maximum crush measured 35 cm (13.8 in) at the front right bumper corner. The observed principal direction of force was 320 degrees and the CDC for the Audi was 11FDEW2.

**Figure 7.** The 2002 Audi A6 3.0 Quattro.
