DOT HS 813 037

**Special Crash Investigations:  
On-Site Frontal Air Bag  
Non-Deployment Crash  
Investigation;  
Vehicle: 2002 Chevrolet  
Trailblazer;  
Location: Pennsylvania;  
Crash Date: January 2016**

**Special Crash Investigations**  
**On-Site Frontal Air Bag Non-Deployment Crash Investigation**  
**Office Of Defects Investigation**  
**Case No.: CR16005**  
**Vehicle: 2002 Chevrolet Trailblazer**  
**Location: Pennsylvania**  
**Crash Date: January 2016**

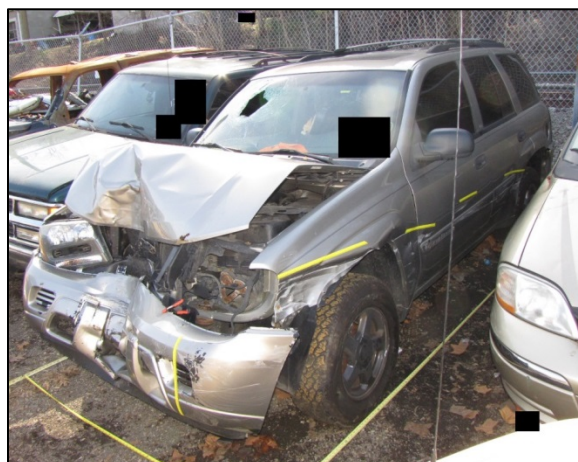
This report documents the on-site investigation of the non-deployment of the frontal air bag system in a 2002 Chevrolet Trailblazer (**Figure 1**) involved in a road departure/fixed object crash. The Chevrolet was equipped with dual-stage air bags for the driver and front right passenger positions. Neither air bag deployed during the crash. An unbelted 43-year-old male driver sustained internal abdominal injuries and was transported by ambulance to a local hospital where he expired 4 hours post-crash. An unbelted 40-year-old adult male front right occupant was transported, treated, and released with non-incapacitating (B-level) injuries from the same facility. Notification of the crash was provided to the National Highway Traffic Safety Administration by the driver's family in February 2016 and forwarded to the Special Crash Investigations (SCI) group for further research. The on-site investigation was conducted during February 2016 and involved the exterior and interior documentation of the Chevrolet, the identification of occupant contact, and an evaluation of the manual and supplemental restraint systems. The Chevrolet was equipped with an event data recorder (EDR) that was imaged during the SCI vehicle inspection using the Bosch Crash Data Retrieval (CDR) tool and software. The crash site was documented using a Total Station electronic mapping system.

**Figure 1:** Front left oblique view of the crash-related damage to the 2002 Chevrolet Trailblazer.

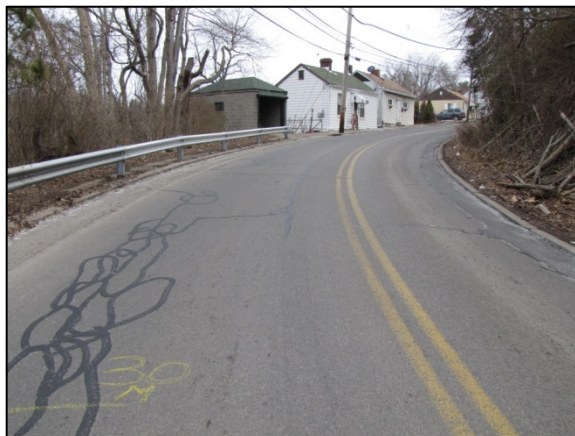
**Figure 2:** Northbound trajectory view of the Chevrolet approximately 30 m south of the point of impact.

The roadway (**Figure 2**) was surfaced with asphalt and curved to the right with respect to the northbound direction of travel for the Chevrolet. The radius of curvature measured 46 m (150.0 ft). The grade was positive and varied from 7.1 to 7.8 percent along the vehicle's trajectory. The northbound travel lane was 2.8 m (9.2 ft) in width while the southbound lane measured 4.2 m (13.8 ft). The lanes were divided by a double yellow centerline. A shallow curb bordered the east edge of the northbound lane while a continuous W-beam guardrail system bordered the west edge of the southbound lane. The guardrail system consisted of I-beams that were spaced on 1.9 m (6.3 ft) centers. Two residential driveways were located at the west road edge with breaks in the guardrail system. A third driveway was located at the north termination of the guardrail. A 33 cm (13.0 in) diameter wooden utility pole located at the roadside 6.7 m (22.0 ft) north of the guardrail termination and 0.3 m (1.0 ft) west of the pavement edge. The posted speed limit was 40 km/h (25 mph).

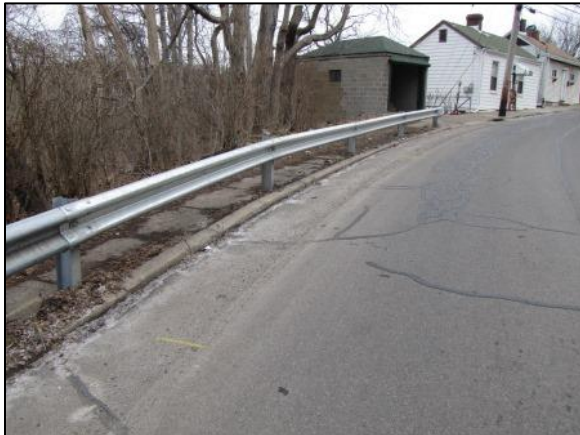
The front right corner area of the Chevrolet struck the W-beam guardrail system that paralleled the west road edge (**Figure 3**). The length of engagement to the guardrail is unknown because four sections of the W-beam had been replaced prior to this SCI investigation. This Event 1 impact was not recorded as an event by the Chevrolet's EDR. The direct contact damage extended the full length of the left plane and consisted of sideswiping engagement with the body panels of the left plane. It did not involve the rigid structure of the vehicle. The estimated severity of this impact (velocity-change) was minor, estimated as less than 10 km/h (6 mph). Reconstruction of this sideswipe impact was outside the scope of the WinSMASH program. The vehicle's trajectory was redirected along the contour of the barrier to the termination of the system. It did not penetrate the guardrail system.

**Figure 3:** Northerly view of the struck (and replaced) W-beam guardrail system.

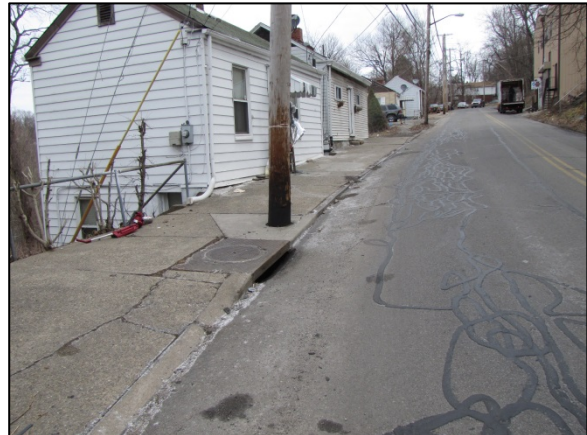
**Figure 4:** Northbound view of the struck utility pole depicting its location relative to the roadway.

The Chevrolet continued an additional 6.7 m (22.0 ft) along the left (west) roadside in a tracking mode to impact with the utility pole (**Figure 4**). The center and right aspects of the frontal plane struck the 33 cm (13.0 in) diameter pole (Event 2) resulting in an impact with a 12 o'clock direction of force. The pole did not yield as the bumper system of the Chevrolet crushed to a maximum depth of 46 cm (18.1 in). This crash event was recorded by the EDR as a non-deployment event and captured a maximum longitudinal velocity change of 38.3 km/h (-23.8 mph) at 117.5 milliseconds after AE. The dual-stage frontal air bag system was not commanded to deploy.

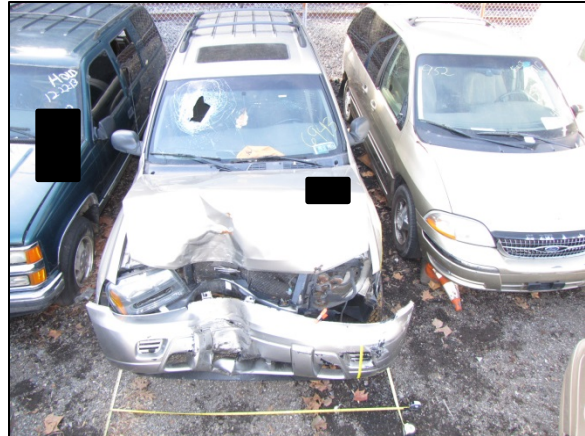
**Figure 5:** Overhead view of the Chevrolet depicting the frontal damage.

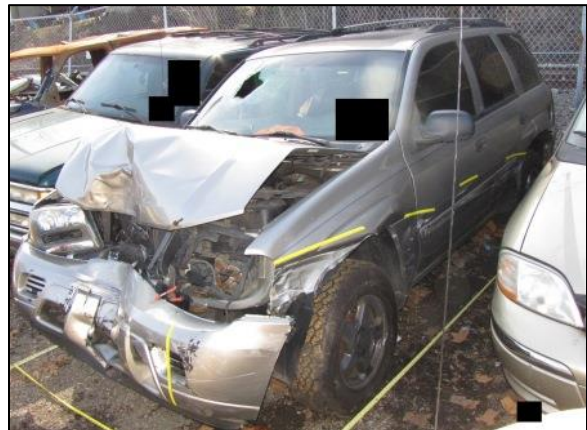
The Chevrolet sustained minor damage to the left plane from the Event 1 impact sequence with the W-beam guardrail system and moderate front plane damage from the Event 2 impact with the wooden utility pole (**Figure 6**). The initial impact with the curved guardrail section began at the left corner of the bumper fascia and extended onto the left plane, involving only the sheet metal of the left front fender, left doors, and the left quarter panel. There was no structural damage or engagement of the tires and wheels. The height of the left plane damage extended to 76 cm (30.0 in) above the ground consistent with the height of the guardrail. The Collision Deformation Classification assigned to this damage pattern was 12FLES9. The Event 2 damage began at the centerline of the front plane and extended 36 cm (14.0 in) to the vehicle's right (**Figure 7 and 8**). The pole impact deformed the bumper fascia, the

**Figure 6:** Front corner and left plane damage to the 2002 Chevrolet Trailblazer.

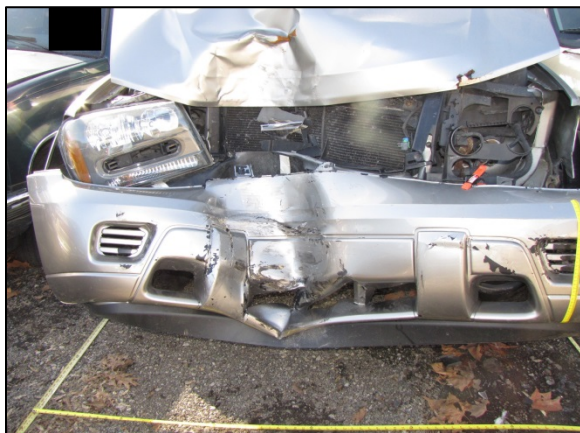
**Figure 7:** Frontal plane direct contact damage from the utility pole.

underlying bumper beam, the radiator support, and the hood to a U-shape. The combined length of the direct and induced damage measured from corner-to-corner of the bumper beam was 142 cm (56.0 in). A crush profile was documented along the deformed bumper beam using the Nikon Total Station as a measurement tool. The profile minus free-space values for bumper taper was as follows: C1 = 0 cm, C2 = 0 cm, C3 = 21 cm (8.3 in), C4 = 46 cm (18.1 in), C5 = 13 cm (5.1 in), C6 = 0 cm. The maximum crush measurement was located 14 cm (5.5 in) right of centerline. Although the impact was located between the frame rails, it still altered the wheelbase dimensions. The left wheelbase was lengthened by 1.5 cm (0.6 in) while the right wheelbase was reduced by 6.0 cm (2.4 in). The CDC for this damage profile was 12FZEN2.

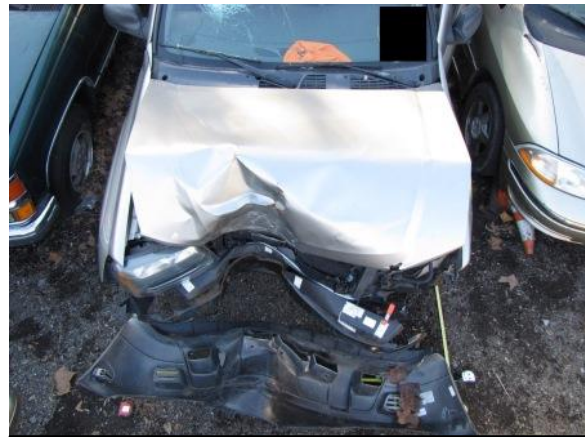
**Figure 8:** Overhead view depicting the depth of crush to the front bumper beam and its location between the frame rails.

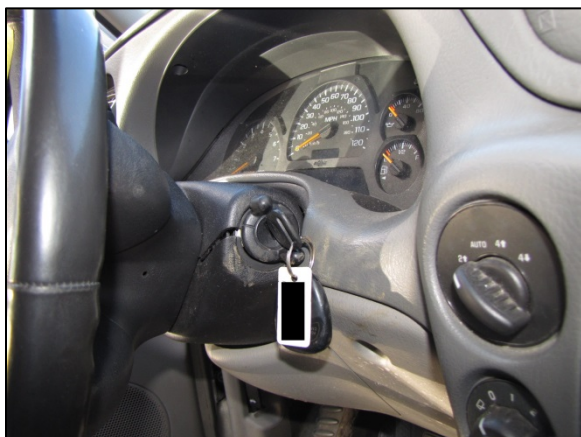
**Figure 9:** Driver loading and compression of the Chevrolet’s steering column.

seat-mounted side air bag systems did not deploy in this crash. The unbelted driver initiated a forward trajectory and loaded the steering assembly with his chest and abdomen. He compressed the energy absorbing column (**Figure 9**) and completely separated the column from the shear capsules. His knees contacted and scuffed the bolster panel. The driver's head struck and fractured the windshield 33 cm (13.0 in) right of the upper left A-pillar and 20 cm (8.0 in) below the windshield header.

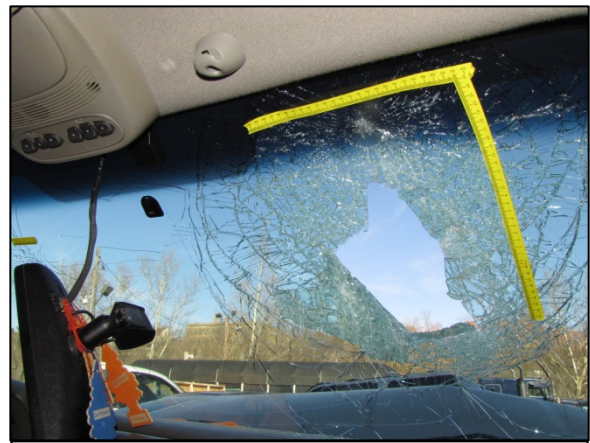
**Figure 10:** Front row right occupant’s head impacts and holing of the Chevrolet’s laminated windshield.

The unbelted front row right occupant initiated a forward trajectory and engaged the glove box door with his knees. His loading scuffed and deformed the door, which released the latch assembly. He attempted to brace against the upper and mid instrument panel with his right hand, and contacted and displaced the right vent louver at the right edge of the mid-instrument panel. Although there was no contact evidence, his chest probably contacted the non-deployed mid-mount air bag module cover. The occupant's scalp contacted the sun visor during his initial forward movement and again on his subsequent rebound. The visor was scuffed at the leading edge and displaced rearward from its mounting point. The occupant's head also struck and fractured the windshield 8 cm (3.0 in) below the header and 28 cm (11.0 in) left of the right upper A-pillar. A secondary head/face contact was located 15 cm (6.0 in) below the header which holed the windshield, centered 32 cm (12.5 in) right of the A-pillar. The hole was 13 x 23 cm (5.0 x 9.0 in) and was large enough for a partial ejection of his face/head (**Figure 10**).

Embedded hair strands were observed in the fracture site. The occupant's deformed and damaged wire framed eyeglasses were found outside the occupant compartment at the base of the right windshield wiper. It is believed that these separated from his face during the partial ejection sequence.

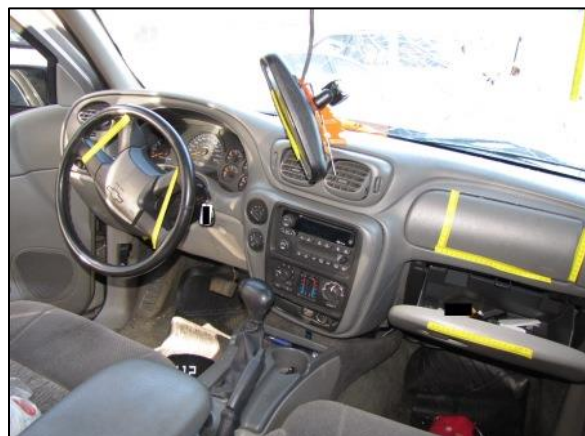
The Chevrolet was equipped with dual-stage frontal air bags for the driver and front row right occupant positions (**Figure 11**). The driver's frontal air bag was incorporated in a module that had I-configuration cover flaps positioned in the

**Figure 11:** Interior view of the Chevrolet and its non-deployed dual-stage frontal air bags.

The center and right aspect of the Chevrolet's front plane struck the utility pole. The location of the direct contact damage was located between the rigid members of the vehicle's sub-frame. Real-world field research of the center-pole impact crashes has found that there is difficulty in accurately sensing the severity of this type of crash, particularly in consideration of the time frame when this model year vehicle was designed (mid/late 1990's). The decision whether or not to actuate/deploy supplemental safety systems is achieved through the use of a predictive sensing algorithm processed during the early stages of the impact (typically 0-30 milliseconds). For supplemental safety device actuation/deployment to occur, the rate (and predicted rate) of the change in the acceleration imparted to the vehicle has to be in excess of the threshold unique to the design of the vehicle make/model in question.

The SCI investigator reviewed the velocity change ( $\Delta V$ ) data reported by the data imaged from the Chevrolet's EDR. It is important to note that  $\Delta V$  data is not acceleration data. However, the acceleration data can be derived from the rate of the change in velocity. That is, acceleration is equivalent to the slope of the velocity change over time. For the available  $\Delta V$  data, the rate of change in the early stage of the crash pulse (0 to 60 milliseconds) appeared to be fairly constant. The sensing algorithm may have predicted that the overall severity of the crash would not exceed the deployment threshold during this time. The slope of the pulse then gradually became steeper approximately 70 milliseconds after AE. It has been shown that a late-deployment of the frontal air bags can cause harm to the occupant, particularly if the occupant is unbelted, and theorized that the frontal air bag deployment threshold has been designed such that late-air bag deployment is prevented. However, due to its proprietary nature, information concerning the manufacturer's deployment algorithm is not available to the SCI investigator. It is unknown if this increased rate of change occurred too late in the overall crash pulse to deploy the air bags. It was not possible to compare the measured crash pulse to the threshold algorithm. Therefore, the root cause of the air bag non-deployment could not be determined.

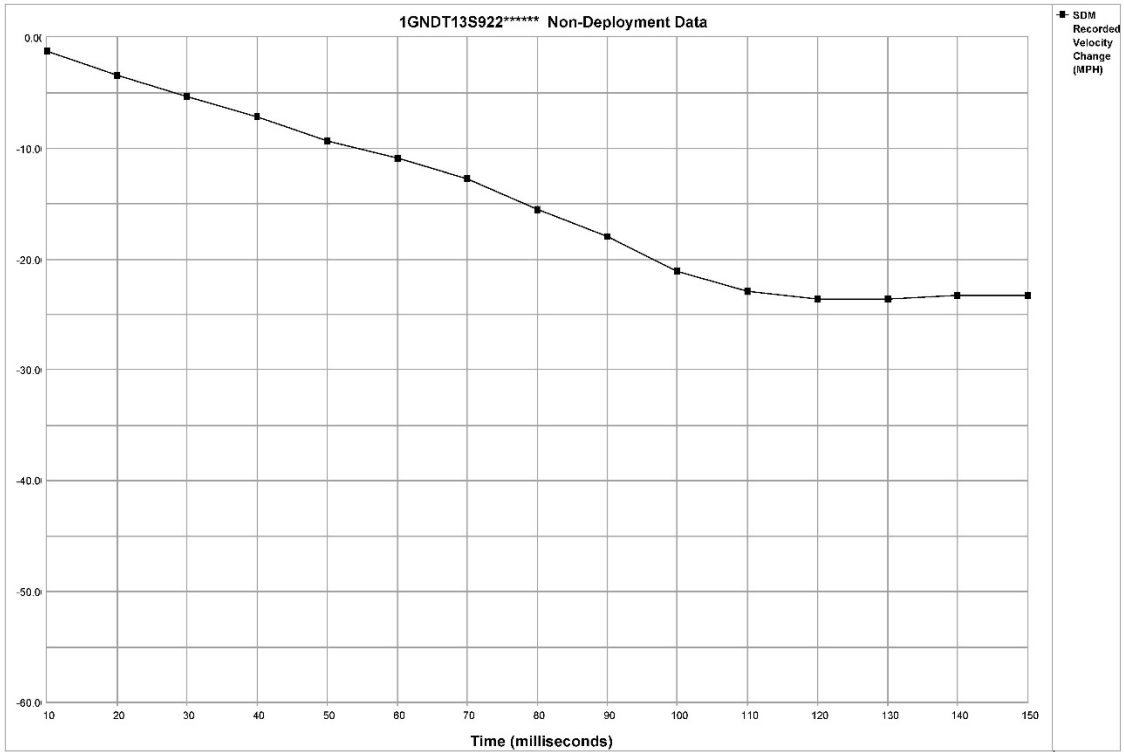
Time (milliseconds)	10	20	30	40	50	60	70	80	90	100	110	120	130	140	150
Recorded Velocity Change (MPH)	-1.24	-3.41	-5.27	-7.13	-9.30	-10.85	-12.71	-15.50	-17.98	-21.08	-22.94	-23.56	-23.56	-23.25	-23.25
