DOT HS 813 043

**Special Crash Investigations:  
On-Site Passenger's Frontal Air  
Bag Inflator Rupture Crash and  
Fire Investigation;  
Vehicle: 2006 Nissan Sentra;  
Location: Florida;  
Crash Date: March 2018**

**Special Crash Investigations**  
**On-Site Passenger's Frontal Air Bag Inflator Rupture**  
**Crash and Fire Investigation**  
**Office of Defects Investigations**  
**Case Number: CR18025**  
**Vehicle: 2006 Nissan Sentra**  
**Location: Florida**  
**Crash Date: March 2018**

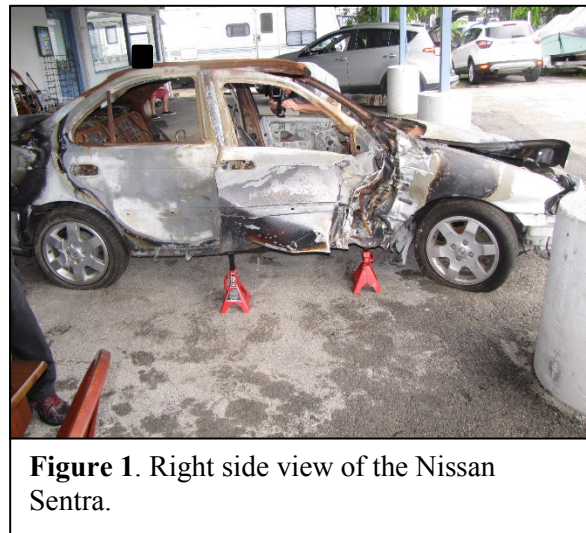
**Figure 1.** Right side view of the Nissan Sentra.

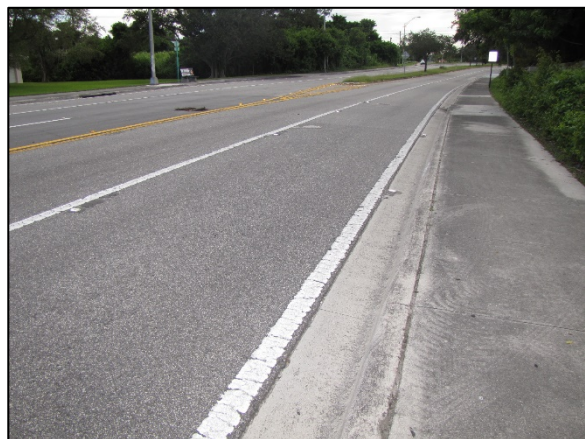
**Figure 2.** West-facing trajectory view of the Nissan.

final rest location of the Nissan. **Figure 2** is a west trajectory view depicting the configuration of the roadway. **Figure 3** is an eastward lookback view depicting the point of impact (tree) and the Nissan's final rest location. A crash diagram is included at the end of this report.

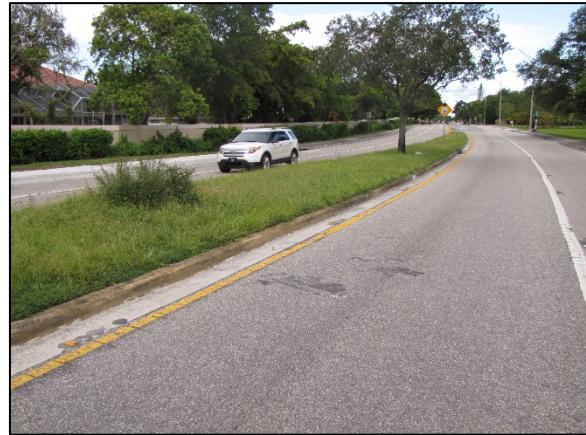
**Figure 3.** East-facing lookback view of the locations of the tree impact and final rest of the Nissan.

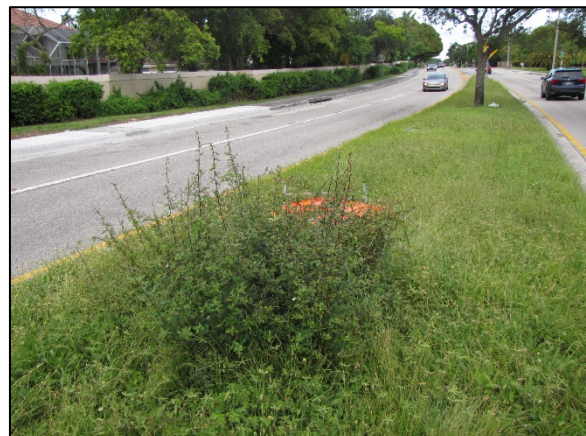
**Figure 4.** East-facing lookback view along the median depicting the roadway curvature.

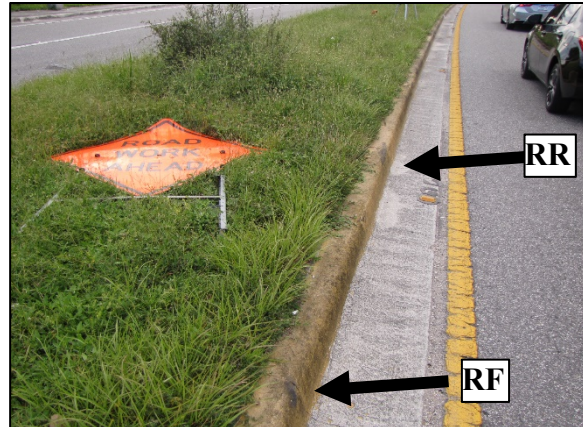
marks (**Figure 5**) were located 67.0 m (219.8 ft) and 69.2 m (227.0 ft) from the end of the median, respectively.

**Figure 5.** West-facing view depicting the locations of the curb strikes of the Nissan's right front and right rear tires.

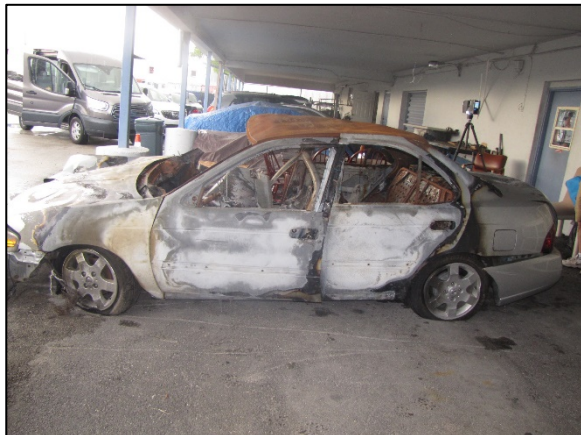
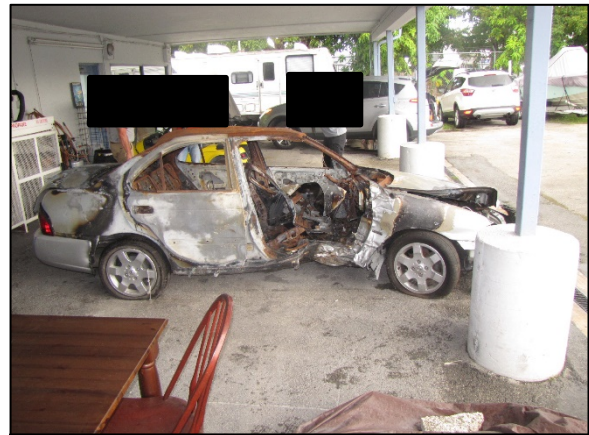
The exterior damage to the Nissan (**Figures 7 and 8**) consisted of damage to each wheel rim due to its individual impact to the median curb, right plane deformation due to the tree impact, and post-crash fire damage. Impacts to the median curb damaged the outer surfaces of the left front and left rear wheel rims (Events 1 and 2) and the inner surfaces of the right front and right rear rims (Events 3 and 4). The collision deformation classification (CDC) assigned to these wheel impacts were 12FLWN3, 12FLWN9, 12FRWN3 and 12FRWN9, respectively. The sidewall of the left front tire was cut with 50 percent of the tire burned. The left rear, right front, and right rear tires exhibited indicators of heat stress on approximately 10- to 20 percent of their tread surfaces. While the fire consumed the vehicle at its final rest location, these tire surfaces would have been at the top of their respective rotations. The minor involvement of the tires was one indicator of the extent of the fire's overall involvement and consumption.

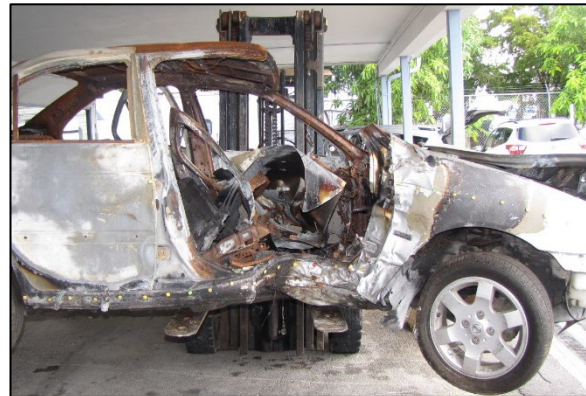
The impact damage to the right plane was located along the sill (forward of the B-pillar), at the forward aspect of the right front door and on the right front fender (**Figures 9 and 10**). The direct

contact damage began on the fender 219 cm (86.2 in) forward of the right rear axle and extended rearward 78 cm (30.7 in). The combined length of the direct and induced damage (field L) measured 117 cm (46.1 in) and began 231 cm (90.9 in) forward of the rear axle reference. The maximum crush at the sill measured 27 cm (10.6 in) and was located 161 cm (63.4 in) forward of the rear axle. The vehicle's deformation was measured along the sill and the right fender, as the firefighters removed the right front door during the removal of the driver's body.

The residual crush profile was as follows: C1 = 0, C2 = 7 cm (2.8 in), C3 = 25 cm (9.8 in), C4 = 24 cm (9.4 in), C5 = 14 cm (5.5 in), and C6 = 2 cm (0.8 in). There was no noted direct contact to the right roof side rail. The right A-pillar appeared to be relatively undamaged, although it was cut and removed by the firefighters. The lack of contact to the A-pillar supported the probable fracture (yielding) of the tree at impact. The CDC assigned to this damage pattern was 02RYEW2. For comparison purposes, the severity (delta V) of this impact was calculated via a borderline analysis with the WinSMASH program. The total calculated delta V was 21 km/h (13 mph). The longitudinal and lateral components of the delta V were -14 km/h (-8 mph) and -16 km/h (-10 mph), respectively. The barrier equivalent speed (BES) was 21 km/h (13 mph). The results were low based on SCI field experience. The yielding properties of the impact (fracture), incompatibility in stiffness coefficients and borderline use of the program in pole-type impact analyses contributed to the low results.

**Figure 9.** Right view depicting the direct and induced impact damage of the Nissan.

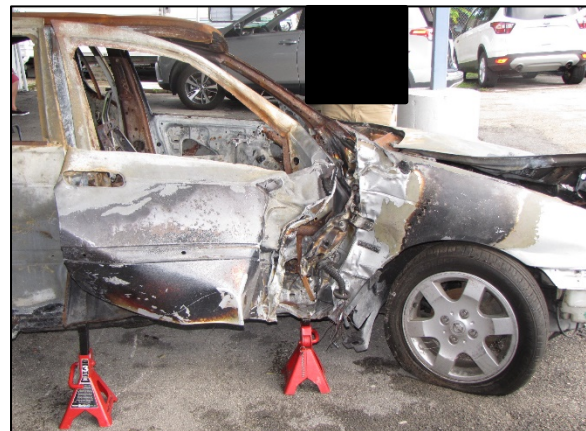
**Figure 10.** Right view of the reconstructed position of the Nissan's front door.

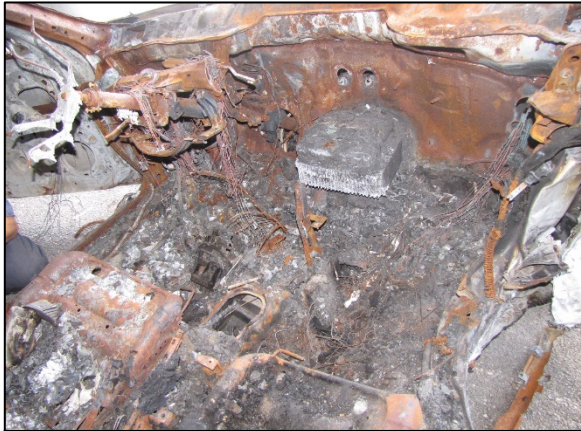
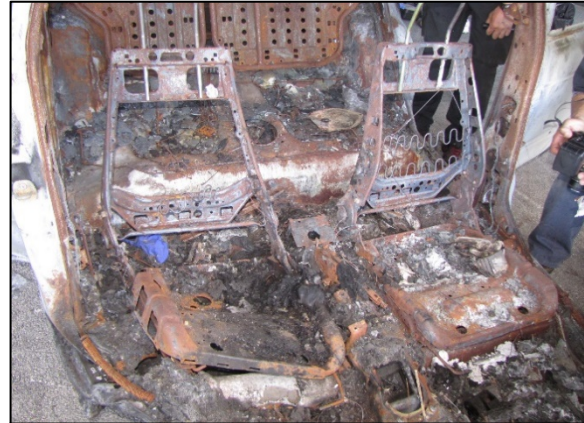
The post-crash fire consumed the interior of the Nissan (**Figures 11 and 12**) and destroyed any evidence of driver contact in the vehicle. The force of the impact caused 25 cm (9.8 in) of lateral intrusion at the right sill. The floor pan deformation resulted in 8 cm (3.1 in) rearward displacement of the right front seat pan, with 22 cm (8.7 in) upward displacement at its forward

**Figure 11.** Interior image looking forward depicting the front row of the Nissan.

**Figure 12.** Interior image looking rearward into the occupant compartment of the Nissan.

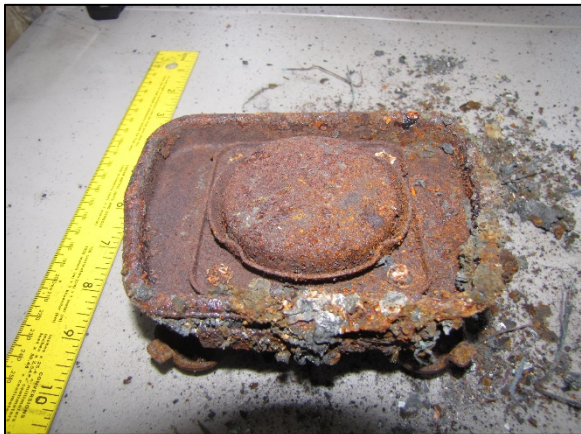
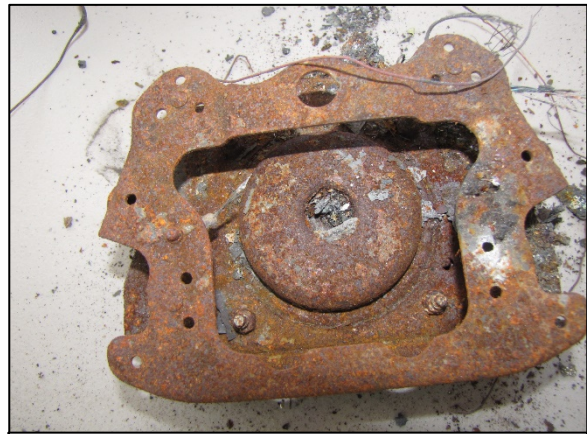
The driver's frontal air bag module (**Figures 13 and 14**) was found beneath the steering column in the driver's floor pan. The components securing the module to the steering column had been consumed in the fire. It was observed that the module was a single stage design. The venting holes in the inflator appeared to be open, which indicated that the module had likely deployed. The fabric of the deployed air bag was completely consumed by the fire. It is likely that if the air bag deployed as a consequence of the fire, the air bag fabric would have started to burn while still packaged in the module, and the residual evidence of the air bag fabric may have partially survived.

**Figure 13.** Front side of the Nissan driver's frontal air bag module.

**Figure 14.** Backside of the Nissan driver's frontal air bag module.

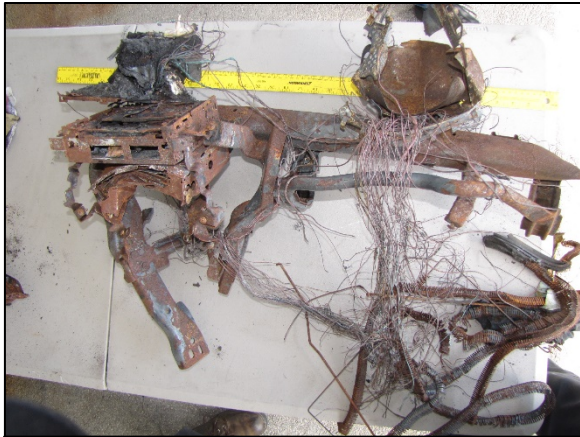
The passenger's frontal air bag module remained attached to the cut section of the instrument panel that was removed from the second row of the Nissan during the SCI inspection (**Figure**

**Figure 15.** View of the instrument panel section that was cut and removed from the Nissan during the SCI inspection.

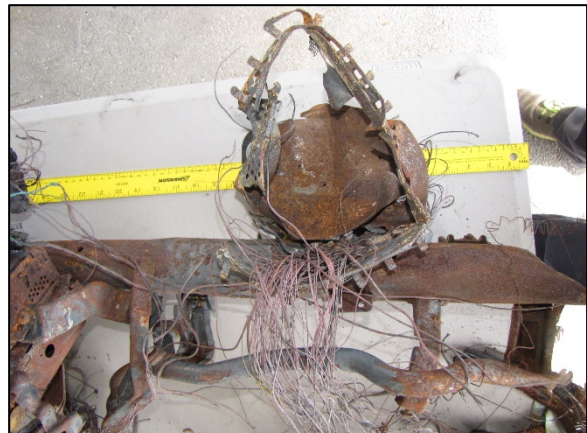
15). Based on its condition, it was observed that the passenger's frontal air bag module (**Figure 16**) had ruptured during its deployment sequence. Similar to the driver's frontal air bag, the passenger's frontal air bag fabric was also completely consumed. Numerous components of the inflator module were recovered from the interior of the vehicle through the course of its inspection. The inflator was found among fire debris in the front right floor pan. The inflator end cap was found behind the front right seat. The auto-ignition cap was located in the forward aspect of the driver's floor pan with wire mesh that may have been part of the module's filter media. A smaller portion of wire mesh was also located in the driver seat.

**Figure 16.** View of the Nissan's ruptured passenger's frontal air bag module which remained attached to the instrument panel.

The dispersed locations of the module components and the condition of the module assembly were supportive evidence that the inflator ruptured. However, the dispersed locations do not necessarily mean that these components were projected to these areas. Any loose fragments were most likely dispersed due to the high-pressure water spray during the suppression of the fire.
