DOT HS 813 064

# **Special Crash Investigations: On-Site Alleged Air Bag Inflator Rupture Crash Investigation; Vehicle: 2009 Kia Spectra; Location: Kansas; Crash Date: March 2018**

**Special Crash Investigations  
On-Site Alleged Air Bag Inflator Rupture Crash Investigation  
Office of Defects Investigation  
Case Number: CR18018  
Vehicle: 2009 Kia Spectra  
Location: Kansas  
Crash Date: March 2018**

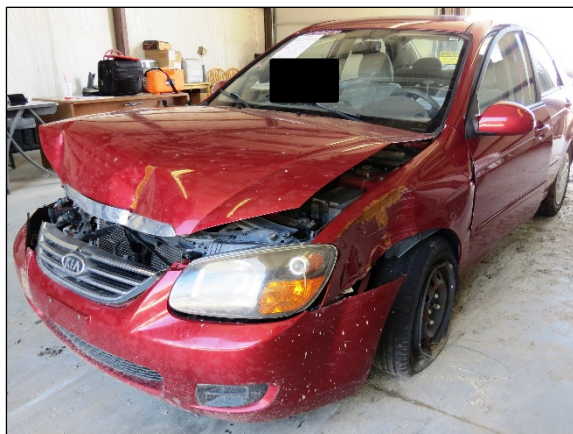
**Figure 1.** Left front oblique view of the Kia at the time of the SCI vehicle inspection.

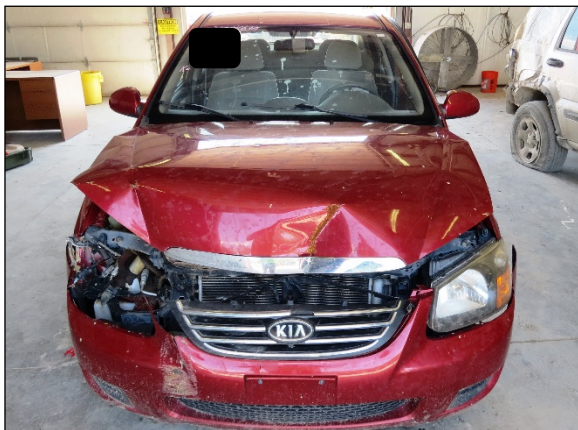
**Figure 4.** View of the Kia's front plane damage as documented during the SCI inspection.

It was apparent to the SCI investigator that the three areas of damage were related to contact with the Ford's trailer hitch (damage to Kia's hood left of center), right rear axle position (Kia's right front headlight), and left rear axle position (Kia's left front headlight, fender, and left front

tire/wheel). The damage pattern indicated that the Kia's driver had initiated a sudden braking and right steering maneuver prior to impact, which caused the front of the Kia to pitch downward and offset the Kia to the right. The braking maneuver allowed the Kia's front plane to underide the Ford's rear plane. The resulting damage pattern to the Kia was consistent only with a crash avoidance sequence as described.

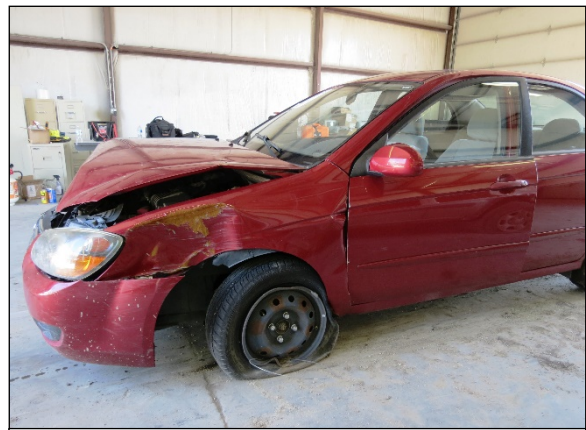
**Figure 5.** Left view of the Kia and the area of damage to the left front fender from the Ford's left rear wheel.

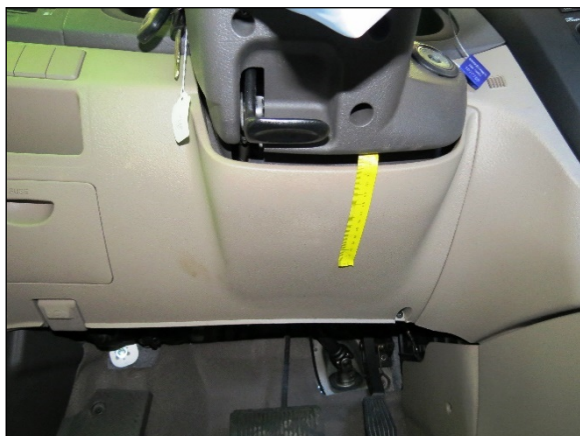
An inspection of the Kia's interior for occupant contact revealed three distinct and identifiable areas of damage from occupant contact. This included two separate scuffs to the left lower instrument panel from the driver's left and right knees, as well as blood and make-up transfer on the face of the deployed driver's air bag. The left knee contact was located immediately left of the contour for the steering column, while the right knee contact was located beneath the steering column. The make-up transfer was centered on the bottom left of the circular center stitch pattern, while the blood transfer was located on the lower left quadrant of the air bag's face. **Figure 6** depicts the driver's knee contacts, while **Figure 7** depicts the driver air bag contacts.

**Figure 6.** Driver knee contacts to the Kia's left lower instrument panel.

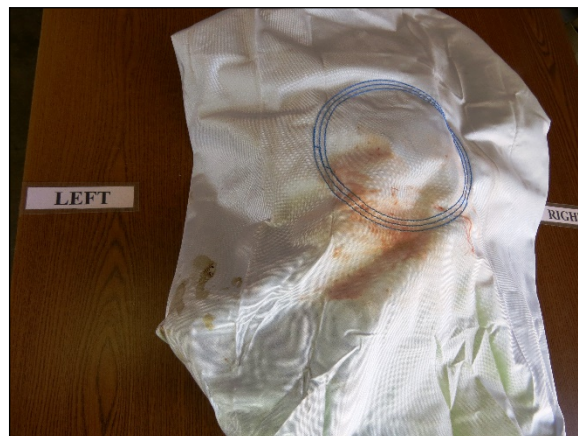
**Figure 7.** Driver contact evidence on the face of the Kia's deployed driver air bag.

The driver's head flexed forward, and her face contacted and loaded through the deployed driver's frontal air bag to the steering wheel rim. Contact to the air bag was evidenced by blood and make-up transfer on the air bag's fabric. Contact/interaction with the steering wheel rim was evidenced by the fracture of the mandible and unspecified facial bones and the subdural hematoma. The driver's contact and engagement with the deployed driver's air bag and steering wheel rim might have been exacerbated by the probable routing of the shoulder portion of the seat belt system beneath her left arm, which would have exposed her to increased forward flexion of her upper body.

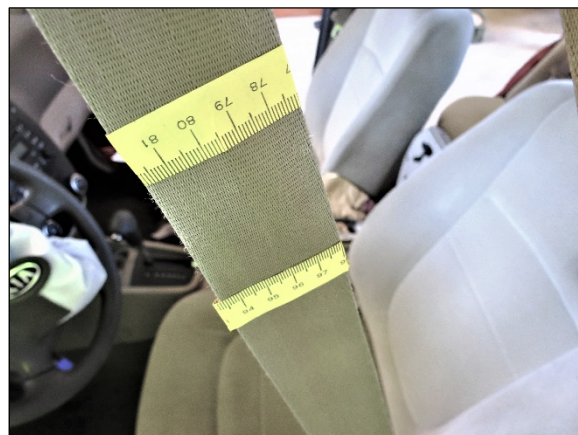
**Figure 8.** Webbing of the driver seat belt system in the Kia with polymer transfer from the latch plate.

cm (1.6 in) polymer transfer on the webbing (**Figure 8**) from latch plate loading, located 89-93 cm (35.0-36.6 in) above the lower anchor.

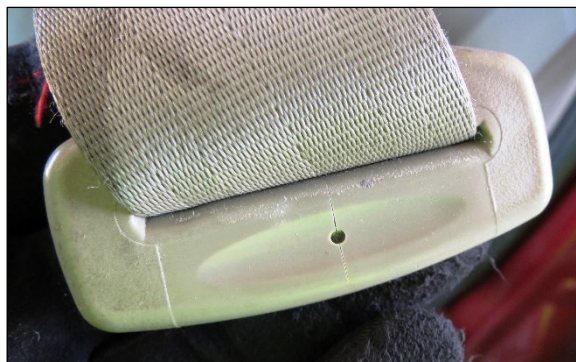
Loading evidence was also visible in the belt path of the latch plate (**Figure 9**). It was apparent to the SCI investigator that the driver's seat belt system was in use at the time of the crash. However, based on the combination of the exposed webbing's length in conjunction with the driver's demographics and the track position of the driver's seat, it is possible that driver had the shoulder portion of the webbing routed beneath her left arm.

**Figure 9.** Loading on the Kia driver's latch plate.

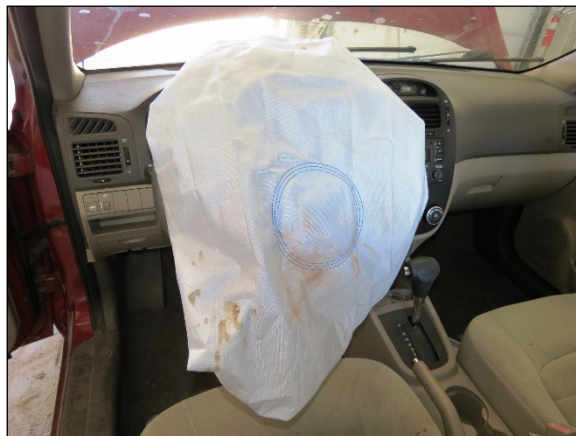
As a result of the crash under investigation, the driver's retractor pretensioner actuated, and the driver's frontal air bag deployed. The deflated driver's air bag measured 68 cm (26.8 in) in overall diameter, with a 14 cm (5.5 in) diameter circular center stitch pattern. A pair of 4 cm (1.6 in) diameter vent ports were located on the back of the air bag at the 10 and 2 o'clock positions. Two distinct areas of occupant contact were discernable on the face of the deployed driver's air bag, including an area of drops of blood on the lower left quadrant and an area of make-up transfer on the lower aspect of the center stitch pattern. The location of these contacts on the air bag (**Figure 10**) supported the SCI investigator's reconstruction of the crash (driver right steering maneuver corresponding to clockwise steering wheel rotation) and the hypothesis that the shoulder portion of the driver's seat belt might have been routed beneath the driver's left arm.

**Figure 10.** View of the Kia's deployed driver air bag at the time of the SCI vehicle inspection.

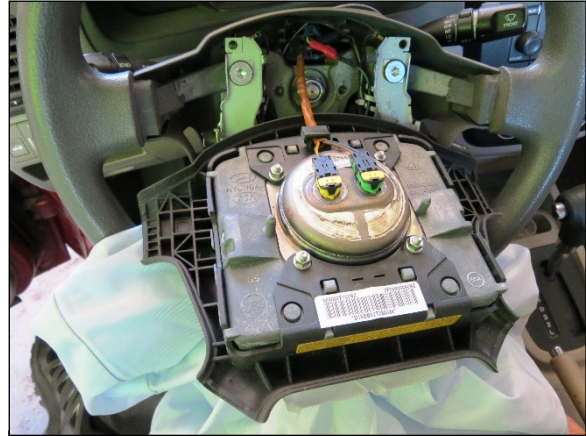
During the vehicle inspection process, the driver's frontal air bag/module was removed from its steering wheel hub-mounted location and disassembled for inspection. Several Torx fasteners were unscrewed from the steering wheel hub to facilitate removal of the module. The SCI investigator observed that the cover flap and module appeared to be the manufacturer's genuine original equipment. Proper manufacturer markings and serialization codes were observed on the module and inflator components (**Figure 11**).

There was no damage or abnormal wear, with no evidence to suggest that the module would not/did not operate as designed. Polymer connectors and wiring in the vehicle were intact, with no evidence of tampering or modification.

**Figure 11.** Driver's frontal air bag module during removal from the Kia's steering wheel hub.

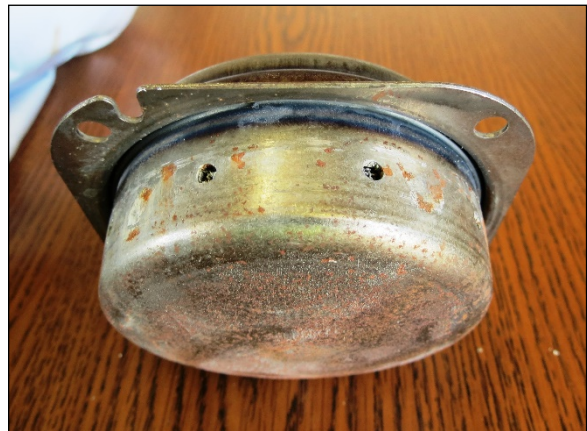
Four nuts were unfastened, and the inflator was removed from the driver's frontal air bag module. Examination of the inflator revealed that the electrical connections were in pristine condition, with no evidence of corrosion or degradation. The inflator was intact, and there was no evidence of abnormal condition or damage. The ventilation holes were all open from the deployment (**Figure 12**).

As a result of this SCI investigation, it was determined that all components of the driver's frontal air bag were OEM and that there was no evidence of inflator rupture or air bag malfunction. These findings were verified and corroborated by the Kia manufacturer's representative during the joint vehicle inspection.

**Figure 12.** View of the Kia driver's frontal air bag inflator at the time of the SCI vehicle inspection.
