DOT HS 813 081

**Special Crash Investigations:
Guardrail End Terminal
Investigation;
Vehicle: 2000 Toyota Corolla;
Location: Missouri;
Crash Date: November 2018**

**Special Crash Investigations
Guardrail End Terminal Investigation
Case Number: DS18028
Vehicle: 2000 Toyota Corolla
Location: Missouri
Crash Date: November 2018**

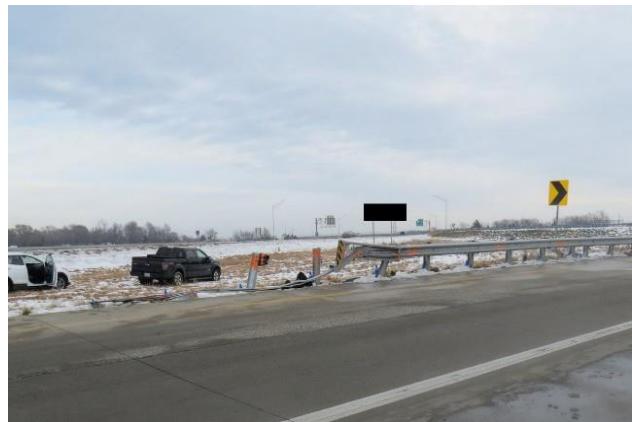
Figure 2. SoftStop guardrail end terminal, looking northeast

As the Toyota entered the curve, the vehicle departed the roadway to the left and struck the end terminal with its front end (Figure 2). The cause of the road departure is not known. The driver indicated that he had struck his head, but EMS was unable to locate any obvious trauma. He also stated that he had no complaints of pain. A C-collar was placed on the driver, and he agreed to be transported to a local hospital for examination and then released.

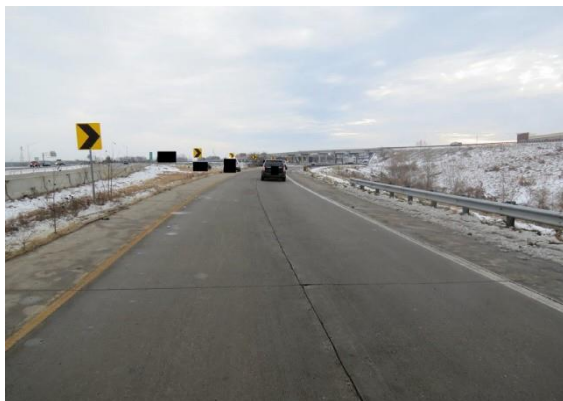
Figure 3. Eastbound approach

The crash site was a curved, single-lane ramp transitioning from an eastbound interstate highway to a State highway (Figure 3). The roadway was level with a right curve radius of 325 m (1068 ft) and a superelevation of 5.2 percent. The curve was marked by multiple curve warning signs on the north side of the roadway. The concrete roadway was bordered on the right by a white fog line, a concrete shoulder, and a W-beam guardrail. The roadway was bordered on the left initially by a yellow fog line, a concrete shoulder, a widening grass-covered median, and a concrete barrier. As the curve continued, the roadway was bordered on the left by a W-beam guardrail with a SoftStop guardrail end terminal.

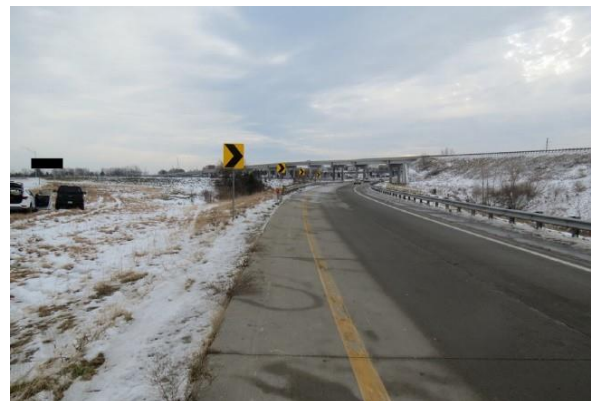
Figure 4. Roadway departure, looking east

The Toyota was driven by an unbelted 21-year-old male who reported he was talking to his girlfriend on his cell phone. He stated that the cell phone was on speaker, and that the phone itself was sitting on his thigh. The police reported that the driver had been drinking alcohol. The vehicle was traveling eastbound on the ramp at an unknown speed while negotiating a right curve. The driver lost control of the vehicle, and the vehicle began a clockwise yaw. The cause of the road departure is not known. The vehicle partially departed the roadway prior to the end terminal (Figure 4).

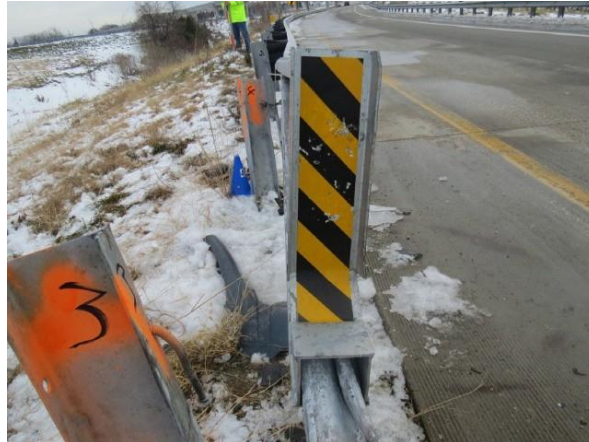
Figure 5. Guardrail end terminal impact, looking east

As the vehicle departed the shoulder on the left, the front plane struck the SoftStop end terminal (Figure 5). The WinSMASH damage-only program calculated a barrier equivalent speed of 23 km/h (15 mph). The driver's and passenger's frontal air bags deployed during this impact. The results are considered borderline because the end terminal yielded. Yielding objects are beyond

the scope of the WinSMASH reconstruction. As the front plane of the vehicle struck the end terminal, the vehicle pivoted around the end and began to rotate in a counterclockwise direction. The end terminal extruded to just past post 3. The Toyota continued to rotate until contacting the guardrail face with its right plane at post 7. The rotation continued until the vehicle came to rest on the ramp facing southwest.

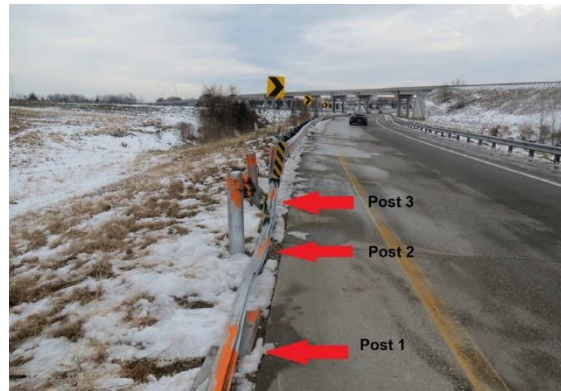
Figure 6. End terminal impact

The guardrail end terminal in this crash was a Trinity SoftStop tangent single-side redirective and gating terminal (Figure 6). It uses a moveable impact head on a W-beam rail section. During an end impact, the head travels down the anchored rails that are extruded toward the ground. The head measured 18 x 53 cm (7.0 x 20.8 in). The system was designed with an anchor post (post 0) and an anchor panel between post 0 and post 1. The head was located in front of post 1. The distance between post 0 and the terminal head was 129 cm (50.7 in). The guardrail height was 78 cm (30.7 in). During the crash, the head traveled east with 3.9 m (13 ft) extrusion toward the ground and came to a stop just beyond post 3. The total length of rail damaged was approximately 7.6 m (25 ft).

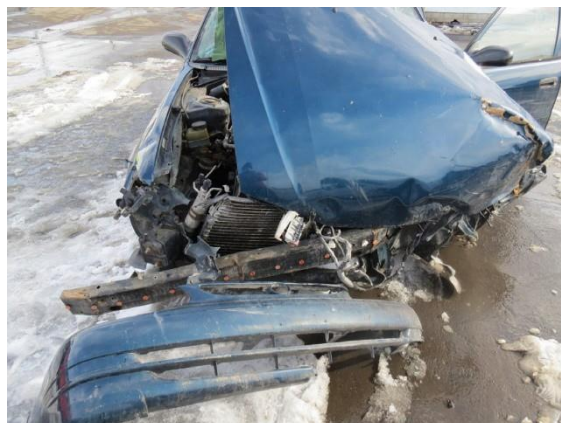
Figure 7. Frontal damage, the 2000 Toyota Corolla

The Toyota was involved in two damage producing events. The vehicle sustained moderate front plane damage from the impact with the end terminal (Figure 7). The damage began at the left bumper corner and extended 40 cm (15.7 in) to the right. The vehicle end was shifted 41 cm (16.1 in) to the right. Fourteen measurements were taken at the backing bar level by the Nikon Total Station, and the Faro Blitz program computed crush measurement in six increments, as follows: $C_1 = 19$ cm (7.4 in), $C_2 = 10$ cm (3.9 in), $C_3 = 14$ cm (5.5 in), $C_4 = 9$ cm (3.5 in), $C_5 = 0$ cm, and $C_6 = 0$ cm. The Collision Deformation Classification (CDC) was 11FLEE3.

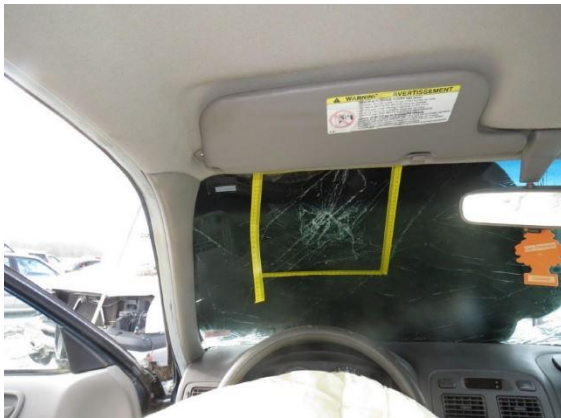
Figure 8. Windshield contact, the 2000 Toyota Corolla

The 21-year-old unbelted male driver was seated in an unknown posture. The vehicle was negotiating a right curve. At impact with the end terminal, the driver was displaced forward and to the left and engaged the deployed frontal air bag. His right hand possibly contacted the windshield (Figure 8), and his left knee contacted the left lower instrument panel (Figure 9). His post-crash position is not known. He was able to exit the vehicle under his own power.
