DOT HS 813 085

**Special Crash Investigations:  
On-Site Vehicle Rollaway Crash  
Investigation;  
Vehicle: 2008 Pontiac G6;  
Location: Indiana;  
Crash Date: March 2018**

**Special Crash Investigations  
On-Site Vehicle Rollaway Crash Investigation  
Office of Defects Investigation  
Case Number: IN18007  
Vehicle: 2008 Pontiac G6  
Location: Indiana  
Crash Date: March 2018**

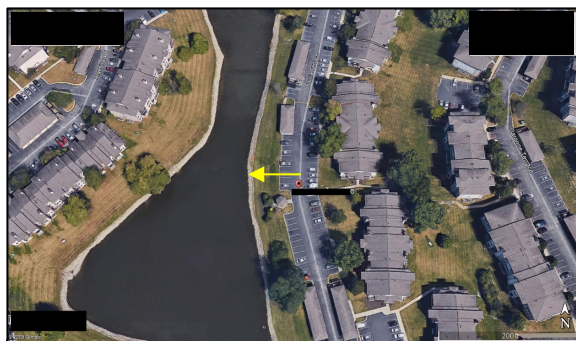
**Figure 2.** Satellite view of incident scene and apartment complex and path of the vehicle.

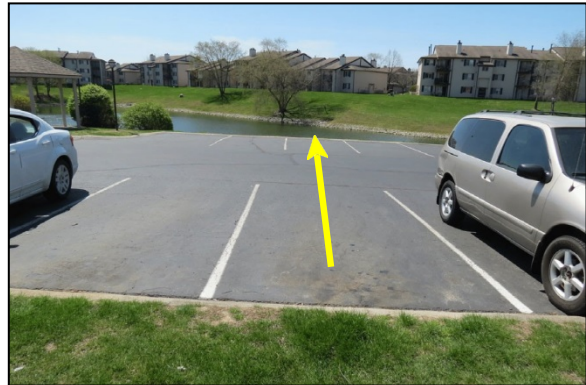
The first witness stated in the police report that the child climbed into the driver's seat and apparently shifted the console-mounted transmission shift lever from the Park-position. The vehicle began to roll backward in a westerly direction across the parking lot for a distance of 13 m (43 ft). The Pontiac overrode the mountable concrete curb and rolled 15 m (50 ft) down the grassy embankment into the pond (**Figure 3**). The father and the first witness both ran after the vehicle. Reportedly, neither the father nor the witness knew how to swim, but both went into the water to rescue the child from the vehicle. The first witness returned back to the east shore of the pond while the father removed the child from the vehicle.

**Figure 3.** Initial location of the Pontiac and trajectory toward the pond.

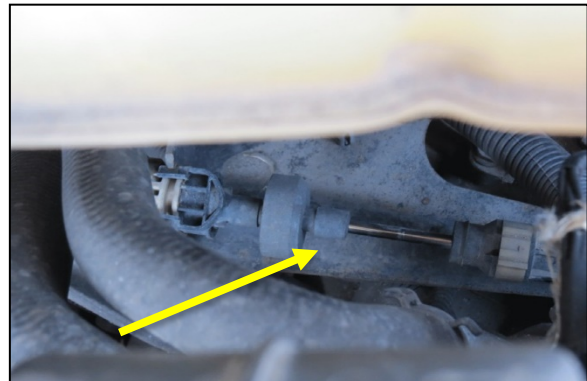
The Pontiac inspection was conducted in conjunction with an engineer from General Motors. No abnormalities were noted to the transmission selector cable in the engine compartment (**Figure 5**). However, when examined, with the ignition switch in the Lock position and the key removed from the switch, the gear shift lever was able to be moved from the Park position.

**Figure 5.** Intact transmission selector cable in the engine compartment.

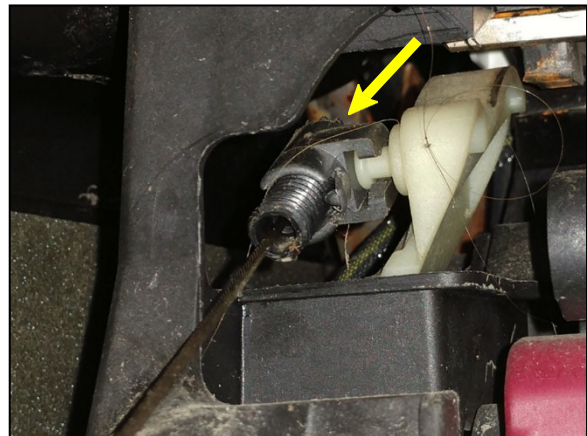
Through the course of the investigation, it was determined that the transmission shift cable was out-of-adjustment, which gave the child the ability to shift the vehicle from the Park position to Neutral without the ignition key and without applying the brake pedal.

Further inspection revealed that the Park lock cable was loose and out-of-adjustment (**Figure 6**). When taut, this cable prevents movement of the shift lever. When the ignition switch is then turned from the Lock position to On or Run, the tautness of the cable is released. Since this cable was in a loose position, movement of the shift lever was possible with the ignition switch in the Lock position.

The police removed the Pontiac from the pond the morning after the incident, and their inspection found the gear shift lever in the Neutral position. The first witness stated to the police that the child "placed the vehicle in gear." It was theorized that the child was able to shift the vehicle from Park to Neutral without the ignition key and without an application of brake pedal.

**Figure 6.** Loose park lock cable. Adjustment is in the back of the attachment point.
