U.S. Department
of Transportation
**National Highway
Traffic Safety
Administration**

DOT HS 813 087

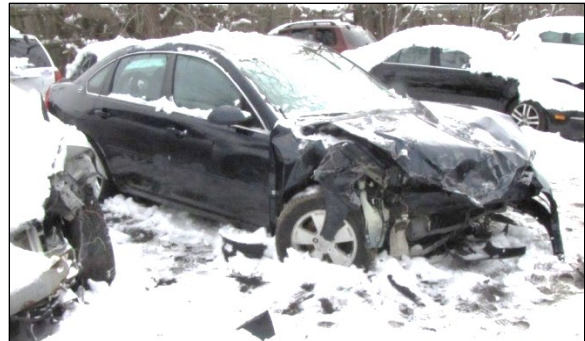
Figure 1. Front right oblique view depicting the frontal damage to the 2007 Chevrolet Impala

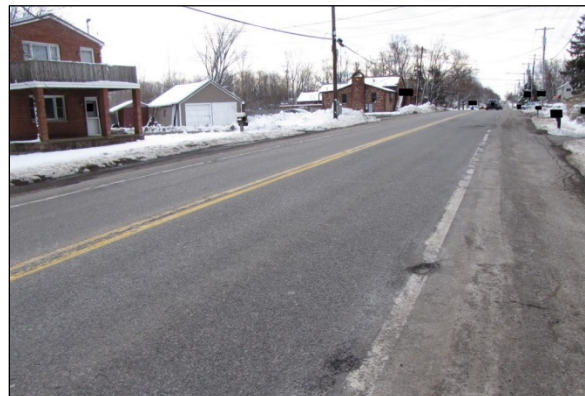
Figure 2. Southbound view of the Chevrolet’s approach to the crash site

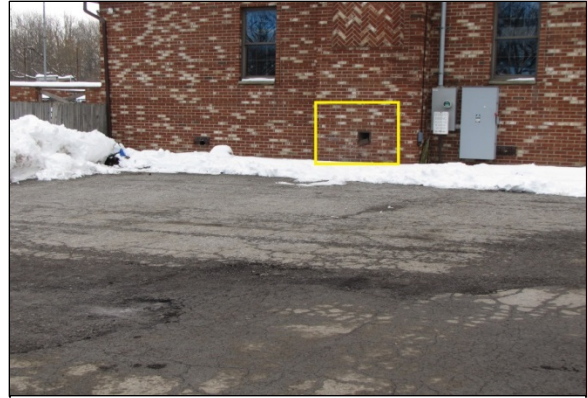
Figure 3. Southerly view of the area of the building struck by the Chevrolet

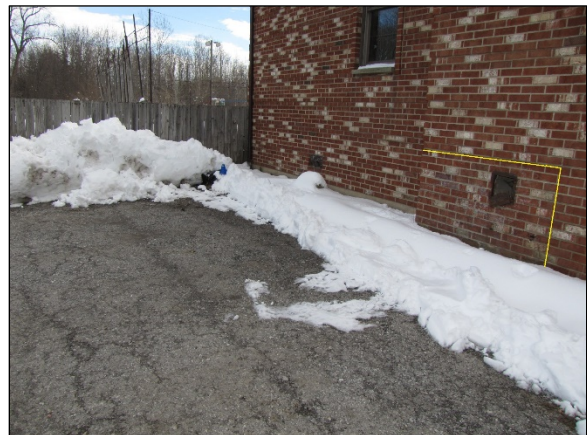
Figure 4: Southeast-facing image of the chimney impact and approximate final rest location of the Chevrolet

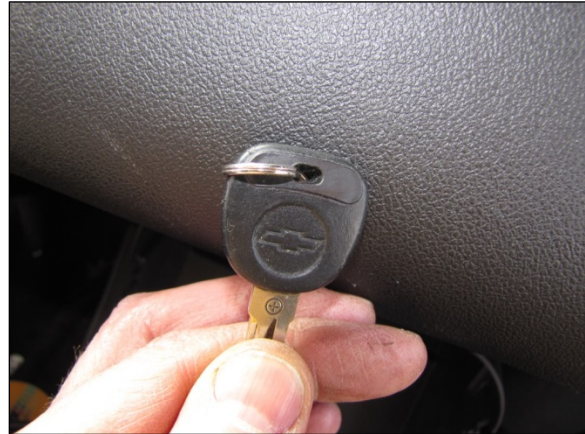
Figure 6. The Chevrolet's ignition key compliant to Recall No. 14V355000

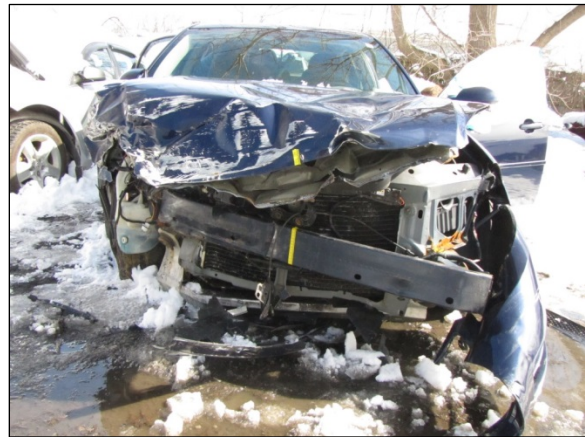
Figure 7: Front plane damage to the Chevrolet

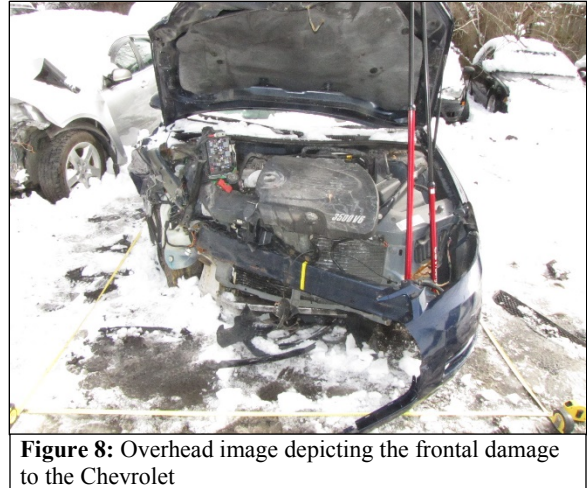
Figure 8: Overhead image depicting the frontal damage to the Chevrolet

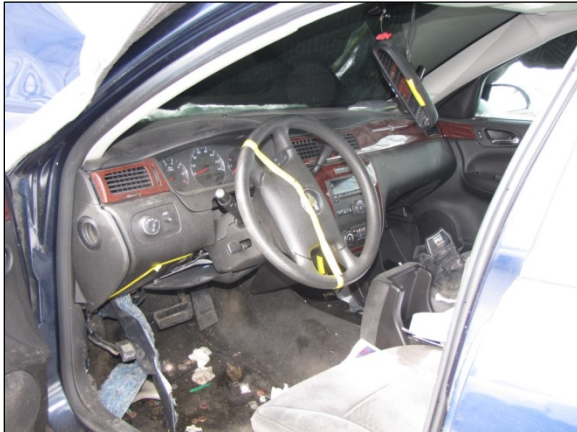
Figure 9: Overall view of the Chevrolet's interior and occupant related damage

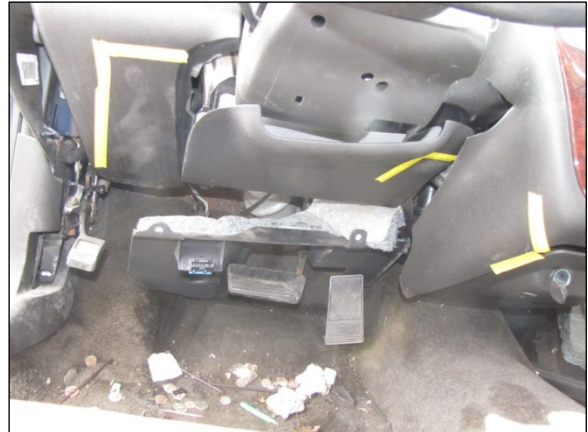
Figure 10: Driver contact damage to the lower instrument panel and knee bolster of the Chevrolet

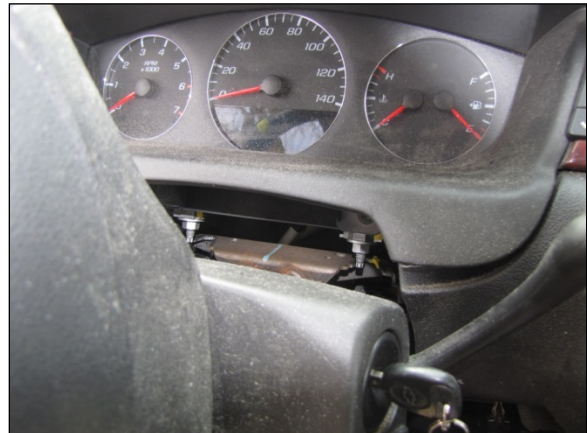
Figure 11: Separation of the steering column shear capsules in the Chevrolet

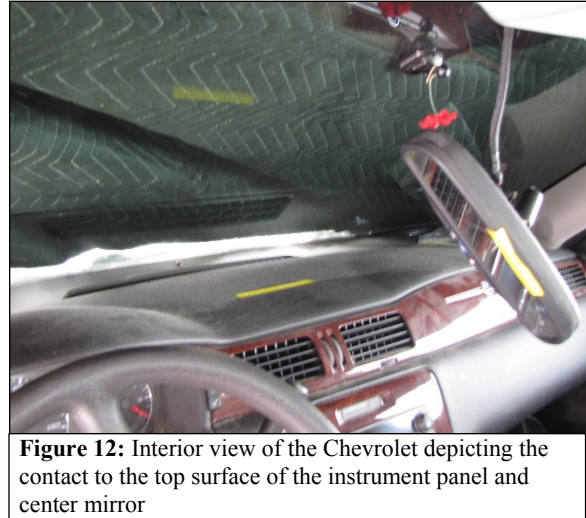
Figure 12: Interior view of the Chevrolet depicting the contact to the top surface of the instrument panel and center mirror

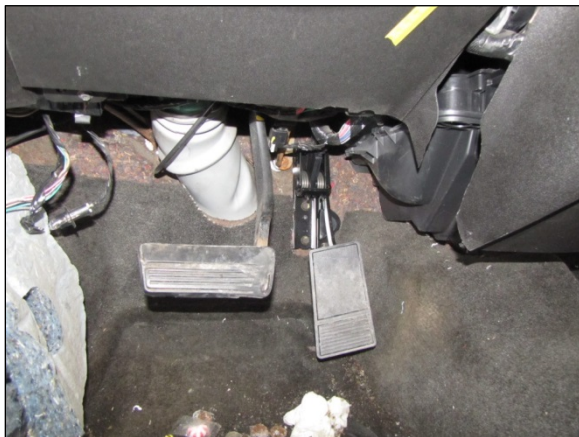
Figure 13: Overall image of the Chevrolet's foot pedals

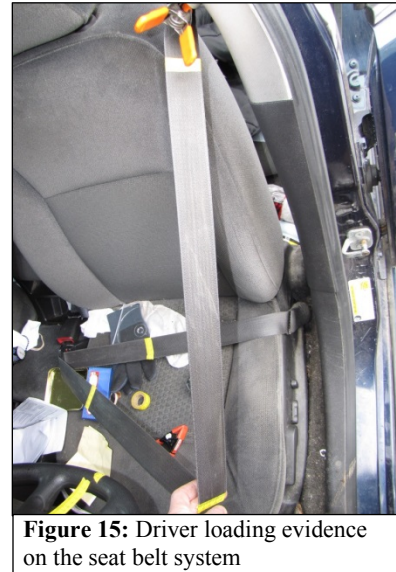
Supplemental Restraint Systems

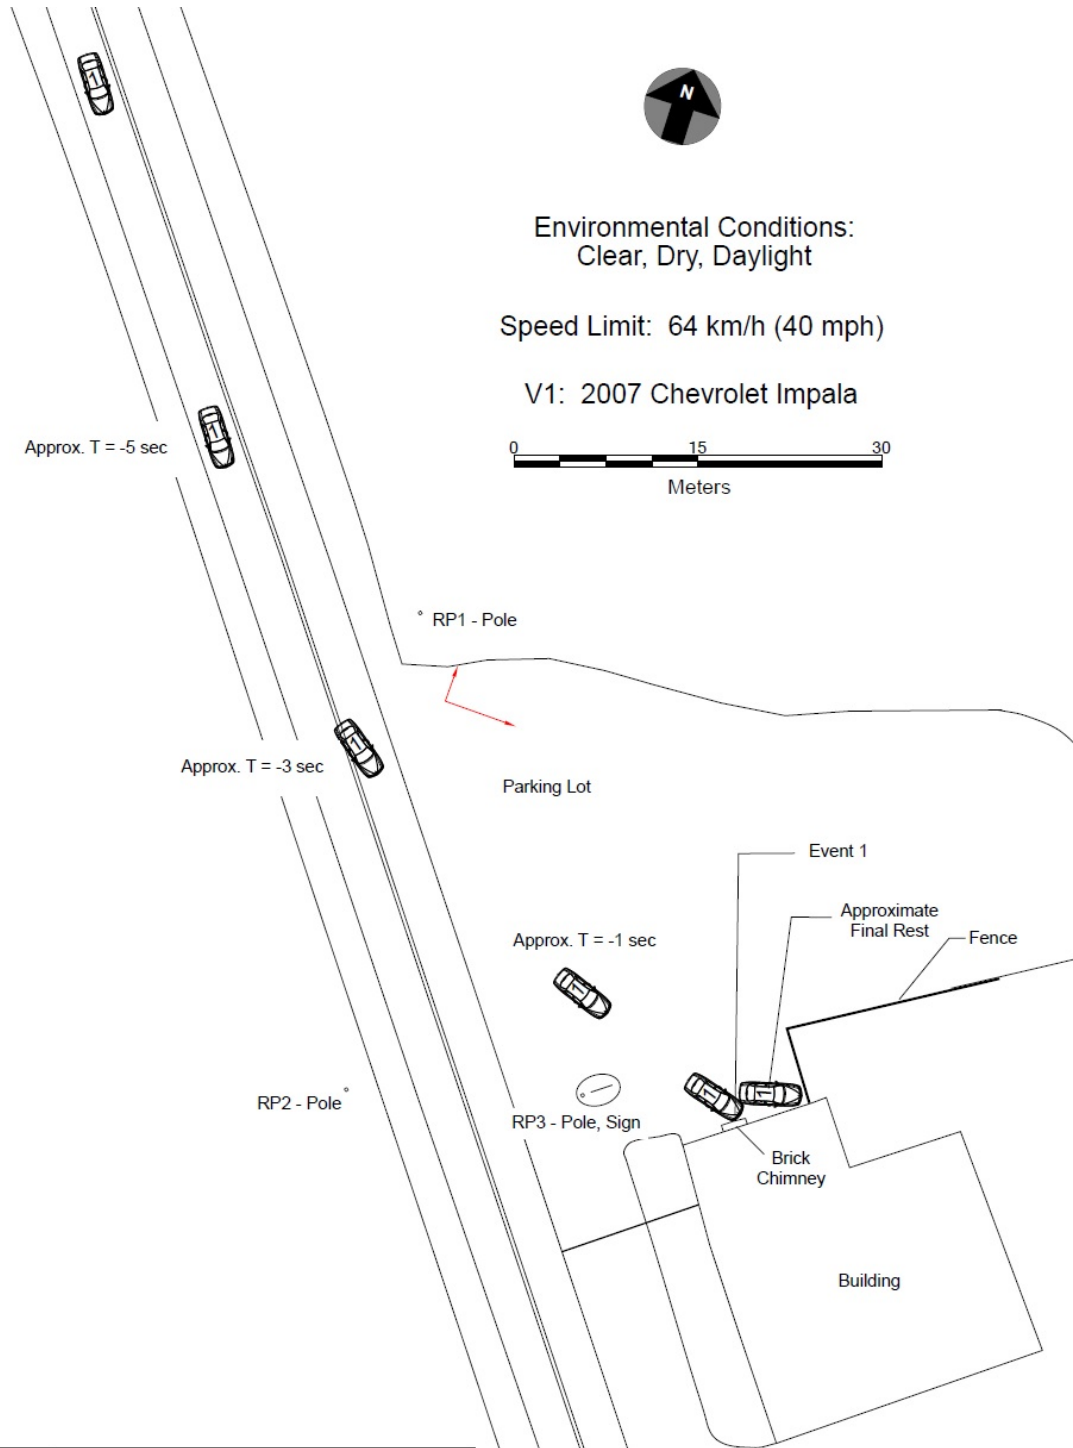
<p>Case Number:</p>	<p>CR18004</p>
