DOT HS 813 088

**Special Crash Investigations:
On-Site Air Bag Non-Deployment
Crash Investigation;
Vehicle: 2010 Chevrolet Cobalt;
Location: Arkansas;
Crash Date: May 2013**

Special Crash Investigations
On-Site Air Bag Non-Deployment Investigation
Office of Defects Investigation
Case Number: IN14015
Location: Arkansas
Vehicle: 2010 Chevrolet Cobalt
Crash Date: May 2013

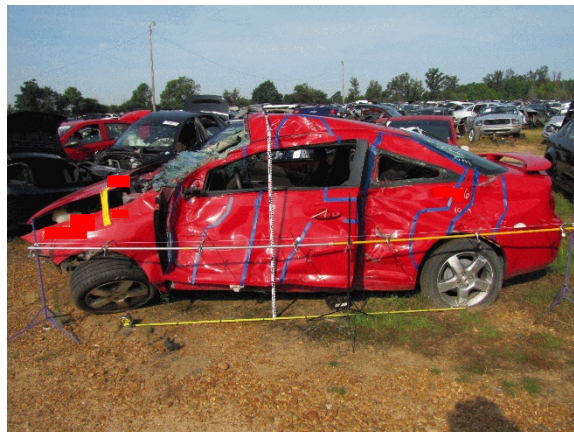
This report documents the on-site investigation of a non-deployment of the left side impact inflatable curtain (IC) air bag in a 2010 Chevrolet Cobalt LT (Figure 1), which was involved in impacts with four trees. This crash investigation was initiated by the National Highway Traffic Safety Administration in March 2014 and assigned to the Indiana University Transportation Research Center. This single-vehicle crash occurred in Arkansas in May 2013 after midnight and was investigated by a local police agency. The Chevrolet and the crash scene were inspected in July 2014 following a lengthy process to obtain the police crash report and then locate the vehicle and obtain permission for an inspection. Attempts to locate the driver for an interview were unsuccessful.

Figure 1. The damaged 2010 Chevrolet Cobalt

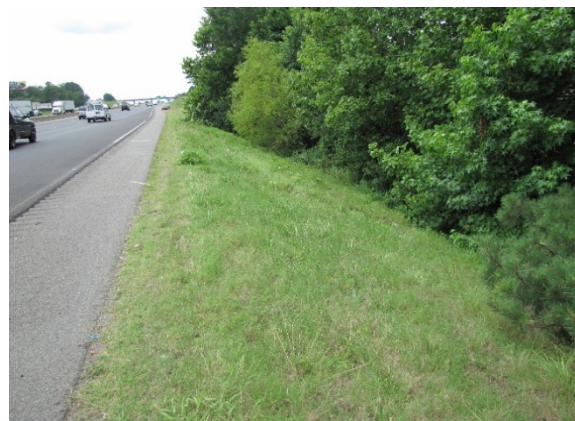
Figure 3. Northwest approach of the Chevrolet down the embankment to the wooded area

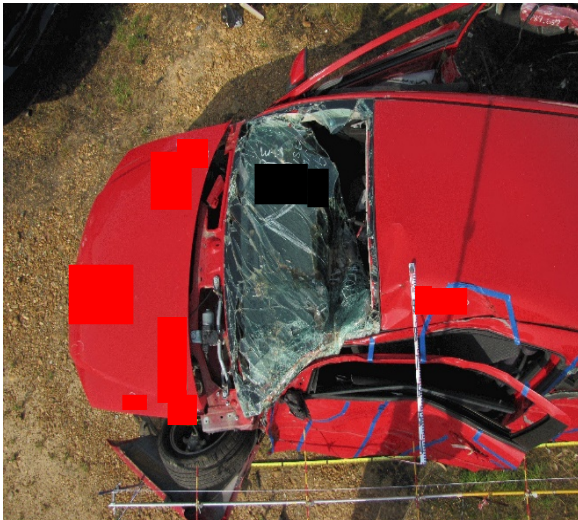
Figure 4. Top view of damage to the driver's door from impacts with 15 cm (5.9 in) and 18 cm (7.1 in) diameter trees

Exterior Damage Event 3: The front portion of the left front door and the left A-pillar were directly damaged during the impact with a tree 15 cm (5.6 in) in diameter. The direct damage began 179 cm (70.0 in) forward of the left rear axle and extended forward 37 cm (14.6 in). The damage from this impact overlapped the damage from Event 4. The CDC was 08LPAN99. The WinSMASH program could not be used to calculate delta V since there was overlapping damage from Event 4 and the tree yielded. The severity of the damage was moderate.

Exterior Damage Event 4: The left front door was directly damaged by the impact with a tree 18 cm (7.1 in) in diameter and the damage extended onto the roof side rail and roof. The direct damage began 91 cm (35.8 in) forward of the left rear axle and extended forward 72 cm (28.3 in). The damage from this impact overlapped the damage from Event 3. The maximum crush to the mid-aspect of the left front door measured 40 cm (15.7 in). The damage profile of the overlapping damage pattern was as follows: C1 = 17 cm (6.7 in), C2 = 20 cm (7.9 in), C3 = 31 cm (12.2 in), C4 = 32 cm (12.6 in), C5 = 40 cm (15.7 in), and C6 = 6 cm (2.4 in). The CDC was 08LPAW3. For reference, the WinSMASH program was used to analyze the overall crash severity in terms of the barrier equivalent speed (BES). The calculated BES was 46 km/h (28 mph). This analysis was considered borderline, and the results were low based on SCI experience.

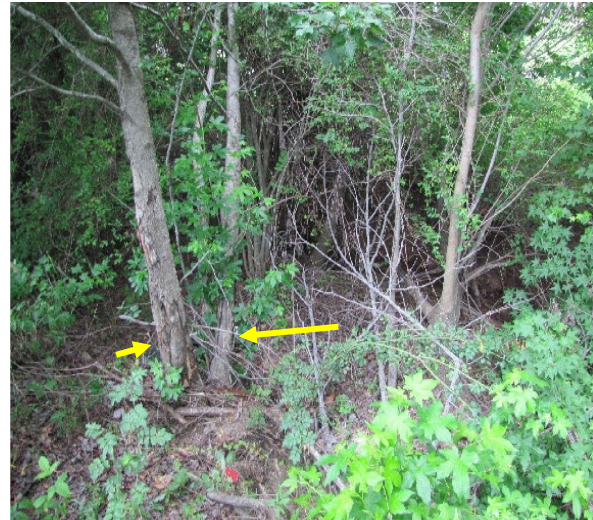
Figure 5. Area of impact with the two larger trees (Events 3 and 4)

The vehicle came to final rest against the 15 cm (5.9 in) and 18 cm (7.1 in) diameter trees, facing east. The force direction for all the impacts was in the 8 o'clock sector, and the multiple impacts resulted in overlapping damage. The vehicle's left IC air bag did not deploy. The vehicle's EDR reported the velocity change (delta V) experienced during the crash for a period of 300 msec. The maximum longitudinal and lateral velocity changes were 34.90 km/h (21.69 mph) at 280 msec and 55.62 km/h (34.56 mph) at 290 msec, respectively. The maximum resultant delta V was 66.03 km/h (41.03 mph) at 320 msec after AE. It could not be determined why the left IC air bag did not deploy.

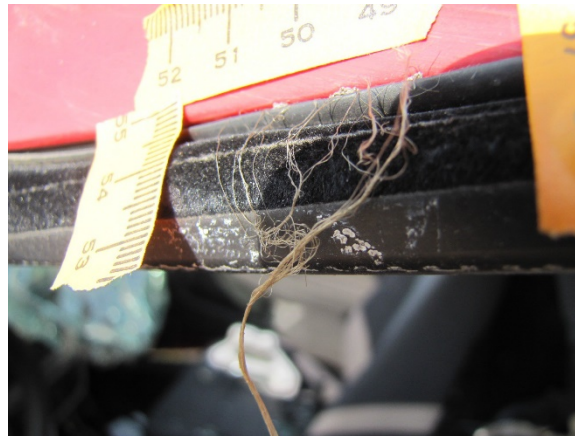
Figure 6. Hair transfer from the driver's head on the outside of the top of the left front window frame, located 30 cm (11.8 in) forward of the driver's head restraint

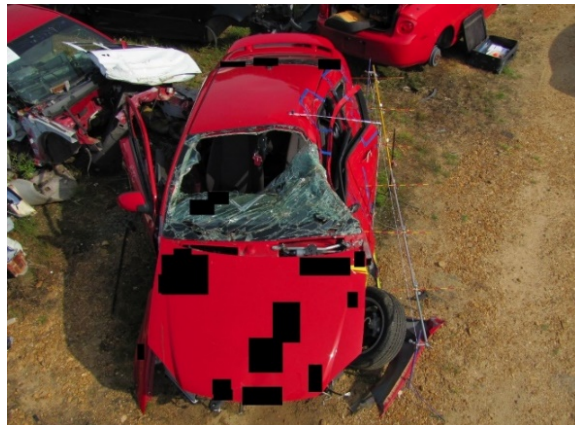
The Chevrolet (Figure 7), a front-wheel drive, five-passenger, two-door coupe with the Vehicle Identification Number 1G1AD1F52A7xxxxxx, was manufactured in March 2010. The vehicle was equipped with a 2.2-liter, I-4 engine, 4-speed automatic transmission; traction control; and 4-wheel antilock brakes. The vehicle was also equipped with multi-stage frontal air bags and a tilt steering column. The column tilt position could not be determined at the SCI vehicle inspection since the column lock was disengaged, and the column was probably moved when the frontal air bag module was removed during salvage operations. The specified wheelbase was 262 cm (103.1 in). The vehicle manufacturer's recommended tire size was P205/55R16. The vehicle was equipped with Hankook Optimo tires of the recommended size on the left front and left rear. The right side tires had been removed. The manufacturer's recommended cold tire pressure for the front and rear tires was 207 kPa (30 psi).

Figure 7. Top view of the Chevrolet

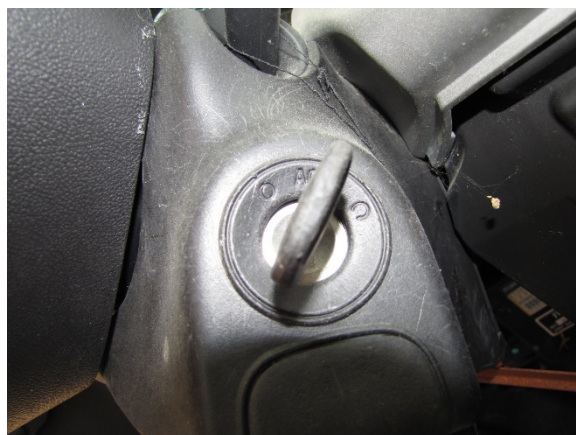
None of the vehicle's supplemental restraint systems deployed in the side-impact crash. The vehicle's EDR reported the vehicle power mode status as "run." Inspection of the ignition switch during the SCI vehicle inspection revealed that the key was still present in the ignition and that the switch was in the "run" position (Figure 8). The driver's frontal air bag did not deploy since the force direction was in the 8 o'clock sector, and the resulting longitudinal velocity change was positive as indicated by the vehicle's EDR longitudinal velocity change graph. Frontal air bags are designed to deploy when the vehicle is subjected to a negative longitudinal deceleration that meets the vehicle's deployment threshold criteria.

Figure 8. Initial status of the Chevrolet's ignition switch at the SCI vehicle inspection

The non-deployment of the left IC air bag is the primary issue in this case. The vehicle's IC air bags, which were designed to deploy independently, deployed during a lateral impact on the struck side of the vehicle. From a visual perspective, the barrier equivalent damage to the vehicle's left plane from the tree impacts was moderately severe, suggesting the severity of the crash would have been sufficient to require deployment of the left IC air bag. However, examination of the lateral crash pulse indicated that the pulse was elongated, occurring over a long duration, relative to a barrier equivalence. The initial slope of the lateral velocity change remained shallow over for the first 80 milliseconds reaching 14.18 km/h (8.81 mph) at 80 msec. The slope then flattened reaching 19.63 km/h (12.20 mph) at 160 msec. The profile of this velocity change may be related to the yielding properties of the impacts. The slope of the velocity change then significantly increased reaching its maximum-recorded value of 55.62 km/h (34.56 mph) at 300 msec. Due to the proprietary nature of the manufacturer's deployment criteria, it could not be determined or verified if the four tree impacts generated sufficient lateral deceleration in the required time constraints to trigger deployment of the left IC air bag. Discussions between NHTSA and the vehicle manufacturer regarding the crash reconstruction and the non-deployment of the left IC air bag provided no further information as the vehicle was no longer available for inspection. The root cause of the non-deployment remains undetermined.
