DOT HS 813 090

**Special Crash Investigations:  
On-Site Non-Crash Vehicle  
Fire Investigation;  
Vehicle: 2017 Chevrolet Volt;  
Location: California;  
Incident Date: November 2018**

**Special Crash Investigations  
On-Site Non-Crash Vehicle Fire Investigation  
Office of Defects Investigation  
Case Number: DS18031  
Vehicle: 2017 Chevrolet Volt  
Location: California  
Incident Date: November 2018**

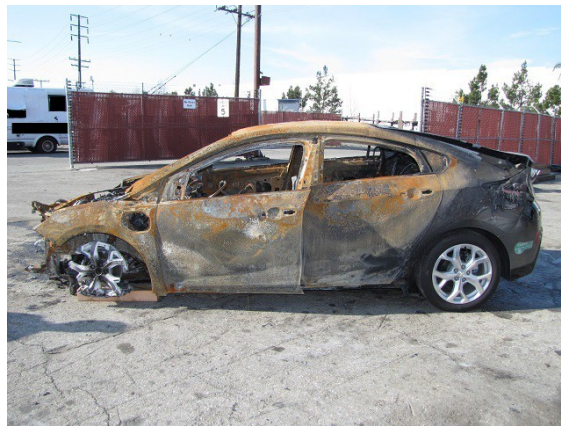
The Chevrolet sustained fire damage distributed to all planes (Figure 3), the engine compartment, and passenger compartment. Sheet metal was largely intact while paint, glazing, plastic, rubber and other composite components were destroyed, including the grille, front bumper, headlamps, front tires, and left front wheel. The vehicle sustained unspecified post-incident damage during fire extinguishment including removal of the hood.

*Figure 3. 2017 Chevrolet Volt*

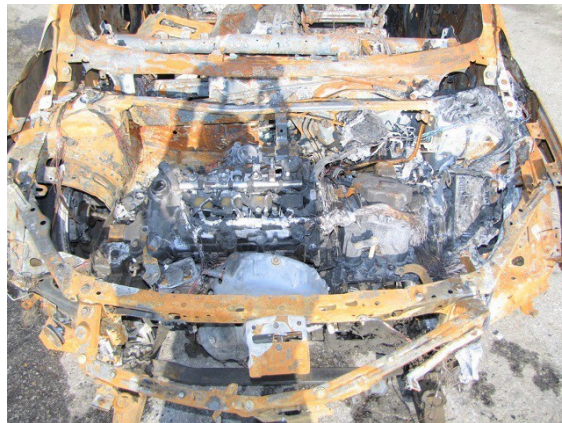
An on-site joint vehicle inspection of the Chevrolet was conducted with a GM investigator present for the purpose of identifying the cause of the fire, its area of origin, and examination of the affected components. Based on the vehicle inspection and information provided by GM, the root cause of the fire was unknown. Exterior burn damage was present on the front, back, left, right, top and bottom planes, engine compartment, and interior front and second rows. Statements made by the driver and data included in the fire incident report suggested the fire likely began in the right aspect of the engine compartment (Figure 4). The engine compartment was examined and the following components were identified: 1.5 liter gas-fuel combustion engine, gas fuel lines, high-voltage traction power inverter, high-voltage cables, low-voltage fuse block, catalytic convertor, master cylinder, and ABS module. The GM investigator noted the presence of visibly exposed copper wiring harnesses in the engine compartment and interior instrument panel where the harness insulation had burned and melted away from the copper strands. He noted that copper wiring has a relatively high melting temperature and much of the wiring exhibited “beading” on the melted ends indicating a high temperature burn. In the occupant compartment, the beading was present on the interior fuse block located in the left instrument panel, on coaxial cables, and on various other exposed wiring in the instrument panel. The GM investigator indicated that, in this particular instance, evidence of high temperature and “beading” do not necessarily indicate high voltage involvement since the copper wiring was connected to low-voltage components.

*Figure 4. Engine compartment, 2017 Chevrolet Volt*

The fuel line connections in the engine compartment were present and intact. In response to the apparent integrity of the fuel lines, The GM investigator did not entirely rule out the possibility that a gas leak caused the fire. The possibility existed because the driver was operating the vehicle in gas fuel mode at the time of the incident.

Underhood components damaged by heat generated by the fire included the engine cover, engine reservoirs, low-voltage battery, electronics cooling systems, fuse block, wiring harnesses, rubber hoses, and most other non- metallic (plastic, rubber, etc.) components. Melted aluminum was present in some areas where copper wiring harnesses were still in place. The GM investigator noted that no magnesium was present in the engine compartment.

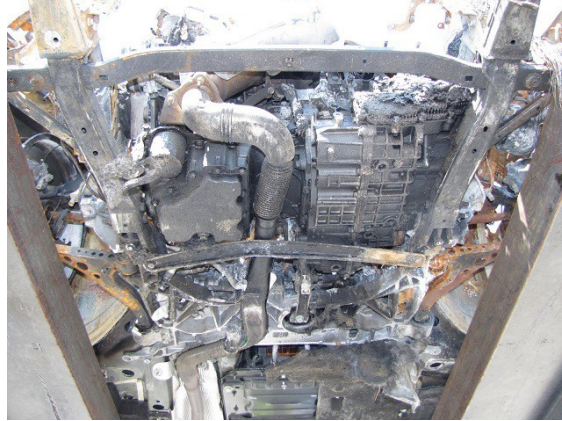
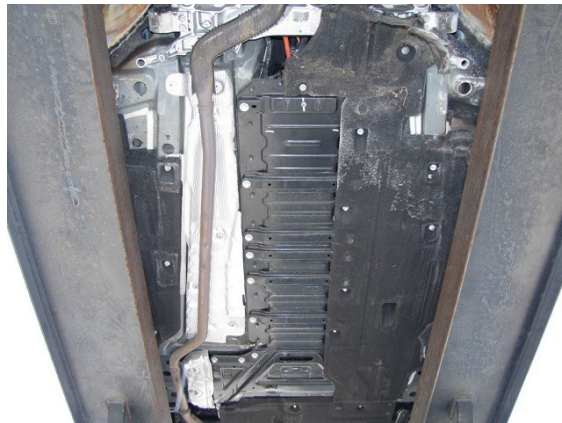
The vehicle was placed on an elevated rack and the undercarriage was examined. Burn damage beginning at the leading edge of the engine compartment extended to just slightly aft of the fire

wall (Figures 5 and 6). Burn damage was less severe on the lower half of the engine compartment than it was on the upper half, and in response the GM investigator suggested the fire did not likely originate in the lower engine compartment or undercarriage. The damage flow suggested the fire spread from the upper engine compartment toward the left and lower aspects and from the forward aspect of the engine compartment rearward to the exterior and interior.

*Figure 5. Undercarriage below engine compartment, 2017 Chevrolet Volt*

*Figure 6. Undercarriage and exposed Li-ion battery location, 2017 Chevrolet Volt*

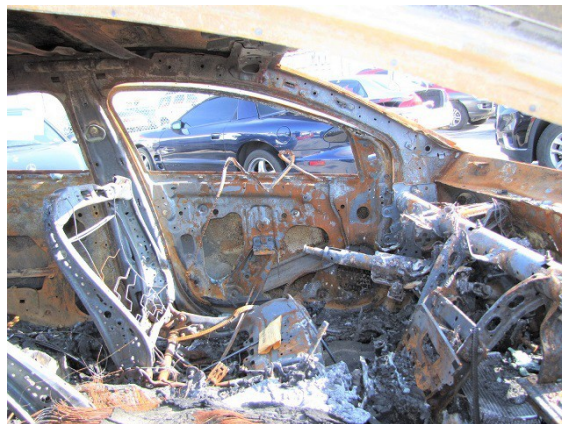
The vehicle's interior was completely consumed by fire (Figure 7). Only metal components, framework, and wiring remained recognizable. Synthetic and fabric components were destroyed. All glazing was disintegrated or displaced. The doors remained closed and operational.

*Figure 7. Interior front row damage, 2017 Chevrolet Volt*
