DOT HS 813 095

**Special Crash Investigations:
On-Site Guardrail End Terminal
Crash Investigation;
Vehicle: 2012 Hyundai Sonata;
Location: Missouri;
Crash Date: June 2018**

Special Crash Investigations
On-Site Guardrail End Terminal Crash Investigation
Case Number: DS18017
Vehicle: 2012 Hyundai Sonata
Location: Missouri
Crash Date: June 2018

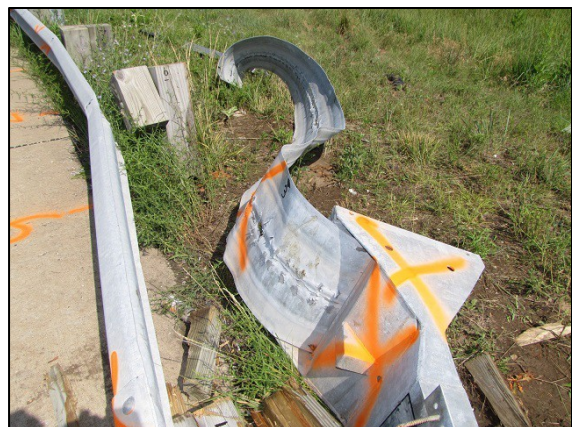
Figure 2. Guardrail ET2000 and extruded W-beam.

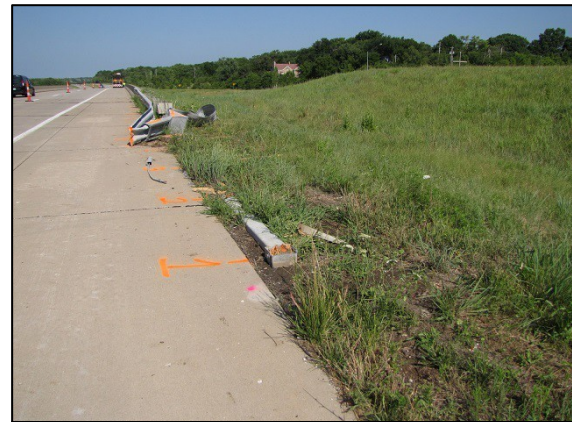
Figure 4. Area of impact, guardrail Post 1.

The crash included two events. Initially, the front plane of the Hyundai struck the ET2000 end terminal head-on (Event 1) (**Figure 4**). The end terminal yielded, the first six posts were damaged, and a section of metal W-beam measuring 4.3 m (14.1 ft) long extruded through the terminal chute. One or more unknown components of the damaged guardrail struck the left plane in a sideswiping configuration, beginning at the left A-pillar and ending at the left C-pillar (Event 2). The Hyundai rotated 30 degrees clockwise and was displaced right to the field side of the guardrail where it traveled in a northwest trajectory depositing a left tire track measuring 19.4 m (63.6 ft) on the descending roadside having a slope measuring negative 1.4 percent. The vehicle came to rest facing northwest 25.9 m (85.0 ft) from the first impact. During the crash, the driver's frontal, seat-mounted, and inflatable curtain (IC) air bags deployed and his seat belt pretensioner actuated.

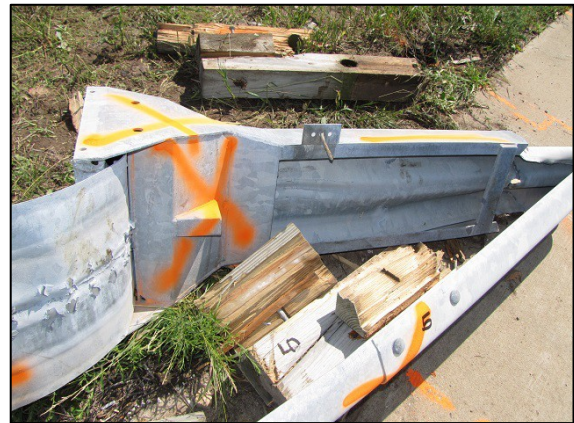
The guardrail was configured with an ET2000 end terminal (**Figure 5**), steel W-beam, wood posts configured with wood offset blocks, and steel posts configured with wood offset blocks. The ET2000 was a 5-inch extruder-type end terminal configured with a rectangular impact face measuring 51 cm (20.0 in) wide x 52 cm (20.5 in) high. The guide chute exit height measured 39 cm (15.3 in). The guardrail was configured with a steel ground strut measuring 205 cm (80.7 in) long located between Posts 1 and 2, an anchor cable attached to Post 1, and an anchor bracket attached to the W-beam between Posts 1 and 2. The wooden guardrail posts 1 to 5 measured 14 x 19 cm (5.5 x 7.5 in) and posts 6 and 7 measured 15 x 20 cm (6.0 x 8.0 in). The steel posts 8 to 12 measured 15 x 10 cm (6.0 x 4.0 in). Posts 3 to 12 were assembled with offset wood blocks measuring 15 x 20 x 36 cm (6.0 x 8.0 x 14.0 in). Spacing averaged 1.9 m (6.2 ft) for Posts 1–12 and W-beam height measured top to ground was 65 cm (25.5 in).

Figure 5. ET2000 end terminal.

At impact with the impact head, the ET2000 end terminal was displaced to the field side and a section of W-beam measuring 4.3 m (14.0 ft) long extruded on the field side. The ET2000 did not exhibit any damage or deformation caused by the impact or extrusion. Posts 1, 2, 3, and 5 were sheared off at ground level and post 4 was uprooted. An additional length of non-extruded W-beam measuring 7.1 m (23.3 ft) was damaged, including three rail kinks at posts 4, 6, and 7. The anchor bracket and cable were displaced to the ground and the ground strut remained in place on the remnants of posts 1 and 2.

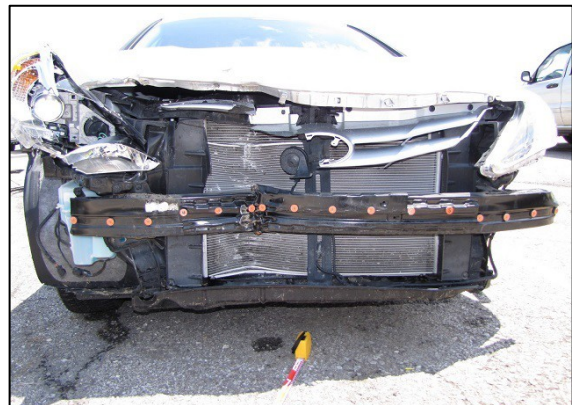
The Hyundai sustained minor severity damage to the front (**Figure 6**), left, and top planes during the crash. The front plane sustained direct and induced damage at head-on impact with the ET2000 guardrail end terminal. The left plane was damaged on the left front fender, left front door, and left rear door at impact with undetermined guardrail components in a secondary sideswipe configuration. The top plane was damaged at the hood, which sustained induced damage in the first impact. Direct damage to the bumper fascia began 13 cm (5.1 in) left of the front right bumper corner and extended 155 cm (61.0 in) to the left. The Field L extended from bumper corner to bumper corner and measured 170 cm (66.9 in). The bumper fascia was displaced, and the backing bar was used to obtain crush measurements. Sixteen measurements in 10.0 cm (3.9 in) increments were taken at bumper level by the Nikon Total Station and the Faro Blitz program computed crush measurement in six increments as follows: $C_1 = 0$ cm, $C_2 = 2$ cm (0.8 in), $C_3 = 7$ cm (2.8 in), $C_4 = 17$ cm (6.7 in), $C_5 = 15$ cm (5.9 in), and $C_6 = 9$ cm (3.5 in). The observed principal direction of force was 0 degree, and the collision deformation classification (CDC) for the Hyundai was 12FDEW1.

Figure 6. Front plane crush measurements, the 2012 Hyundai Sonata.

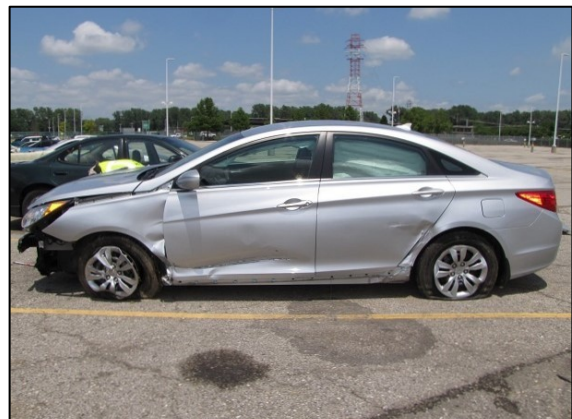
Figure 7. Left plane damage, the 2012 Hyundai Sonata.

The Hyundai sustained minor severity damage to the left plane in a secondary impact with unknown components of the guardrail (**Figure 7**). The left front fender sustained induced damage, the trim at sill level was displaced, and both tires were flat and the wheel covers were bent. Direct damage began at the left A-pillar 45 cm (17.7 in) aft of the left front axle, extended 215 cm (84.6 in) rearward and ended at the left C-pillar. This was a side swipe damage configuration with an observed PDOF of 350 degrees and the CDC was 12LYES1.
