DOT HS 813 126

**Special Crash Investigations:
On-Site Guardrail End Terminal
Crash Investigation;
Vehicle: 2006 Kia Sedona;
Location: Pennsylvania;
Crash Date: November 2018**

Special Crash Investigations
On-Site Guardrail End Terminal Crash Investigation
Case Number: CR18033
Vehicle: 2006 Kia Sedona
Location: Pennsylvania
Crash Date: November 2018

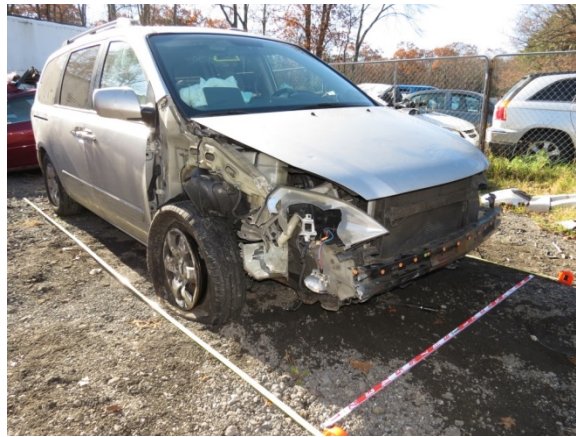
This report documents the investigation of an impact to an SKT guardrail end terminal by the front plane, right aspect of a 2006 Kia Sedona (Figure 1). The investigation was conducted on behalf of the Federal Highway Administration (FHWA). The Kia was occupied by a belted 53-year-old female driver, a belted 46-year-old female front-right occupant, and two 3-year-old male children seated in forward-facing child restraint systems (CRS) in the outboard positions of the second row. The driver reported that, while traveling south in the right lane of a divided highway at night, a tractor-trailer encroached into her lane of travel. She steered the Kia right and braked into a gore area, continued south, and struck the SKT end terminal. Impact forces displaced the SKT end terminal along the guardrail and extruded a portion of the W-beam. The Kia's front seat belt pretensioners actuated, and its frontal air bags deployed. The driver and both child occupants were uninjured. The front passenger was transported by ambulance to a local hospital, where she was treated and released within hours of the crash.

Figure 1. Front right oblique view of the guardrail damage to the Kia Sedona

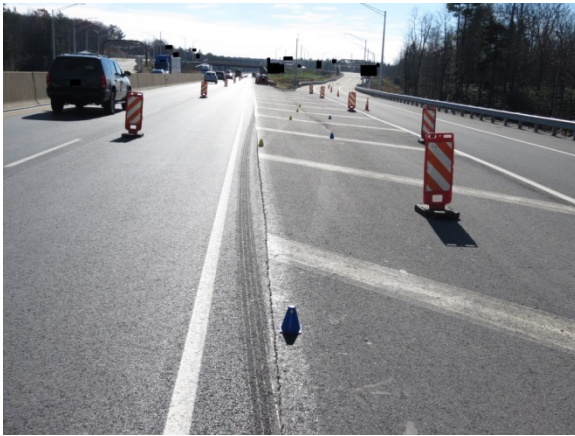
lane of travel. The driver of the Kia steered right into the painted gore area (Figure 3) and applied the brakes to avoid the encroaching combination unit. Tracking tire marks consistent with the Kia's trajectory and braking actions were observed on the asphalt-surface of the gore. The left front tire mark was 26.4 m (86.6 ft) long and the right was 23.1 m (75.8 ft) long. The tire marks arced left counterclockwise as the driver applied a left counter-steer in an attempt to regain directional control.

Figure 3. Southbound view of the Kia's departure from the travel lane onto the gore area

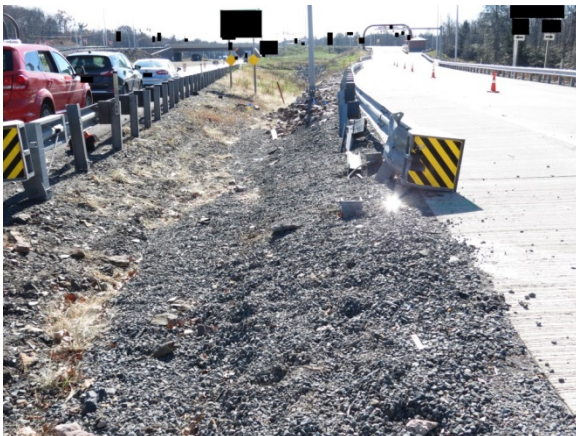
The guardrail and end terminal was a tangent system recently installed adjacent to the shoulder of the new concrete exit ramp. The maximum total height of the W-beam measured 52 cm (20.5 in) at an undamaged section of the beam at Post 9. The Kia struck the face of the end terminal (Figure 5) originally located at Post 1. The impact face measured 51 x 51 cm (20.0 x 20.0 in). The left aspect of the flange of the SKT face was bent inward and deformed 5 cm (2.0 in) at a height of 18 cm (7.1 in) above the bottom aspect, resultant from direct contact by the Kia's right front bumper corner.

Figure 5. South-facing view of the struck SKT end terminal and guardrail system

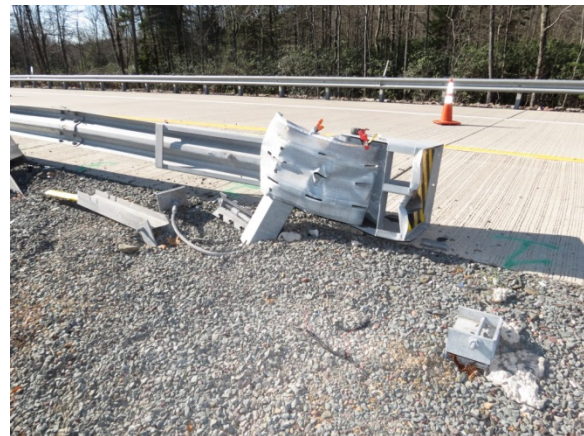
Despite the minor damage to the face of the impact head, the feeder channel chute was not deformed, and all welds remained intact. The force of the impact displaced the end terminal to the south and extruded 1.2 m (4.0 ft) of the W-beam. The extruded W-beam curled to the field side, between the exit ramp and the highway (Figure 6).

Figure 6. West-facing view of the extruded guardrail and displaced SKT end terminal

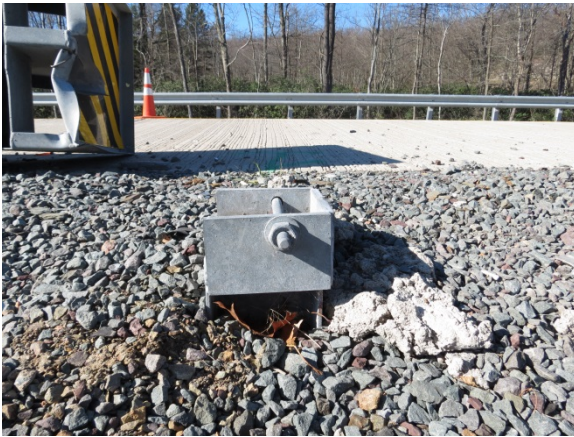
Post 1 was the steel foundation post. The base of the post remained intact in the ground, with the slip post and cable attachment separated from the base as a result of the impact by the Kia

(Figure 7). The through bolt remained in place in the base. The post was completely separated from the base and displaced 142 cm (55.9 in) downstream.

Figure 7. Westerly view of the displaced Post 1

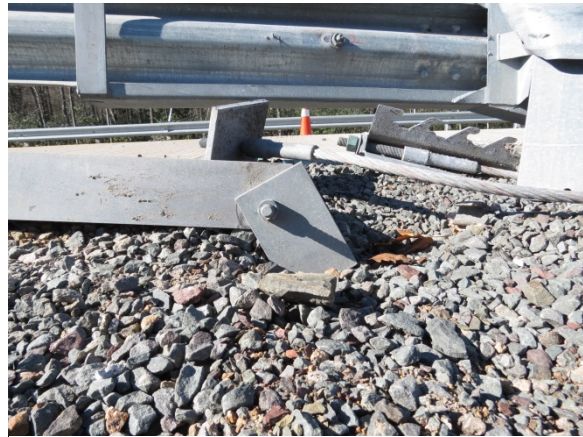
Figure 8. Westerly view of the displaced Post 2 at the hinge

Post 2 was a 10x15 cm (4.0x6.0 in) steel hinge post. The base of the post was displaced in the ground as the attachment point between the post and the W-beam separated from slot 2. The hinge point remained intact as the post was displaced to the ground by the impact (Figure 8).

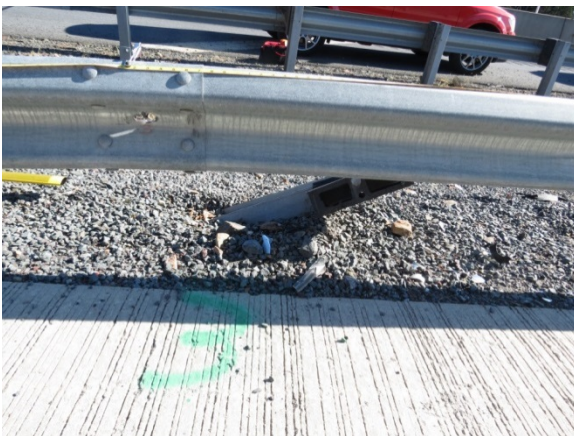
Post 3 was a 10x15 cm (4.0x6.0 in) steel I-beam post. A splice point of W-beam was located at this post location. The composite block-out remained attached to the post by the carriage bolt, the head of which had pulled through the slot in the W-beam. The post was deflected 45 degrees downward (Figure 9) in the south trajectory of the vehicle.

Figure 9. Easterly view of the displacement to Post 3

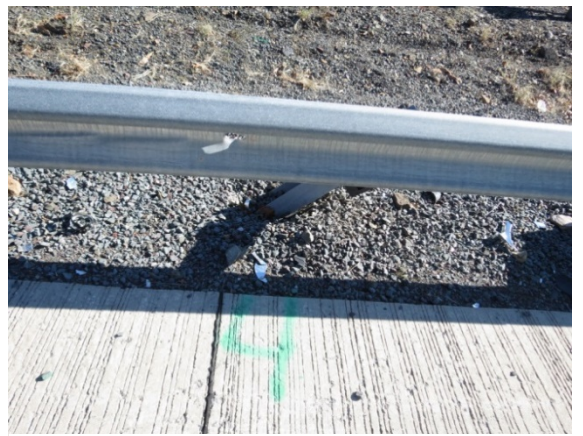
Figure 10. Easterly view of the bolt separation and displacement of Post 4

Post 4 was rotated approximately 45 degrees. The block-out remained attached to the post via the carriage bolt, and the head of the carriage bolt had pulled through the slot in the W-beam (Figure 10).

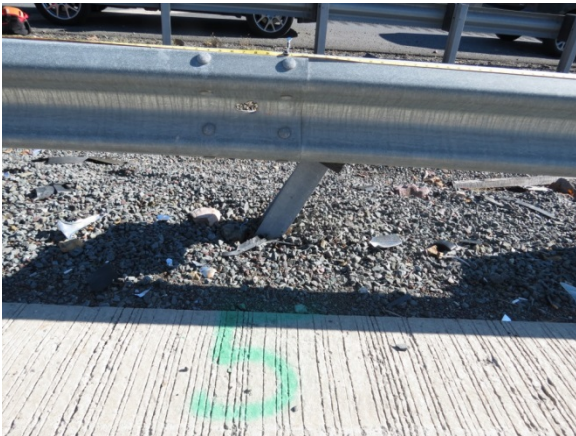
Post 5 was at a splice joint of the W-beam. The post was deformed approximately 30 degrees along the vehicle's trajectory and slightly rotated by crash forces (Figure 11). This post was also separated from the W-beam at the attachment bolt location after the head of the carriage bolt had pulled through the slot in the rail. The composite block-out remained attached to the post.

Figure 11. Easterly view of the bolt separation and displacement of Post 5

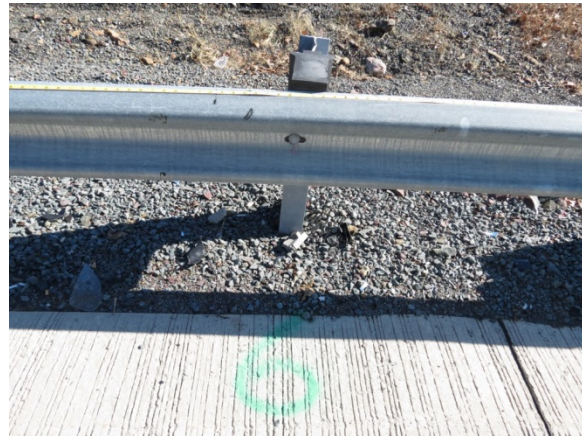
Post 6 remained attached to the W-beam by its carriage bolt, with the block-out in place. The post was deflected approximately 5 degrees to the south by the impact forces (Figure 12).

Figure 12. Easterly view of the minimal displacement of Post 6

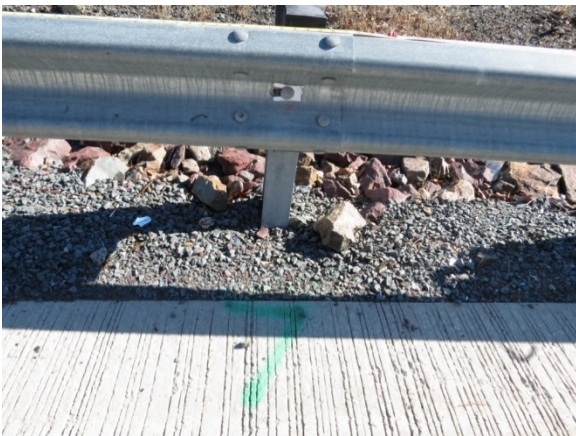
There was no damage to the guardrail system at Post 7 or beyond (Figure 13). The block-out at Post 7 remained in place, with the carriage bolt attaching the W-beam to the post. A northwest-facing lookback view of the struck guardrail system is depicted in Figure 14.

Figure 13. Easterly view of the system at Post 7

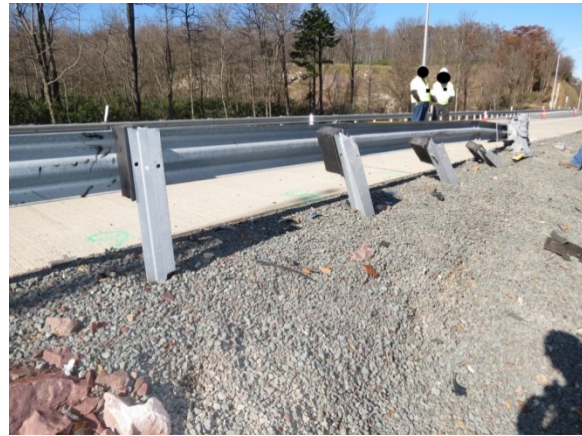
Figure 14. Northwesterly lookback view of the damaged guardrail system

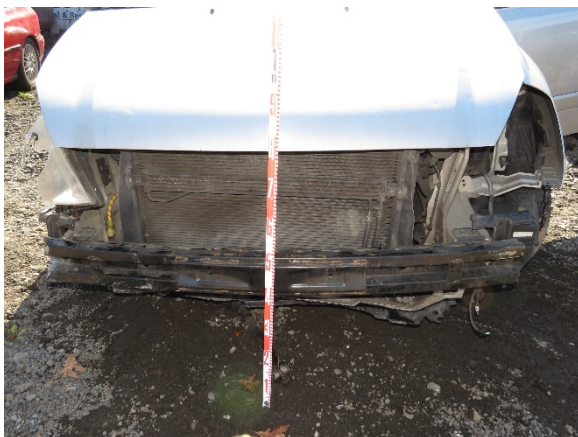
Direct contact damage on the exposed bumper beam began 30 cm (11.8 in) right of the vehicle's centerline and extended 37 cm (14.6 in) to the front-right corner (Figure 16). The overall width of the beam was 134 cm (52.8 in). A residual crush profile was documented along the width of the beam using a Nikon total station mapping system, and produced the following measurements: C1 – C3 = 0 cm (0 in), C4 – C5 = 1 cm (0.4 in), and C6 = 4 cm (1.6 in). Maximum crush was located at the right-front bumper corner, and the right wheelbase was reduced 15 cm (5.9 in) by the rearward displacement of the right-front tire/wheel (Figure 17). The collision deformation classification (CDC) assigned to the Kia for the front plane guardrail impact damage was 12FREE4.

Figure 16. Exposed bumper beam of the Kia

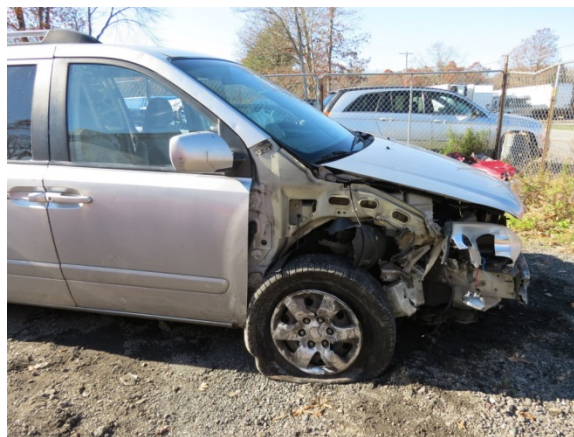
The Kia sustained damage to the front plane, right aspect from the crash with the end terminal of the guardrail system. Engagement with the impact head and posts of the guardrail system resulted in damage to the grille, right headlight assembly, right-front fender, right wheel, and separation of the right drive axle. The headlights, grille, bumper fascia, and right-front fender were all completely separated from the vehicle. Only the damaged bumper fascia remained with the Kia at the time of the SCI inspection.

Figure 17. Right front view of the damage to the Kia

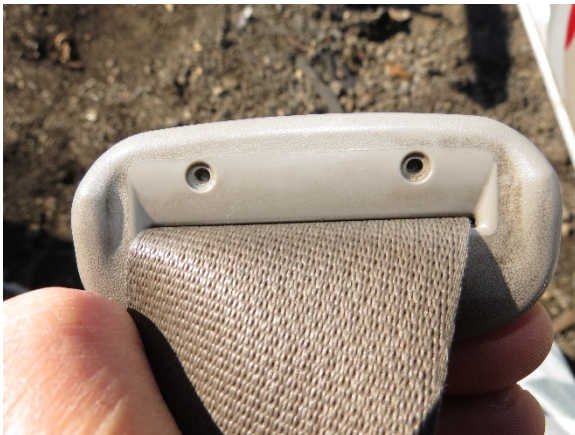
At the time of the SCI inspection, the driver's seat belt was found loosely stowed against the B-pillar. The webbing, which exhibited evidence of significant historical wear, was stained from frequent use. The webbing spooled from and retracted onto the retractor, suggesting that the pretensioner had relaxed after actuation. There was no discernable loading evidence on the webbing or latch plate (Figure 18). However, based on the lack of occupant contact evidence, it was determined that the driver was belted at the time of the crash.

Figure 18. Latch plate of the driver's seat belt system in the Kia

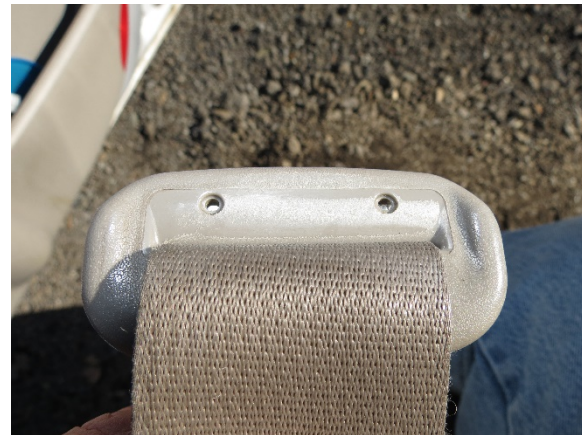
Figure 19. Loading evidence on the latch plate of the Kia's front-row right occupant seat belt system

The retractor of the Kia's front-row right seat belt system was locked in position, presumably as a result of retractor pretensioner actuation. Similar to the driver's system, the front-row right seat belt system displayed significant evidence of historical use. There were 180 cm (70.9 in) of webbing exposed from the locked retractor. Frictional abrasions to the polymer surface of the

latch plate (Figure 19) evidenced occupant loading and supported use of the system by the front-row right occupant at the time of the crash.

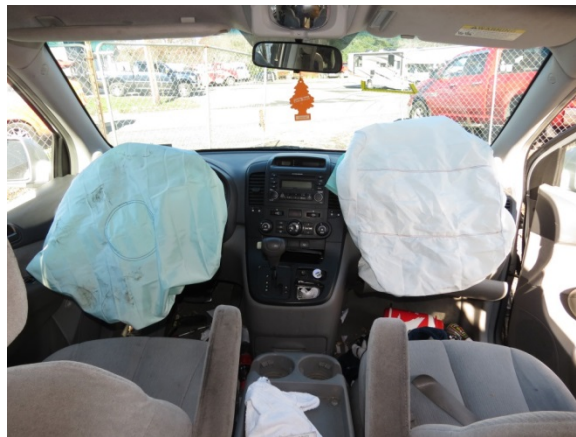
The Kia was equipped with multiple supplemental restraint systems. This included CAC frontal air bags, front-seat-mounted side impact air bags, and side impact-sensing IC air bags. The frontal air bag system consisted of front seat belt retractor pretensioners and dual-stage air bags for the driver and front-right passenger positions with seat track positioning sensors, seat belt buckle switches, and a front-right occupant presence/classification sensor. Supplemental side impact protection was available with front-seat-mounted and roof side-rail-mounted IC air bags that provided protection for all three rows. In this crash, both front seat belt pretensioners actuated, and the frontal air bags deployed (Figure 20).

Figure 20. Deployed frontal air bags in the Kia
