DOT HS 813 133

**Special Crash Investigations:  
On-Site Ambulance Crash  
Investigation;  
Vehicle: 2014 Ford E-350 Type III  
Ambulance;  
Location: Ohio;  
Crash Date: March 2018**

**Special Crash Investigations  
Transportation Research Center  
On-Site Ambulance Crash Investigation  
Case Number: IN18005  
Vehicle: 2014 Ford E-350 Type III Ambulance  
Location: Ohio  
Crash Date: March 2018**

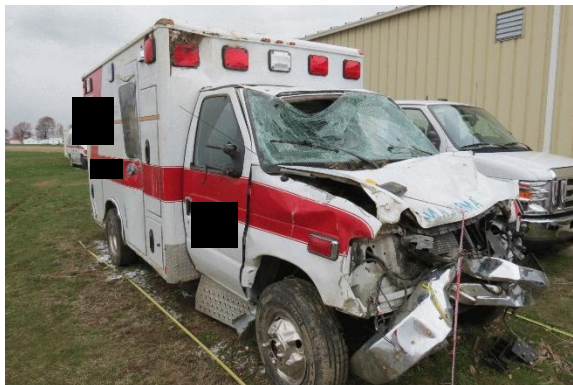
This report documents an on-site investigation of the single-vehicle crash that involved a 2014 Ford E-350 Type III ambulance (Figure 1). This investigation was initiated by the National Highway Traffic Safety Administration in April 2018 through NHTSA's Office of Emergency Medical Services (EMS) and assigned to the Indiana University Transportation Research Center. The crash occurred in Ohio in March 2018 during daylight and was investigated by a local police agency. The vehicle was inspected, and the driver and manager of the ambulance service were interviewed in April 2018.

*Figure 1. The damaged 2014 Ford E-350 ambulance*

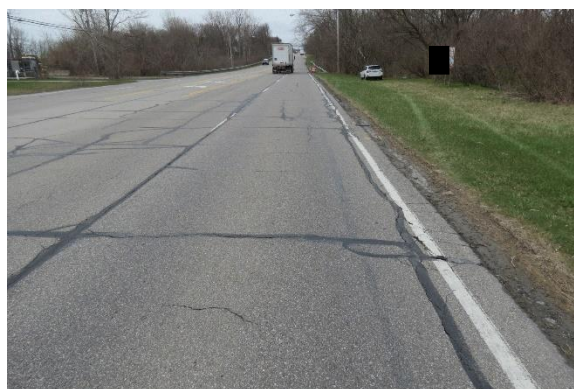
*Figure 2. East view of the ambulance's approach to roadway departure*

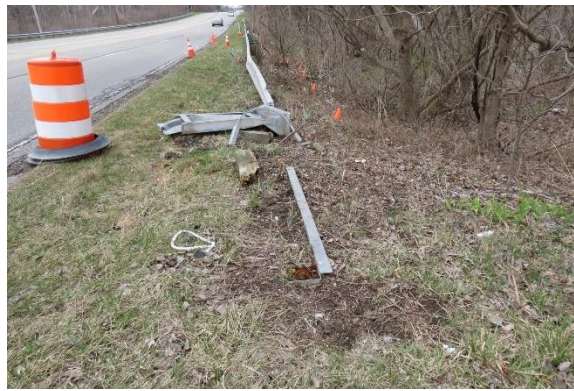
The front plane, right aspect of the ambulance struck the end terminal of the guardrail system (Event 1, Figure 3). The force direction on the ambulance was in the 12 o'clock sector. The EDR reported the maximum longitudinal and lateral delta Vs as -39.90 km/h (-24.79 mph) and 8.26 km/h (5.13 mph). These values were recorded at 300 and 294 milliseconds of AE respectively. The WinSMASH program could not be used to calculate a delta V as the Event 1 impact was with a yielding object that was out of scope for the program and there was overlapping damage. The frontal air bags did not deploy and the retractor pretensioners did not actuate. The impact kinked the first section of W-beam 180 degrees and kinked the second section of W-beam 90 degrees. The left aspect of the undercarriage overrode the displaced end terminal and approximately 4.6 m (15.1 ft) of W-beam. During this engagement, the undercarriage directly contacted the back side of the wood posts. In all, five break-away wood posts were fractured.

*Figure 3. Area of impact with end terminal*

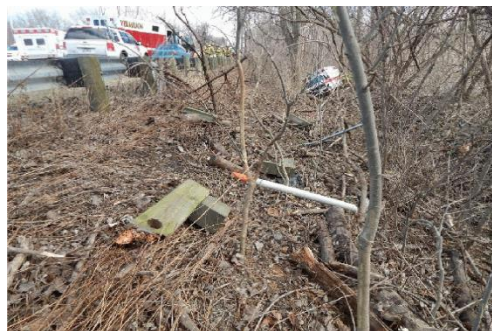
*Figure 4. Area of PVC pipe impact*

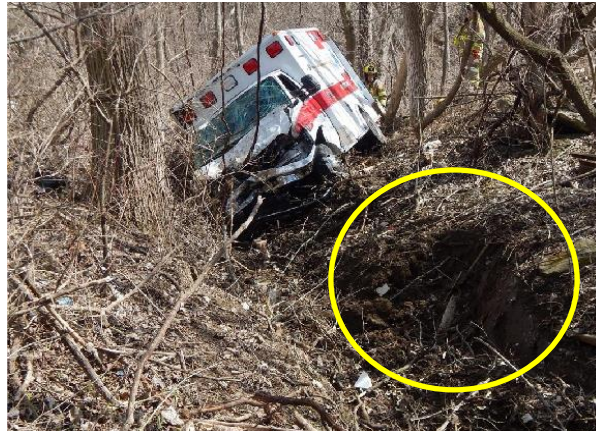
The right-side tires of the ambulance were in the ditch as the left side tires remained in contact with the embankment. The front right corner of the cab and the top right corner of the patient compartment struck and wedged into the ditch bank (Event 6), interrupting and tripping the ambulance into a “cartwheel” type, end-over-end continuation of the rollover. During the end-over-end, the unit rotated 180 degrees about its longitudinal axis without ground contact before coming to final rest on its wheels facing west with its right wheels in the ditch (Figure 5).

*Figure 5. Police photo showing impact of upper/right-front corner of the patient compartment into ditch bank and the ambulance at final rest*

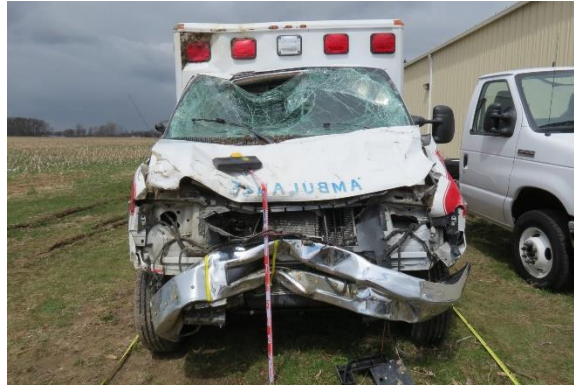
Exterior Damage Event 1: The ambulance sustained front plane damage during the impact with the end terminal. The front bumper, grille, and radiator were directly damaged (Figure 6). The direct contact damage began 43 cm (16.9 in) left of the right front bumper corner and extended 37 cm (14.6 in) to the left. Maximum residual crush was 19 cm (7.5 in), occurring 10 cm (3.9 in) right of center of the front plane. The collision deformation classification (CDC) was 12FZEN2.

*Figure 6. Front plane damage*

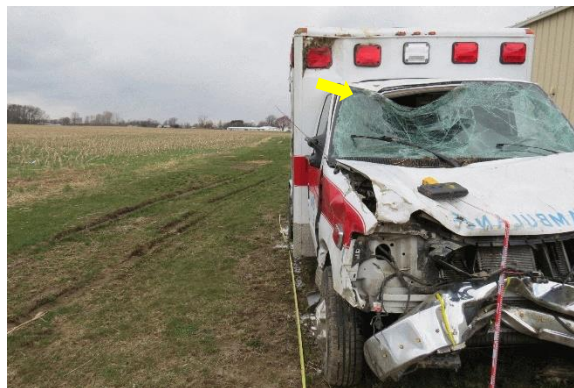
Due to the slope of the embankment, the ambulance initiated a fall-over type rollover involving one-quarter turn (Event 5) as the tires remained in contact with the ditch and embankment. The CDC for this event was 00RDAO2.

*Figure 7. Maximum vertical crush occurred at the right windshield header*

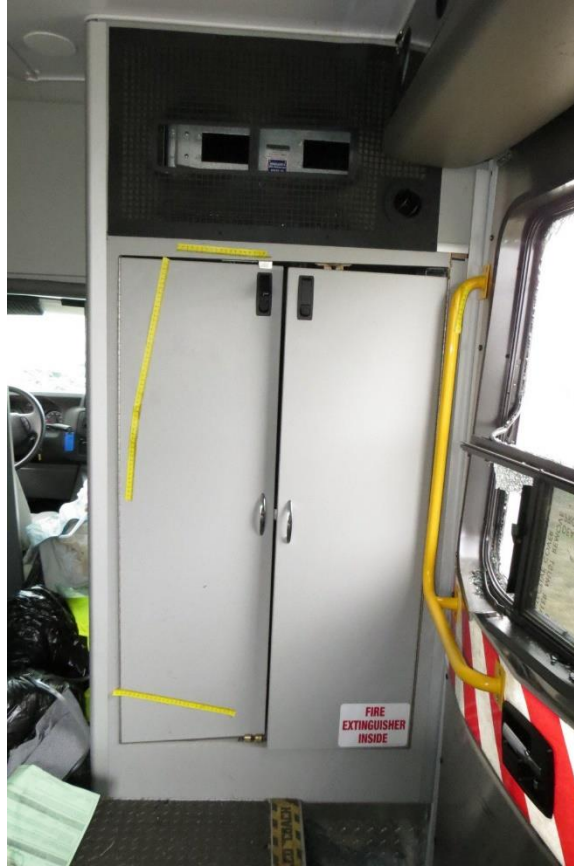
*Figure 8. Occupant contact to cabinet located at front right of the patient compartment*

The left door of the supply cabinet located at the front right of the patient compartment was deformed from contact by the paramedic (Figure 8). The HVAC vent grille located above the cabinet was also fractured, displaced, and scuffed with fabric transfers. Scuffing was present on the yellow grab bar mounted to the right-side exterior door.

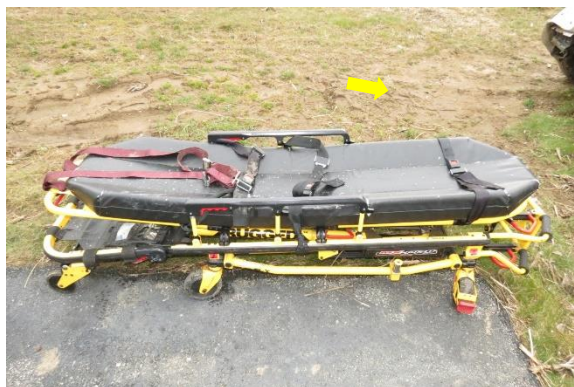
The cot that was used to transport the patient was a Stryker REF Model 6082 MX-PRO (Figure 9), Serial Number 040440xxx. It was an X-frame design with a maximum capacity of 295 kg (650 lbs). It was 205 cm (80.7 in) in length and 58 cm (22.8 in) in width and had a height range of 34 cm (13.4 in) to 95 cm (37.4 in). The backrest could be adjusted from 2-73 degrees from horizontal. It was equipped with shoulder, chest, hip, and knee restraints, all of which were secured to the frame of the cot.

*Figure 9. Image depicting the Stryker cot at the time of the SCI inspection*

The paramedic reported to the police that the cot was secured to the floor prior to transport of the patient. The antler bracket secured the head of the cot by restraining the undercarriage using the wheel frames as anchor points. The rail clamp was located at the back left of the patient compartment and secured the cot to the floor. The SCI inspection revealed no abnormalities of the patient cot, restraints, or the antler clamp. The rail clamp was found to be jammed in the open position. The paramedic stated that the cot was forcibly removed by passersby as they attempted

to help her and the patient, indicating that the status of the rail clamp was probably related to the removal of the cot.
