DOT HS 813 134

**Special Crash Investigations:
On-Site Alleged Air Bag Non-
Deployment Crash Investigation;
Vehicle: 2017 Kia Forte;
Location: Illinois;
Crash Date: July 2017**

Special Crash Investigations
On-Site Alleged Air Bag Non-Deployment Crash Investigation
Office of Defects Investigation
Case Number: CR18028
Vehicle: 2017 Kia Forte
Location: Illinois
Crash Date: July 2017

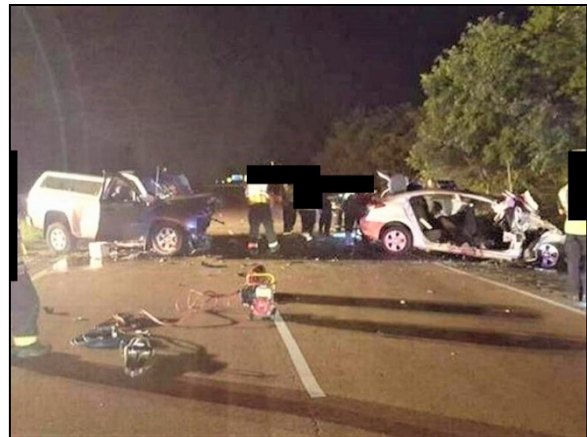
Figure 3. East-facing view of the Kia and GMC at final rest (on-scene image obtained from an online news source).

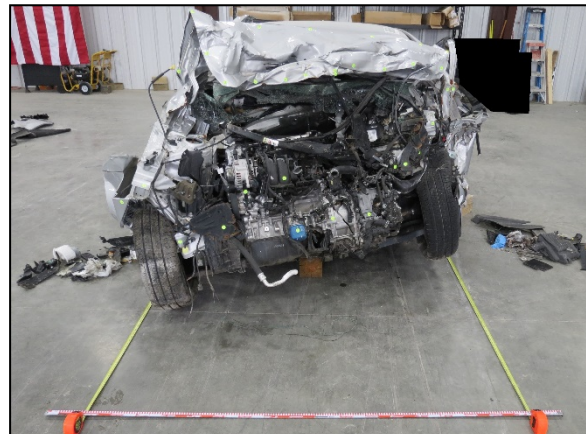
Damage to the exterior of the Kia was located on the front plane (**Figure 5**), associative to the frontal crash event with the GMC. Direct contact began 50 cm (19.7 in) right of center and extended 135 cm (53.1 in) to the left front bumper corner of the Kia. The bumper fascia, front headlight assemblies, and grille were completely fractured and separated from the vehicle. Additionally, the bumper beam, radiator, and radiator support were also separated from the vehicle. Major longitudinal crush was observed to the front plane. The entire hood was deformed rearward and pushed onto the top of the instrument panel, with direct contact damage to the left

Figure 5. View of the Kia's front plane crush profile as documented during the SCI inspection.

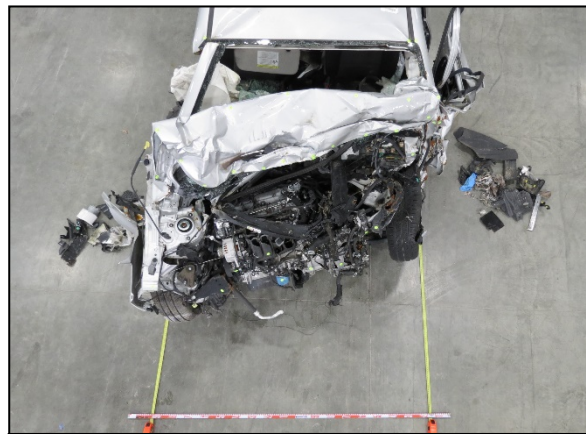
A residual crush profile was documented to the front plane of the Kia (**Figure 6**). Measurements were obtained at a high and low level to remaining vehicle structure, using a Field-L width of 130 cm (51.2 in) from the outside edges of the exposed frame rail ends. The averaged results of this profile included C1 = 107 cm (42.1 in), C2 = 99 cm (39.0 in), C3 = 94 cm (37.0 in), C4 = 89 cm (35.0 in), C5 = 82 cm (32.3 in), and C6 = 67 cm (26.4 in). Maximum crush in the profile was observed to the upper left of the front plane, above the left front bumper, and measured 118 cm (46.5 in). The left wheelbase was reduced by 31 cm (12.2 in). Based on the observed damage to the Kia, the collision deformation classification (CDC) assigned for the Event 1 impact was 12FDAW6.

Figure 6. Overhead view of the front crush profile to the Kia.

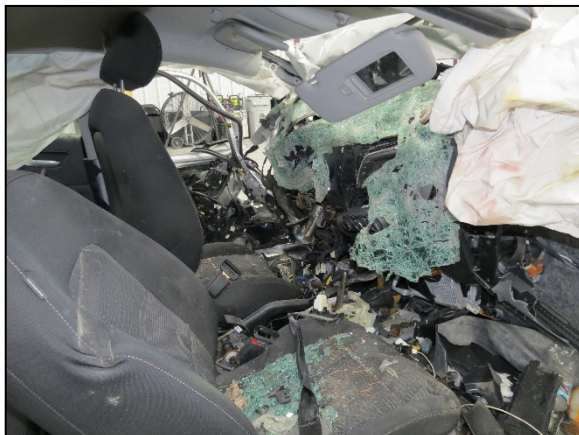
instrument panel were displaced longitudinally into the occupant compartment by exterior deformation. There was also vertical and longitudinal intrusion of the floor/toe pan. Documented intrusions included the following:

Figure 7. Left-facing view of the Kia's front row and the visible longitudinal intrusion of the instrument panel.

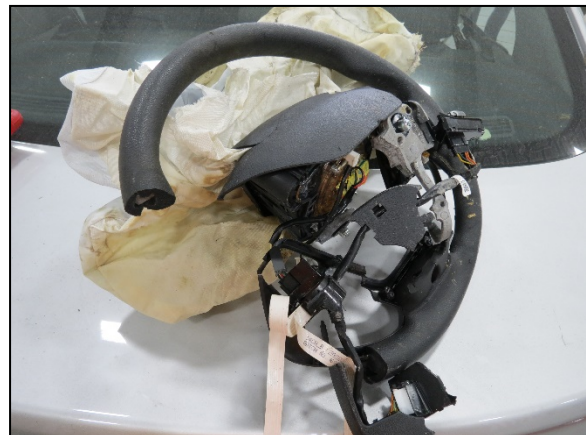
The driver overloaded the seat belt system and deployed driver air bag, and in conjunction with the rearward intrusion of frontal components, he loaded the steering wheel and column. This contact and loading resulted in the complete fracture and separation of the steering wheel assembly, inclusive of the driver's frontal air bag module, from the steering column. It also sheared a section of the steering wheel rim from the assembly.

Figure 8. Sheared steering wheel and fractured assembly resultant from loading by the Kia's driver.

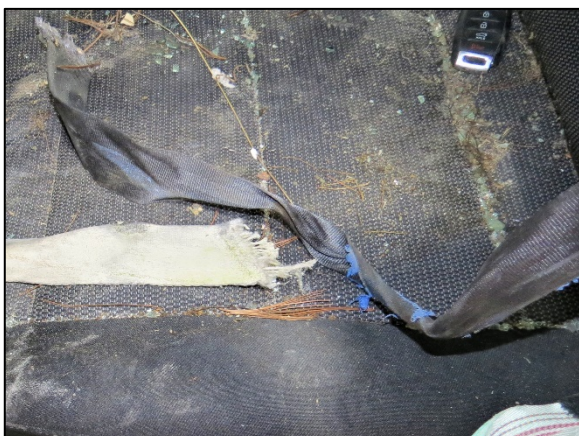
The latch plates of both systems remained engaged in their respective buckles, and the webbing of both systems was broken into two sections. Both latch plates were missing their respective lightweight locking mechanisms, and the webbing breaks both appeared frayed and stretched. As for the webbing, the driver's system had a 94 cm (37.0 in) lower portion and a 118 cm (46.5 in) upper section, while the front passenger's had a 74 cm (29.1 in) lower section and a 111 cm (43.7 in) upper section.

Figure 9. Webbing of the driver seat belt system in the Kia with blue fabric transfer from the driver's clothing.

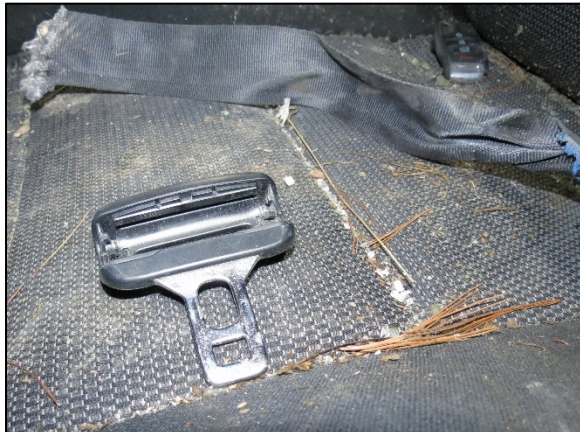
Figures 11 and 12 depict the broken latch plates of the driver's and front passenger's seat belt systems.

Figure 11. Latch plate of the Kia's driver seat belt system with the lightweight locking portion missing.

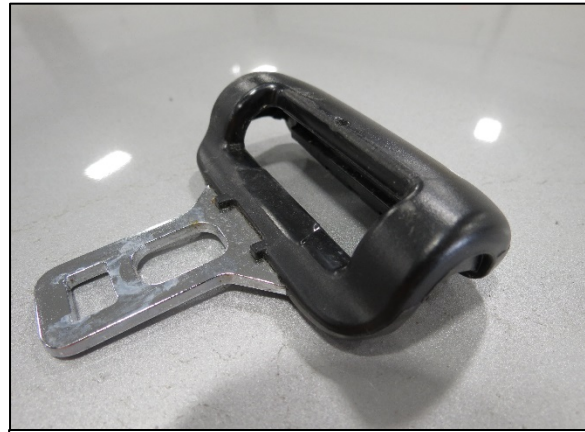
Figure 12. Latch plate of the front passenger's seat belt system with the lightweight locking portion missing.

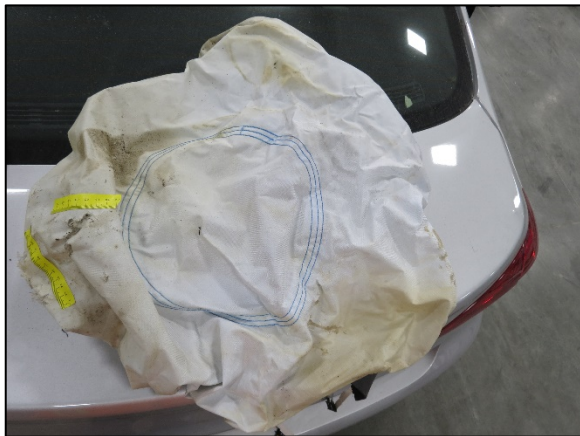
The driver's frontal air bag deployed from the steering wheel hub-mounted module through the cover flaps without damage. It measured 58 cm (22.8 in) in overall diameter in its deflated state, and was internally tethered via a 25 cm (9.8 in) diameter circular center stitch pattern. A pair of 2 cm (0.8 in) diameter vents were located on the back of the air bag at the 11 and 1 o'clock positions. On the left side of the face of the air bag was a 5 cm (2.0 in) long tear. Although this tear did not appear to be related to occupant contact, the SCI investigator was unable to determine if the tear was related to the crash or had occurred post-crash. However, a 6 cm (2.4 in) long tear in the outer circumference of the deployed air bag at the 9 o'clock position, as well as a diagonal 38 cm (15.0 in) long tear on the back of the air bag were attributed to the driver's overloading of the air bag during the crash. These tears were the result of over-pressurization of the inflated bag as it was loaded and compressed between the driver as he was displaced forward and the steering wheel hub/column as it intruded rearward. The large tear in the back was located in the vicinity of where a section of the steering wheel sheared, which likely contributed to the size of the tear. **Figure 13** depicts the deployed Kia driver's frontal air bag, with the two small tears highlighted by yellow masking tape. **Figure 14** depicts the large tear. A visual inspection of the driver's frontal air bag module confirmed that the inflator was intact.

Figure 13. Deployed Kia driver's frontal air bag.

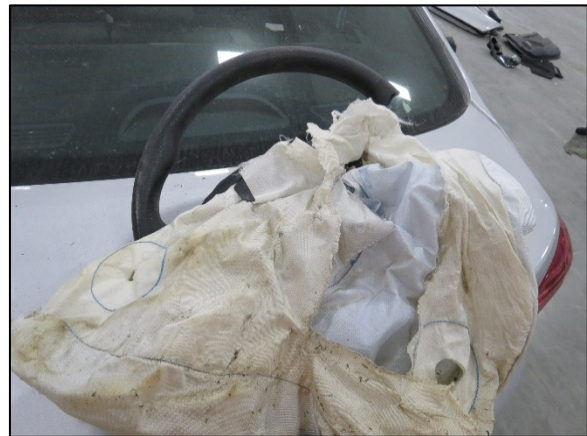
Figure 14. Tear on the back of the Kia driver's air bag.

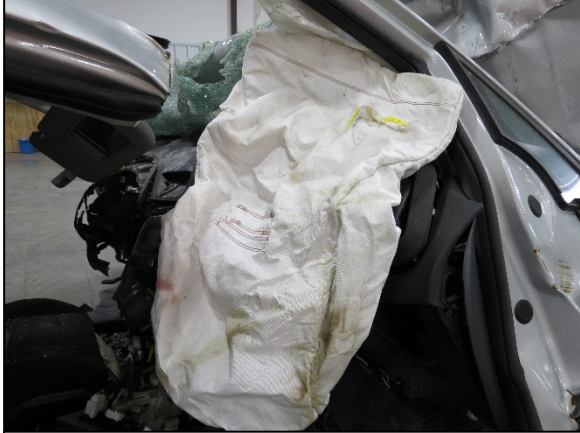
The passenger's frontal air bag deployed from the top instrument panel-mounted module through the H-configuration cover flaps without damage. The air bag's overall measurements were 58 cm (22.8 in) tall by 36 cm (14.2 in) wide in its deflated state. It was vented by a 4 cm (1.6 in) diameter vent and a 6 cm (2.4 in) diameter vent on each side. Similar to the driver's frontal air bag, it had an 11 cm (4.3 in) long tear in the upper right aspect of its face, as well as a 23 cm (9.1 in) tear along its left side. Despite the lack of discernable occupant contact, like the driver's frontal air bag, it was evident that the passenger's frontal air bag had burst as a result of the combination of front row right occupant loading and rearward occupant compartment intrusion. **Figure 15** depicts the Kia's deployed passenger's frontal air bag, while **Figure 16** depicts the large burst tear. A visual inspection of the passenger's frontal air bag module confirmed that the inflator was intact.

Figure 15. Deployed passenger's frontal air bag in the Kia.

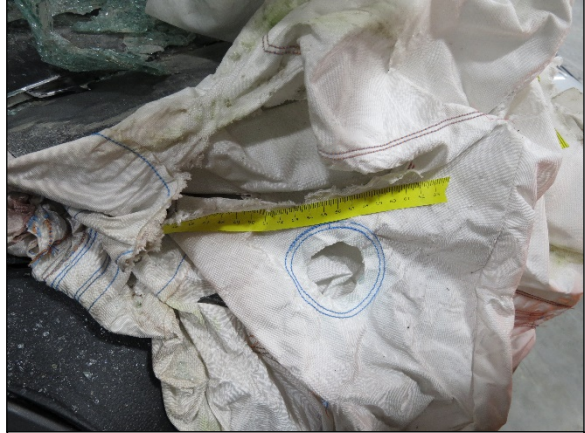
Figure 16. Large tear on the left side of the Kia's passenger's frontal air bag.

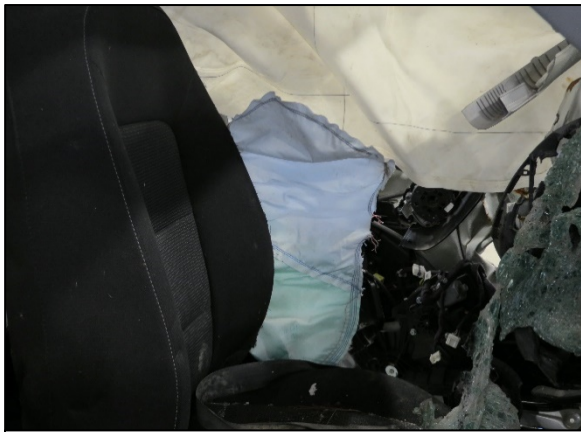
The left front seat-mounted side impact air bag deployed from the driver's seatback through the outer seam. It measured 60 cm (23.6 in) tall and 25 cm (9.8 in) wide in its deflated state. There was a 6 cm (2.4 in) vent on the leading edge near the center aspect of the air bag. No discernable occupant contact or loading was visible to the driver's side impact air bag (**Figure 17**).

Figure 17. Deployed Kia driver's seat-mounted side-impact air bag.

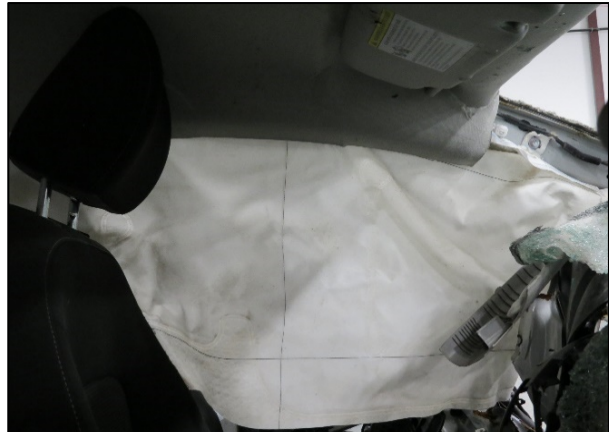
The Kia's left IC air bag deployed from the left roof side rail through the edge of the headliner. It provided 50 cm (19.7 in) of vertical coverage and measured 175 cm (68.9 in) in overall length when deflated. It was tethered at the A-pillar by a piece of fabric. There was no discernable occupant contact to the Kia's left IC air bag (**Figure 18**).

Figure 18. Deployed left IC air bag in the Kia.
