DOT HS 813 139

**Special Crash Investigations:
On-Site Driver Air Bag Inflator
Rupture Crash Investigation;
Vehicle: 2004 Honda Civic;
Location: Alabama;
Crash Date: March 2018**

Special Crash Investigations
On-Site Driver Air Bag Inflator Rupture Crash Investigation
Office of Defects Investigation
Case Number: CR18024
Vehicle: 2004 Honda Civic
Location: Alabama
Crash Date: March 2018

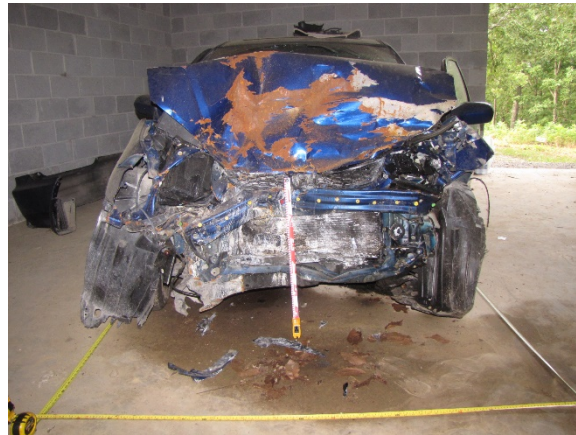
The 2004 Honda Civic 2-door coupe with the EX-level trim package (Figure 7), manufactured in October 2003, was identified by VIN 1HGEM22944Lxxxxxx. The powertrain was a 1.7 liter, transverse-mounted, 4-cylinder gasoline engine linked to a 4-speed automatic transmission. Standard equipment included power-assisted front disc/rear drum brakes with 4-wheel ABS and electronic brakeforce distribution, traction control, and power steering. The gross vehicle weight rating for this vehicle was 1,601 kg (3,530 lb) with gross axle weight ratings of 835 kg (1,841 lb) front and 771 kg (1,700 lb) rear. At the time of the crash, the Honda had Dextero Touring P195/60R16 tires of the manufacturer-recommended size, with matching tire identification numbers of Y9K5 CVHX 0717. Each had a tread depth measuring 6 mm (8/32 in). The sidewall of the left front tire was cut. The tires at the right front and rear axle locations remained inflated.

Figure 7. Front view of the Honda depicting the extent of its deformation

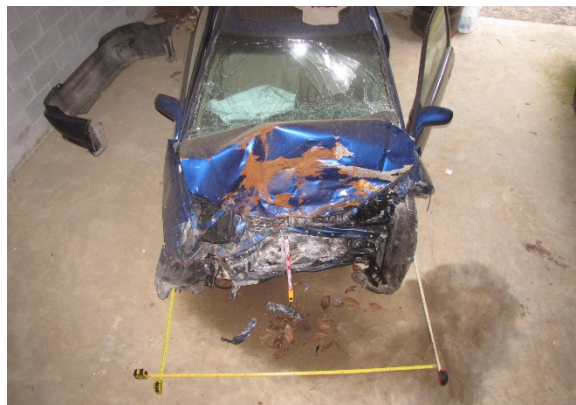
The Honda sustained severe damage to its front (Event 1) and minor damage to the left side (Event 2). The direct contact damage (Figure 8) associated to Event 1 extended across the entire 142 cm (56.0 in) end width of the vehicle's front plane. The structures of the engine compartment crushed rearward. The hood buckled and tented vertically. The Field L measured 108 cm (42.5 in). The residual crush profile measured across the deformed bumper reinforcement beam was as follows: C1 = 59 cm (23.2 in), C2 = 61 cm (24.0 in), C = 67 cm (26.4 in), C4 = 72 cm (28.3 in), C5 = 54 cm (21.3 in), and C6 = 44 cm (17.3 in). The maximum crush was located 12 cm (4.7 in) right of centerline and measured 72 cm (28.3 in). The left wheelbase was reduced 23 cm (9.1 in). The right wheelbase was reduced 11 cm (4.3 in). Both front tires were in contact with the aft portion of the wheel openings and were restricted. The windshield was fractured across its entire width. The left door was open at the time of inspection and would not latch closed due to deformation of the vehicle's body. The right door was operational. The Collision Deformation Classification (CDC) assigned to the frontal damage pattern was 12FDEW4. The delta V calculated by the missing vehicle algorithm of the WinSMASH program was 86 km/h (53 mph). The longitudinal and lateral components were -86 km/h (-53 mph) and 0, respectively.

Figure 8. Overhead view of the Honda's frontal deformation

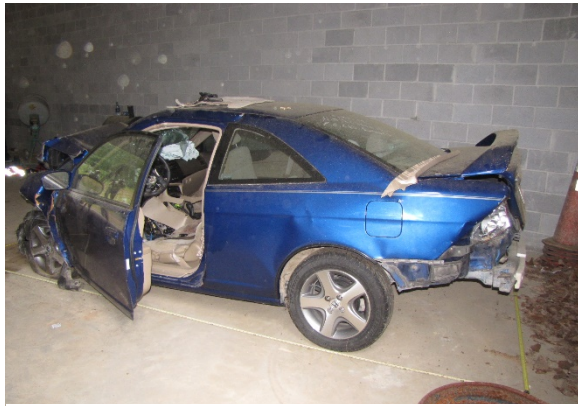
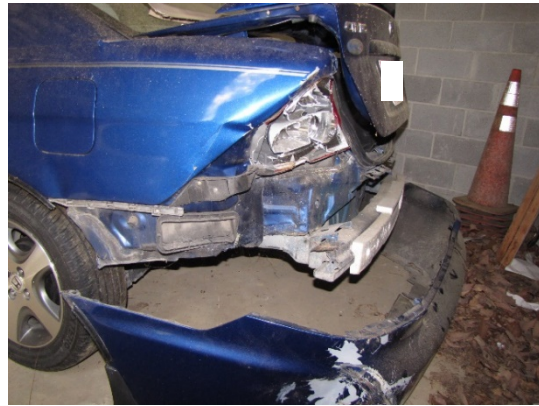
The Event 2 left plane damage was located on the Honda's quarter panel (Figures 9 and 10). The direct contact damage began 54 cm (21.3 in) aft of the left rear axle and extended to the rear corner. The damage consisted of minor deformation (less than 5 cm [2.0 in]) of the body panel. There was no involvement of the rear bumper. The rear bumper fascia was separated from the structure at the time of the SCI inspection. The assigned CDC was 09LBEW3.

Figure 10. Close-up view of the secondary impact damage to the Honda's quarter panel

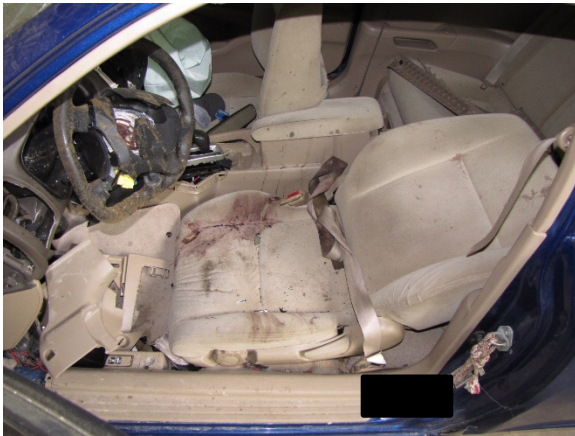
The Honda interior (Figure 11) sustained moderate longitudinal intrusion and floor pan buckling as a result of the Event 1 impact. The toe pan intrusion (Figure 12) was uniform across the width of the interior and was an estimated 15 cm (5.9 in) at both the left and right positions of the front row. The floor pan buckling jammed the track adjustment of both front seats in their at-crash positions. The estimated position of the driver seat was a mid-to-rear track adjustment. The forward aspect of the driver's seat cushion was deformed downward an estimated 10 cm (3.9 in) due to driver loading. The left and right instrument panel intrusion was an estimated 2 cm (0.8 in). The bolster covering of the lower instrument panel had separated and was missing. The lower aspect of the steering column was exposed. The displacement of the steering column shear capsules was approximately 13 mm (0.5 in). The lower half sector of the steering wheel rim (Figure 13) was deformed forward 9 cm (3.5 in). Blood spatter was noted over a large portion of the surfaces of the front left interior. A 15 cm (5.9 in) semi-circular area was noted to the interior

Figure 11. Left lateral view of the Honda's interior

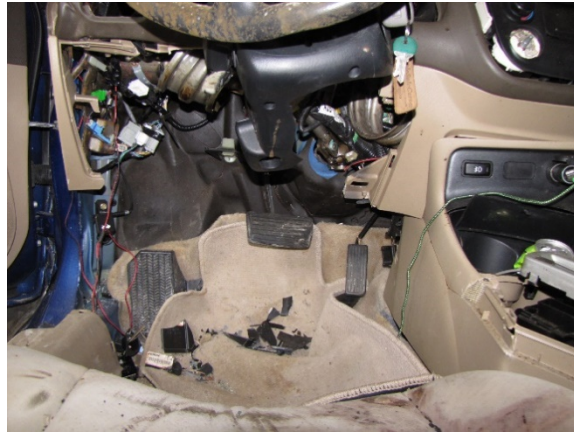
Figure 12. Interior view looking forward at the left lower instrument panel of the Honda

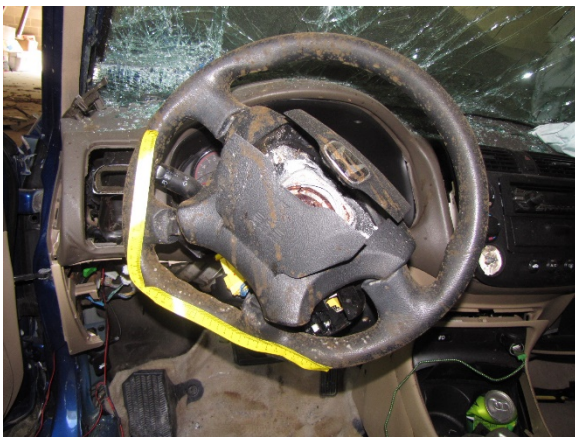
Figure 13. Interior view depicting the steering wheel rim deformation of the Honda

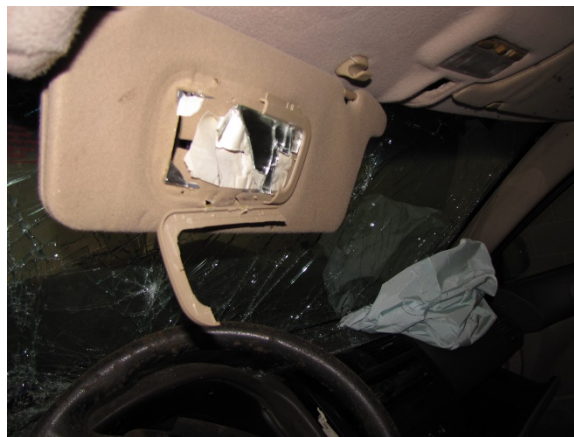
surface of the left front window. The vanity mirror attached to the backside of the left sun visor was fractured (Figure 14).

Figure 14. Interior view depicting the left sun visor and fractured vanity mirror of the Honda

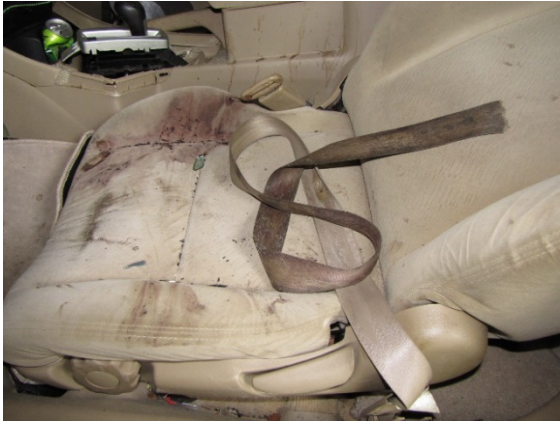
At the time of the SCI inspection, the driver's belt was extended from its retractor, and the webbing was locked by the actuation of the retractor pretensioner. The webbing had been cut 29 cm (11.4 in) below the D-ring by the first responders during rescue. The total length of the extended webbing (Figure 15) measured 175 cm (68.9 in) from the floor anchor to the D-ring. The latch plate was still in the buckle receiver (Figure 16). The buckle pretensioner had also actuated. As a result of contact and loading from the driver's lower torso, the lap section of the

webbing was cupped over a 13 cm (5.1 in) length. The shoulder portion of the webbing was blood stained and appeared waffled from driver loading. The cut shoulder webbing was abraded at the D-ring. The observations of the seat belt inspection showed that the driver was belted at the time of the crash.

Figure 15. Left lateral view depicting the condition of the driver's seat belt in the Honda

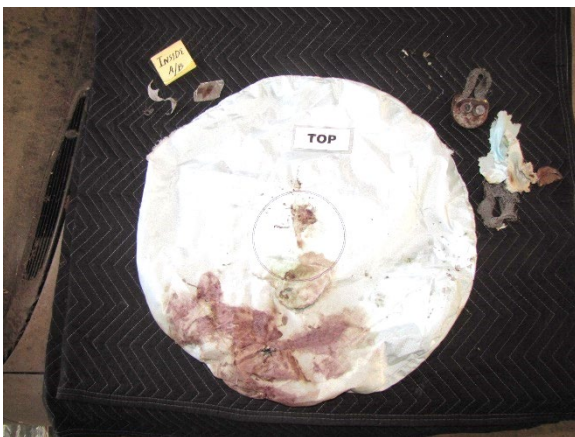
At an unknown time prior to SCI's involvement in this investigation and at the request of the attorney, the Honda was inspected by people representing the driver. During that inspection, the driver's frontal air bag fabric and the separated components of the inflator (Figure 17) were removed from the interior of the Honda and were secured by the attorney as evidence. The driver's frontal air bag module remained fastened to the steering column (Figure 18).

Figure 17. Overall image depicting the Honda's driver's frontal air bag fabric and the separated components of the inflator

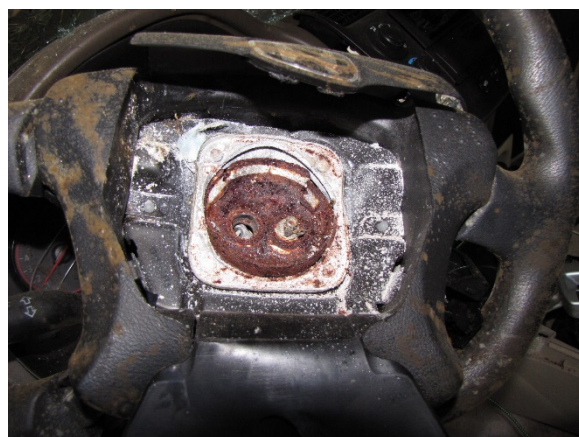
Figure 18. Image of the Honda's driver's frontal air bag module depicting the condition of the ruptured inflator. Image taken five months post-crash

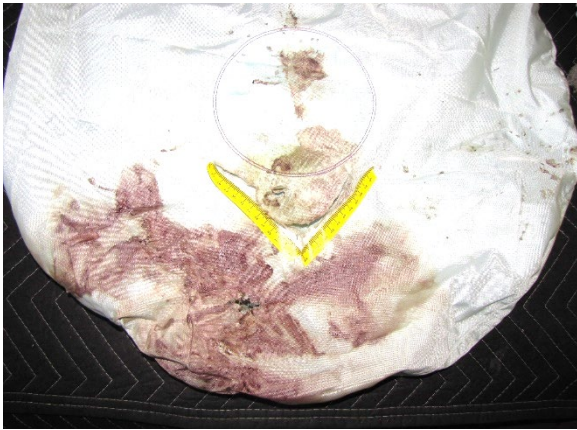
The driver's frontal air bag fabric measured 66 cm (26.0 in) in diameter at inspection. This air bag was tethered and was vented by two vent ports located on the backside of the fabric. It was embossed with the date, September 27, 2003, and the number 0007455. The face of the air bag was blood-stained in the 5- to 7 o'clock sectors. At the center of the air bag (Figure 19), there was a 14 cm (5.5 in) semi-circular tear in the fabric caused by the penetration of the separated cap of the inflator. A 13 cm (5.1 in) tear in the peripheral seam at the 10 o'clock sector was also identified (Figure 20).

Figure 19. Image depicting the tear in the fabric at the center of the Honda's driver's frontal air bag

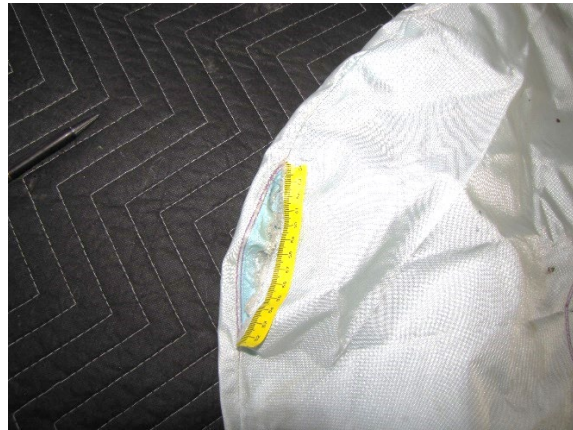
Figure 20. Image depicting the tear in the peripheral seam of the Honda's driver's frontal air bag

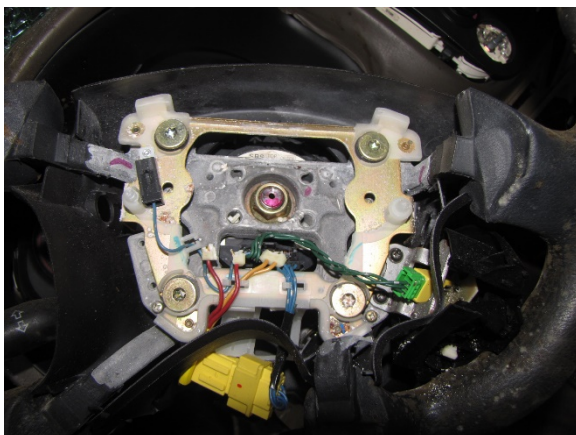
The Honda representative removed the driver's frontal air bag module from the steering wheel (Figure 21). It was observed that the electrical connectors had fractured and had separated from the squibs. Figure 22 is an image of the backside of the module and the inflator. The serial number of the driver's frontal air bag module was H0YF53996, and the serial number attached to the inflator was JGDP738936N. The Stage 1 squib had detonated. The Stage 2 squib was missing and separated. This squib was located on the floor of the Honda forward of the driver seat. An imprint of the steering shaft and retainer nut was observed on the back plate of the inflator.

Figure 21. Image depicting the Honda's steering wheel after the driver's frontal air bag module was removed

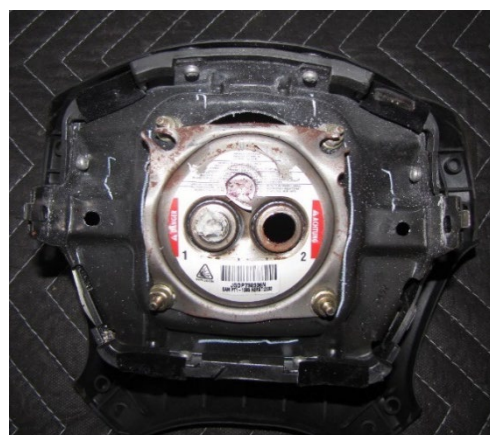
Figure 22. Image depicting the backside of the Honda driver's frontal air bag module

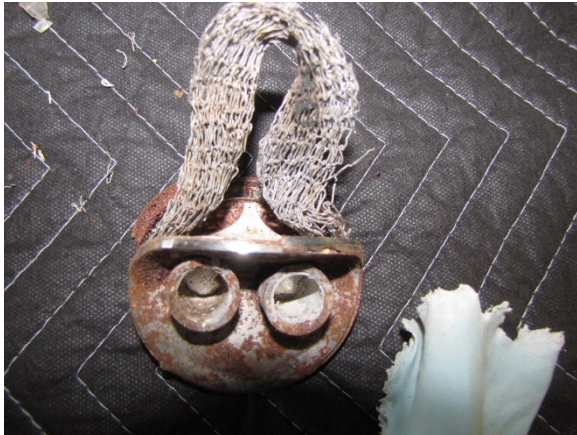
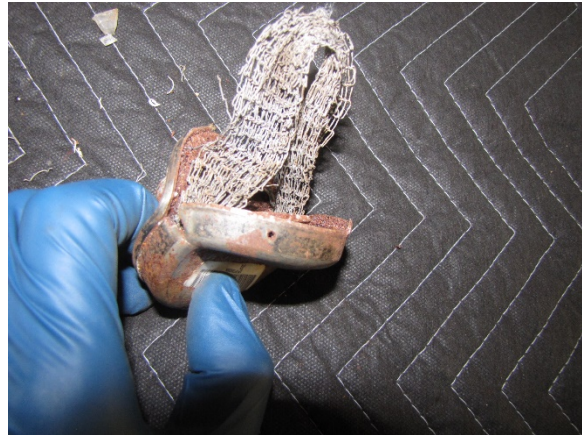
During the deployment sequence, the cap of the inflator (Figures 23 and 24) ruptured. It was observed that the dome of the cap had fractured and deformed 90 degrees across its mid-line. The wire mesh filter in the cap was extruded. The cap then separated from the base of the inflator at the friction weld and was projected rearward through the fabric of the air bag, striking the driver. The cap of the inflator was manufactured with four vent holes, oriented symmetrically around its circumference. Each vent hole was open and clear during the inspection.

Figure 23. Back view depicting the Honda's ruptured and separated driver's frontal air bag inflator cap

Figure 24. Side view depicting the Honda's ruptured and separated driver's frontal air bag inflator cap

At deployment, the driver’s upright posture positioned him directly in front of the steering wheel and air bag module. During the deployment of the driver’s frontal air bag, the air bag inflator ruptured with a separation of the inflator cap and its internal components. As the air bag was inflating, the separated cap and other undetermined internal components penetrated through the air bag fabric and struck the driver, inflicting blunt force facial/head injuries. Observations of the on-scene police images indicated that the driver was struck in the central-left aspect of his face. The entire fabric membrane of the driver’s frontal air bag separated from the module.

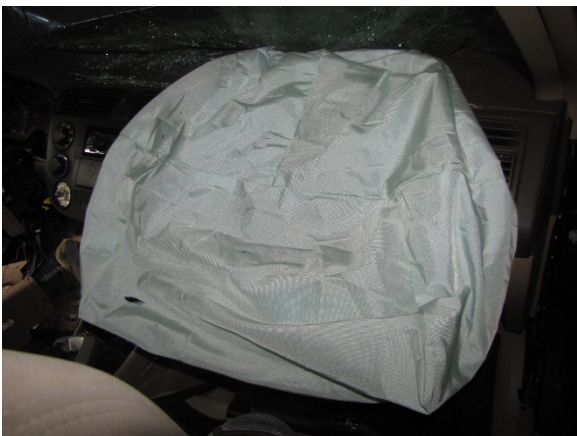
The passenger's frontal air bag module was a top-mount design located in the right instrument panel. This air bag deployed as designed (Figure 25). It was not tethered and was vented by two ports located on its side panels. The inspection of the air bag fabric was unremarkable. A label fixed to the module assembly (Figure 26) identified the module with the number PQP05Q217.

Figure 25. Interior image of the Honda depicting the deployed passenger's frontal air bag
