DOT HS 813 155

December 2021

# **Special Crash Investigations: On-Site Driver Frontal Air Bag Non-Deployment Investigation; Vehicle: 2013 Chevrolet Impala; Location: Pennsylvania; Crash Date: January 2017**

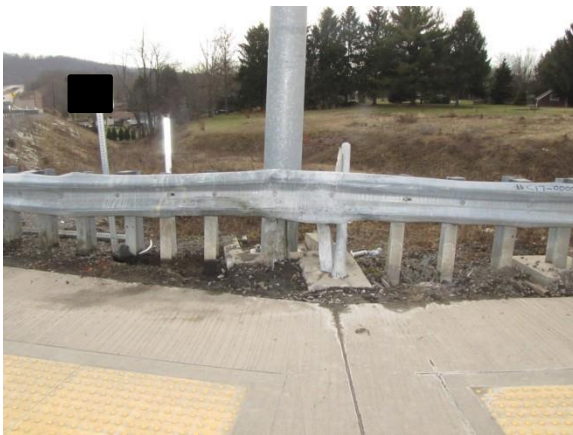
The guardrail installation (Figure 6) consisted of the W-beam mounted to 10 x 16 cm (4.0 x 6.0 in) I-beam posts with 19 cm (7.5 in) composite block-outs. The I-beams were embedded in the ground on a 46 cm (18.0 in) nominal spacing. The height at the top of the W-beam measured 72 cm (28.5 in). The length of the direct contact to the guardrail measured 236 cm (93.0 in) as a result of the impact which was distributed across the entire width of the Chevrolet's front plane. The force of the impact deflected eight I-beam posts that supported the guardrail to the southwest. At the center of the deformed guardrail section, the residual deflection measured 39 cm (15.3 in). The I-beam post located at the maximum deflection point contacted the utility pole supporting the traffic lights during the impact. A 4 cm (1.5 in) wide area of the I-beam flange was deformed by this contact and is highlighted by the arrow in Figure 7. The damaged flange indicated that the maximum dynamic deformation of the guardrail was an estimated 56 cm (22.0 in). The driver air bag did not deploy as a result of the impact.

*Figure 6. Southwest-facing trajectory view of the damaged guardrail*

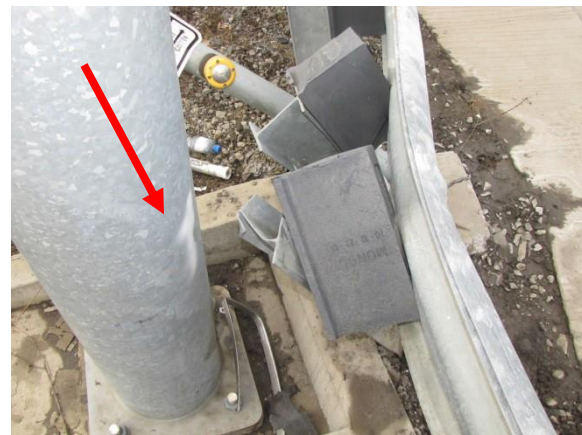
*Figure 7. Close-up view of the deformed guardrail and the evidence of contact between the I-beam post and the pole (highlighted by the arrow)*

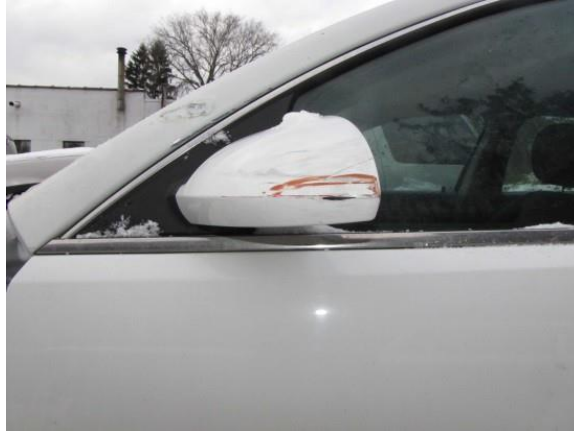
Any damage associated to the impact with the sign post (Event 1) was masked by the overlapping guardrail impact. The SCI reconstruction of the crash determined that the left aspect of the front plane struck the sign post. The collision deformation classification assigned to the Chevrolet for the impact to the sign post was 12FLLN1. The Event 2 damage consisted of an orange/yellow paint transfer on the forward surface of the body of the left-exterior mirror (Figure 9). The paint transfer measured approximately 10 cm x 7 cm (4.0 x 3.0 in) length by width. The mirror's height was (40.0 in) above ground level. This damage was consistent with swiping contact with the polymer delineator located in the median. The CDC associated to this damage was 12LPMS1. The guardrail impact (Event 3) damage and direct contact extended across the entire 152 cm (60.0) front plane end width. The bumper fascia fractured during the impact and exposed the reinforcement beam. The hood was removed post-crash and was missing. The extent of crush deformation was biased to the right due to the orientation of the vehicle relative to the curved profile of the guardrail at the point of impact.

*Figure 9. Image depicting the swiping abrasion/paint transfer to the left mirror of the Chevrolet (Event 2)*

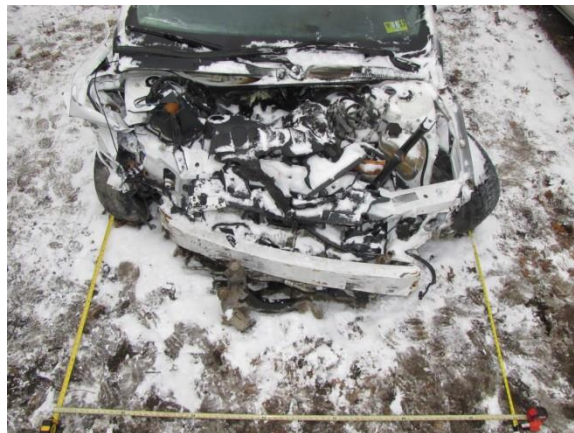
A residual crush profile (Figure 10) was measured along the bumper reinforcement beam using a Field L of 119 cm (47.0 in). It produced the following resultant measurements: C1 = 30 cm (11.8 in), C2 = 38 cm (15.0 in), C3 = 49 cm (19.3 in), C4 = 56 cm (22.0 in), C5 = 59 cm (23.2 in), and C6 = 69 cm (27.1 in). The maximum crush was observed at the right-front corner. The front wheel assembly was displaced rearward into the lower A-pillar shortening the wheelbase 19 cm (7.3 in). The right-front wheel rim was deformed from contact with an I-beam supporting the guardrail. The lower control arm of the left-front suspension fractured at the frame, and the wheel assembly was only attached by its upper strut. The left drive shaft had separated from the transmission. The CDC assigned to the guardrail impact (Event 3) damage pattern was 12FDEW4. The WinSMASH program was used to produce a barrier equivalent speed (BES) calculation of the Event 3 impact. The calculated BES was 50 km/h (31 mph). Comparatively, the EDR recorded delta V components were -88 km/h (-55 mph) longitudinal and -12 km/h (-7 mph) lateral.

*Figure 10. Overhead view of the Chevrolet's frontal deformation*

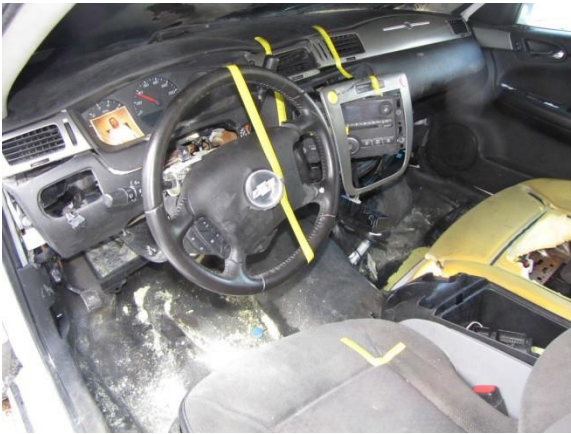
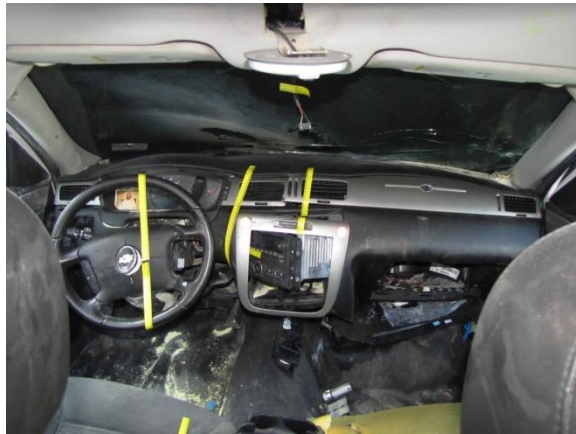
*Figure 11. Left-interior view of the Chevrolet*

*Figure 12. Image depicting the driver interior contact points in the Chevrolet*

Figures 11 and 12 are interior views of the Chevrolet. The unbelted driver responded to the crash force with a forward displacement. A 6 cm (2.4 in) long friction abrasion attributed to the driver's buttock was observed on the forward-right aspect of the seat cushion. The abrasion was located 32 cm (12.6 in) forward of the seat bight and 15 cm (5.9 in) right of the centerline of the seat. The forward-right corner of the driver seat was compressed downward approximately 8 cm (3.1 in). The right aspect of the knee bolster was loaded by the driver's lower extremities. The metal backer panel behind the vinyl bolster trim was deformed forward. This contact began 4 cm (1.5 in) right of the bolster's centerline and extended 13 cm (5.1 in) to its right edge. The driver contacted the center aspect of the instrument panel (IP). This contact extended the full height of the IP. The trim and vent louvers were fractured over an 18 cm (7.1 in) wide area. The face plate of the displaced radio was fractured. The center mirror was displaced from its mount, and an isolated crack in the windshield laminate was indicative of a probable head contact.

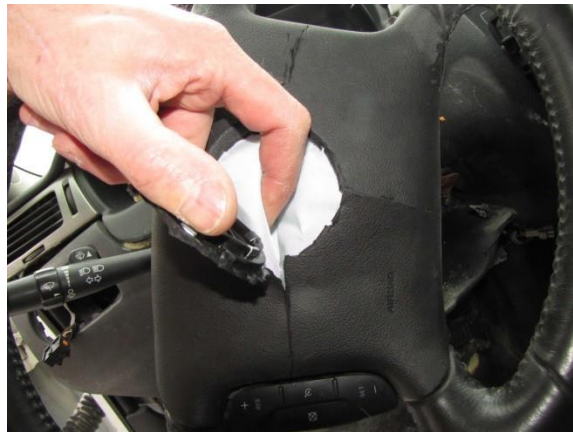
The Chevrolet was equipped with six air bags to provide supplemental crash protection in front, side, and rollover crashes. The front air bag system consisted of CAC dual stage driver and passenger frontal air bags. The vehicle was further equipped with front-seat-mounted, side-impact air bags and roof-side rail-mounted, IC air bags. The driver's frontal air bag was housed in the center hub of the four-spoke steering wheel and did not deploy in the crash. Prior to the SCI inspection, the state police also inspected the vehicle. During this inspection, the cover flap was cut open by the investigator to ensure that indeed there was an air bag installed in the module (Figure 13).

*Figure 13. Image depicting the presence of the undeployed air bag housed in the driver's frontal air bag module in the Chevrolet*

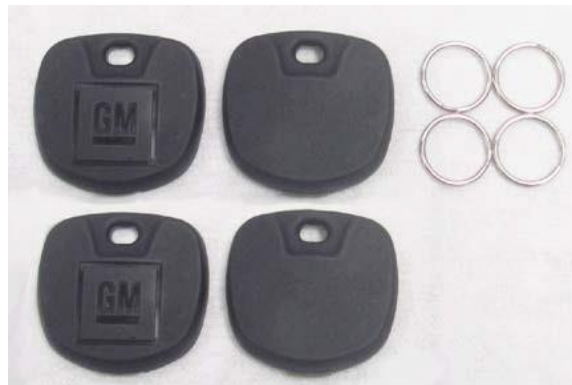
*Figure 14. Image depicting the key cover and key ring corrective action of the recall, obtained from TSB No. 14299C*

The Technical Service Bulletin (TSB) No.14299C indicated that the corrective action for this recall was to place a filler-insert in the slotted key or place a key cover over the head of the key such that the key only had a single hole (Figure 14). Additionally, two 13 mm (0.5 in) key rings (chained together) were then added to the replacement hole with the remote keyless entry (RKE) transmitter attached to the second ring. Additionally, the TSB advised to only add items to the second ring and to limit the number to a few essential keys or small items no larger than the RKE transmitter. The TSB is included at the end of this report as Appendix B.

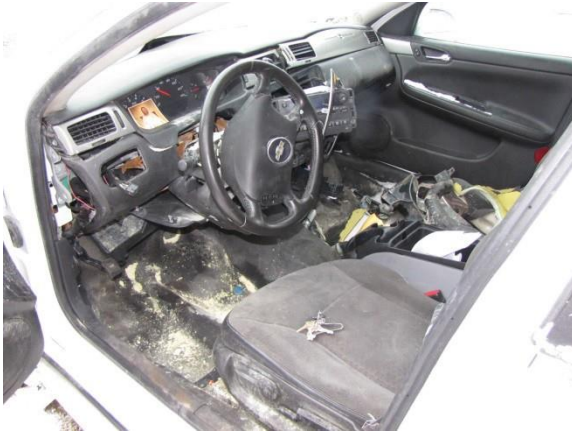
At the time of the SCI inspection, the Chevrolet’s ignition key (and key ring) was found lying on the driver seat (Figure 15). The ignition key was broken with the end of the key remaining in the ignition switch. The police investigator reported that at some point in time during the post-crash movement of the vehicle, the key was broken. Examination of the vehicle’s key revealed that the recall’s corrective action had been performed by the placement of a single-hole key cover over the head of the key (Figure 16). A key ring that measured 32 mm (1.3 in) diameter was attached to the key cover. Five keys were attached to a 16 mm (0.6 in) ring and linked to the large diameter key ring, along with a bent fork. The items attached to the ignition key weighed 73.7 grams (2.6 oz.).

*Figure 15. Left-interior view of the Chevrolet and the position of the keys on the driver seat at the time of the SCI inspection*

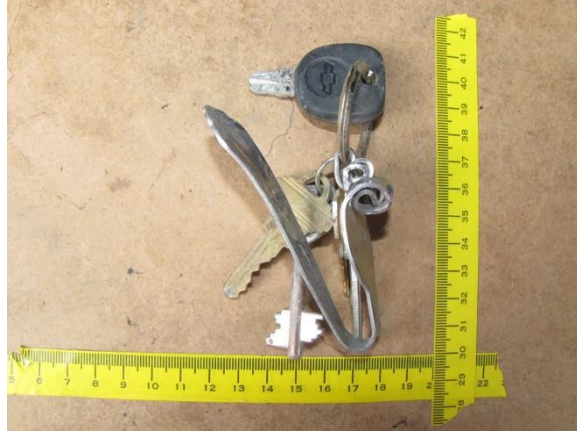
*Figure 16. Image depicting the Chevrolet's broken ignition key, 32 mm key ring, and additional attached items*

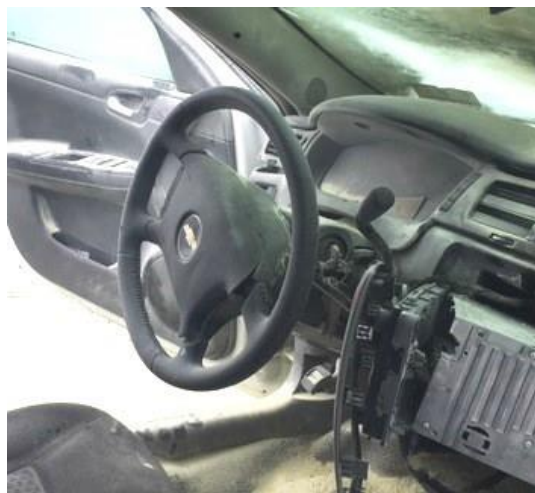
However, while it could not be confirmed as a certainty, the police investigator did believe that the on-scene police images may have been taken prior to anyone manipulating the steering wheel, column, or ignition. Figure 17 is an on-scene image of the steering column and ignition switch, taken 53 minutes after the reported time of the crash. Based on the SCI inspections of the Chevrolet and an exemplar Chevrolet Impala, the ignition switch depicted in Figure 17 is in the "Accessory" position. The switch was in this same position at the time of the SCI vehicle inspection in February 2017.

*Figure 17. On-scene police image of the steering wheel and column depicting the position of the ignition switch*

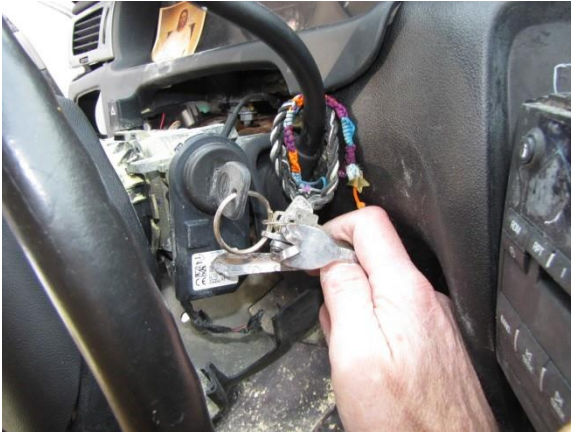
During the SCI inspection, the broken key was inserted into the ignition switch. The switch rotated to all positions. It was then observed that the ignition switch could be rotated from “Run” to “Accessory” by applying a small force at the attached fork and key group (Figures 18 and 19). It was theorized that the sudden vehicle deceleration (jarring), as the Chevrolet encountered and crossed the median, may have set the items attached to the key in motion and caused the switch to rotate from the “Run” position to “Accessory.” The ignition switch rotation removed 12-volt electrical power to the (driver) air bag module circuitry impeding the air bag deployment, despite the fact that the deployment command was sent by the control module (ACM). The ACM circuit remained powered regardless of the ignition switch position.

*Figure 18. Image depicting the ignition switch of the Chevrolet in the “Run” position*

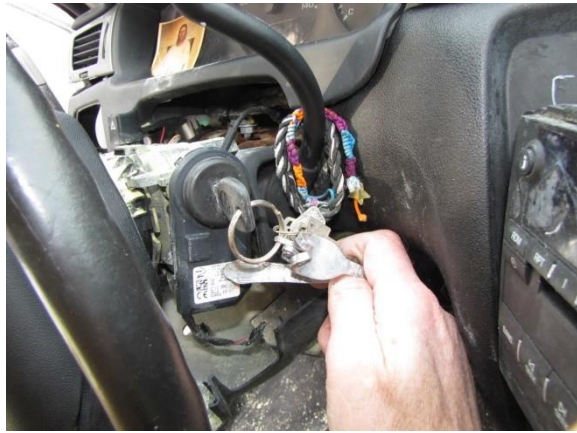
*Figure 19. Image depicting the ignition switch of the Chevrolet in the “Accessory” position with a force application applied at the attached items*
