DOT HS 813 157

**Special Crash Investigations:
On-Site Remote Child Restraint
System/Fire Crash Investigation;
Vehicle: 2001 Chevrolet Impala;
Location: Florida;
Crash Date: May 2016**

Special Crash Investigations
Remote Child Restraint System/Fire Crash Investigation
Case Number: CR19039
Vehicle: 2001 Chevrolet Impala
Location: Florida
Crash Date: My 2016

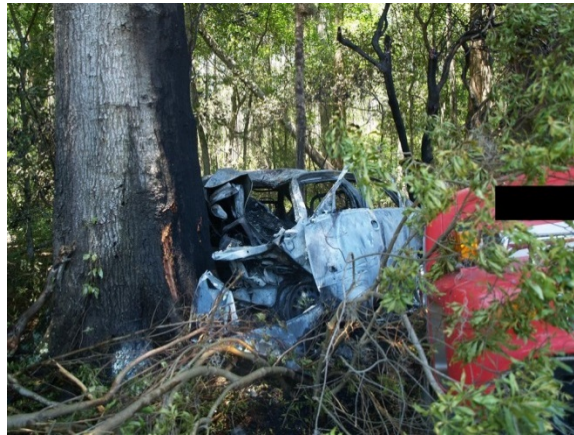
This remote investigation documents the involvement of a 20-month-old male restrained in a child restraint system (CRS) in the second row of a vehicle involved in a high-speed frontal crash into a large-diameter tree and the subsequent fire (Figure 1).

Figure 1. On-scene image of the final rest position of the Chevrolet and the struck tree. (Image provided by the investigating law enforcement agency)

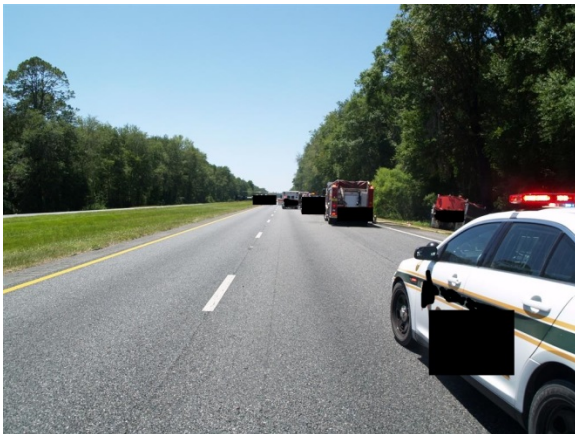
Figure 2. Westbound view of the travel lanes of the interstate roadway. (Image provided by the investigating law enforcement agency)

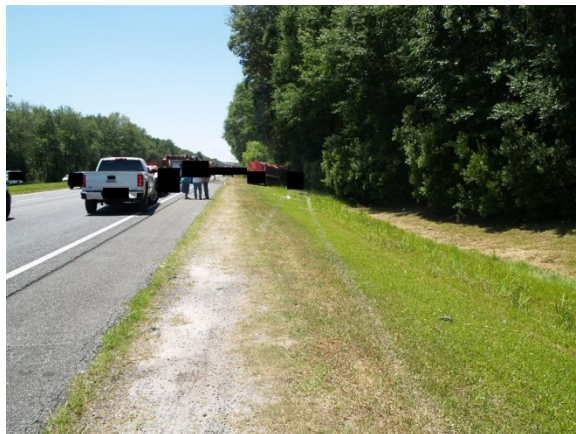
Figure 3. Westbound view of the Chevrolet's roadside departure. (Image provided by the investigating law enforcement agency)

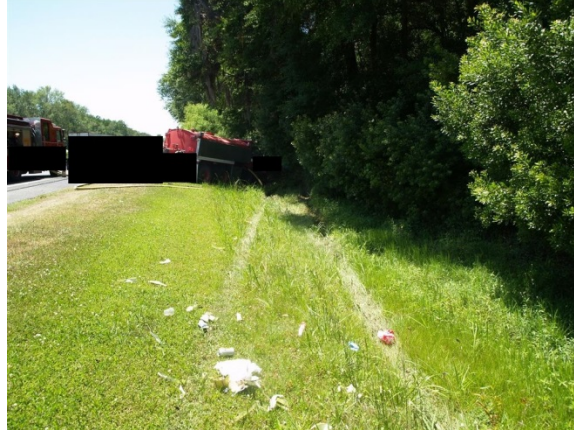
The driver of the Chevrolet was traveling in west in the right through lane of the divided interstate at a minimum speed of 103 km/h (64 mph) as computed by the police. The Chevrolet drifted to the right for unknown reasons and traversed the acceleration lane onto the shoulder before exiting the paved surfaces onto the roadside. Rotating tracking tire marks identified the trajectory of the vehicle across the grass roadside (Figure 4). The police documented approximately 46 m (150 ft) of left- and right-side tire marks that traveled through the shallow drainage ditch. The tires furrowed into the soft soil of the ditch without altering the trajectory of the vehicle. There was no evidence to support corrective actions of braking or steering by the driver.

Figure 4. Westerly view of the off-road trajectory of the Chevrolet on the grass roadside. (Image provided by the investigating law enforcement agency)

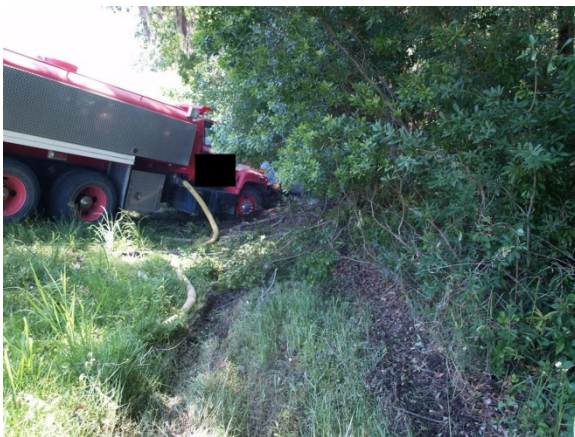
The front plane of the Chevrolet initially contacted several trees of small diameter (Event 1) as it continued forward (Figures 5 and 6). The frontal plane then struck a large-diameter tree (Event 2) that resulted in a force direction of 12 o'clock. The impact produced severe frontal crush that appeared to have involved the windshield header of the vehicle, indicating crush extending to a collision deformation classification (CDC) zone of 6. The Chevrolet rotated counterclockwise and rebounded slightly as the back plane, left aspect contacted a small-diameter tree as it came to final rest (Event 3). Due to the severity of the crash, a fire ensued that ultimately consumed the entire vehicle (Event 4).

Figure 5. Westerly view of the Event 1 impact with small diameter trees. (Image provided by the investigating law enforcement agency)

The front plane of the Chevrolet initially struck and traveled through the brush at the edge of the tree line (Event 1). Although superficial damage may have occurred, any damage was masked by the subsequent tree and fire events. A CDC of 12FDEW1 was assigned for this event.

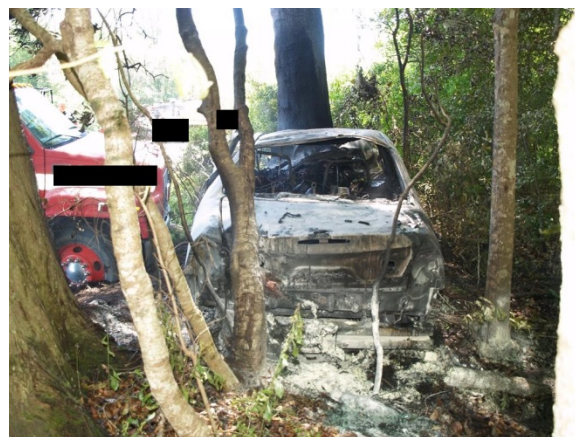
Figure 6. Westbound view of the Events 2, 3 and 4. (Image provided by the investigating law enforcement agency)

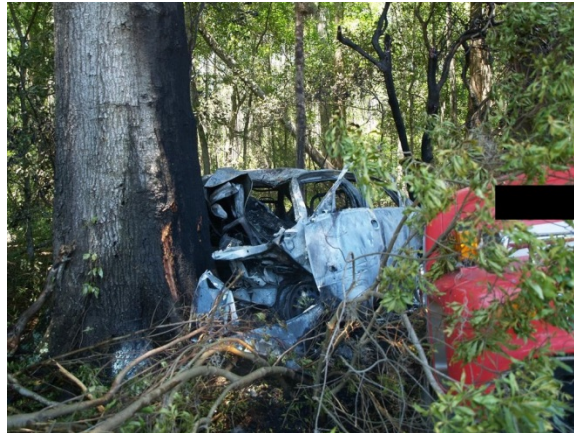
The Chevrolet rebounded slightly and came to final rest close to the large-diameter tree (Figure 7). Passersby saw the crash site, stopped, and called the emergency response system. Several approached the vehicle to offer assistance; one retrieved a tire iron and disintegrated the left-rear door window to unlock the door to gain access to the passenger compartment. Another used a knife to cut the seat belt webbing of the second-row left and center child passengers. All three child passengers were removed from the vehicle and carried to a safe distance from the Chevrolet. The second-row left male child was administered cardiopulmonary resuscitation; however, it was determined that he was deceased.

Figure 7. Northeasterly view of the final rest position of the Chevrolet. (Image provided by the investigating law enforcement agency)

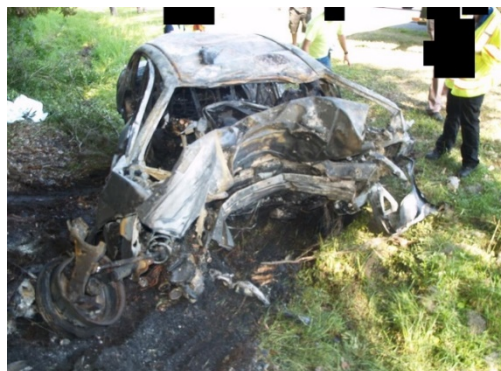
The front plane then struck the large-diameter hardwood tree (Event 2). Although the impact was centered on the vehicle, the diameter of the tree spanned all three lateral zones (left, center and right). A police image depicting the width of the direct contact damage on the hood spanned 64 cm (25.2 in). The severity of the crash displaced the frontal structure beyond the base of the windshield. The hood folded and crushed rearward, resulting in windshield header deformation. The CDC for this impact was estimated at 12FDAW6 (Figure 8).

Figure 8. Frontal damage from the Event 2 impact with the large diameter tree. (Image provided by the investigating law enforcement agency)

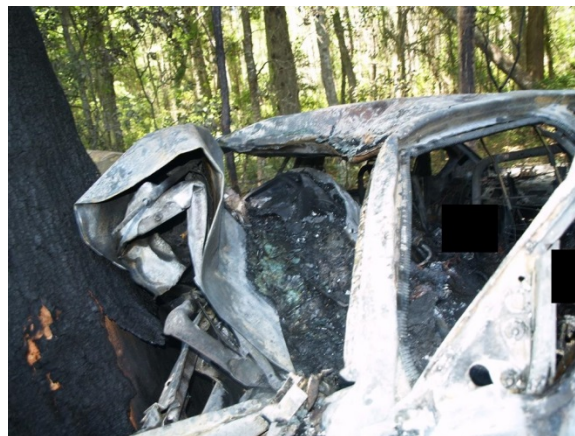
The interior of the Chevrolet was reduced in size by intrusion of frontal components. The specific and extent of intrusions could not be determined from the police images. The entire occupant compartment was completely consumed by the fire (Figure 9).

Figure 9. Distant image of the interior of the Chevrolet. (Image provided by the investigating law enforcement agency)
