DOT HS 813 171

**Special Crash Investigations:
On-Site ET-Plus Guardrail End
Treatment Crash Investigation;
Vehicle: 2003 Nissan Maxima;
Location: Missouri;
Crash Date: April 2016**

Special Crash Investigations
On-Site ET-Plus Guardrail End Treatment Crash Investigation
Case Number: CR16013
Vehicle: 2003 Nissan Maxima
Location: Missouri
Crash Date: April 2016

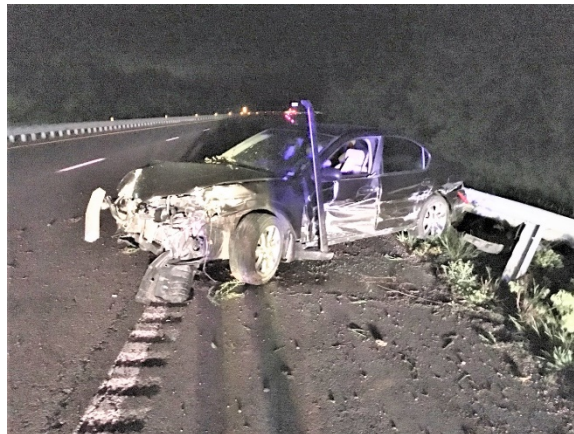
Figure 1. East-facing view of the Nissan and partial view of the struck guardrail system (on-scene image supplied by MoDOT)

At rest the Nissan had its back plane against the guardrail between Post 5 and Post 6, facing northwest at an angle across the south shoulder (Figure 1). The Nissan's center of mass was located 7.1 m (23.2 ft) east of the initial guardrail impact and 1.2 m (4.0 ft) north of the roadway edge. During the crash, the Nissan engaged and deformed 9.8 m (32.3 ft) of the W-beam guardrail.

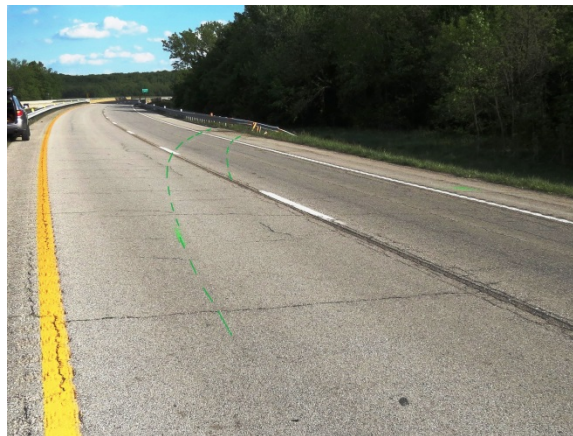
As the Nissan approached the south roadway edge and the ET-Plus guard rail end treatment, it achieved approximately 80 degrees of total clockwise rotation, evidenced by yaw marks from the left side tires on the asphalt. Figure 3 shows the visible yaw marks, which have been highlighted in the image for clarity. The total length of the left rear tire mark measured 46.5 m (152.6 ft), while the left rear measured 21.2 m (69.6 ft) long. Based on these tire marks, the Nissan's angle of approach to the ET-Plus end treatment was 29 degrees.

Figure 3. East-facing view of the Nissan's CW yawing tire marks on approach to impact with the guardrail

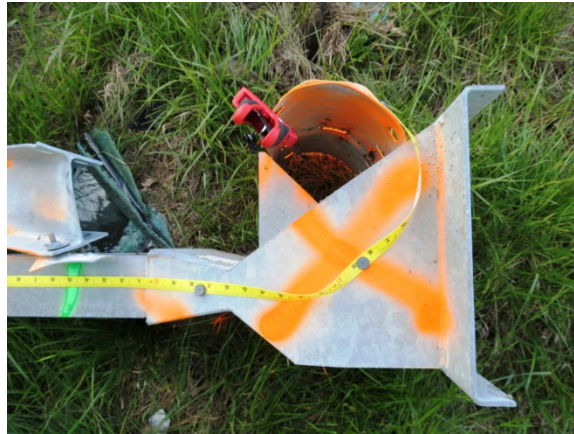
During the crash, the Nissan struck the traffic-side edge of the impact face of the end terminal. Only cosmetic damage was sustained by the impact head. Displacement of the impact head flattened the guardrail, which curled toward the field side. Approximately 38 cm (15.0 in) of flattened W-beam extruded from the impact head (Figure 5). Note that the orange paint markings were not related to the SCI inspection of the guardrail system or the impact head. Based on comparison to the exemplar guardrail installation located on the opposite side of the roadway from the focus system, the total displacement of the impact head along the guardrail was approximately 79 cm (31.1 in).

Figure 5. West-facing view of the ET-Plus end terminal impact head and deformed W-beam guardrail in their displaced position following the crash

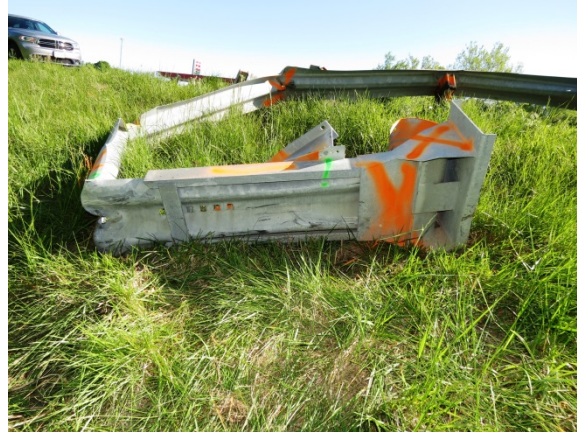
The deflection of the guardrail and inertia of the impact head produced an approximate 80-degree bend in the guardrail at the Post 2 and Post 3 locations, with an approximate 20-degree bend at the Post 4 location and an approximate 70-degree bend at the Post 6 location. There were no apparent kinks formed in the guardrail during the crash sequence. Figure 6 shows the deformed ET-Plus end terminal in its displaced position in the area of protection at the time of

Figure 6. North-facing view of the impact head and deformed end terminal system lying in the area of protection at the time of the SCI crash site inspection

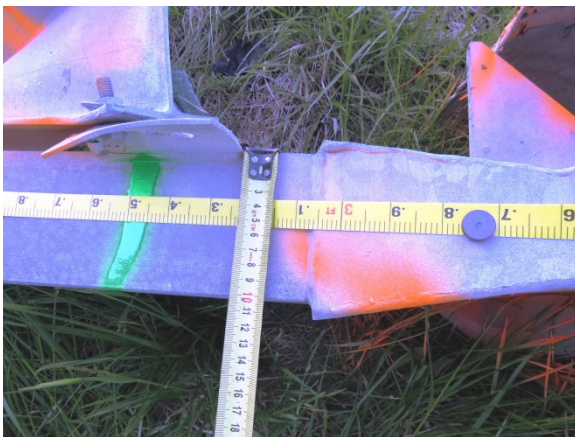
The height of the W-beam was 69 cm (27.0 in), measured at an undamaged section of the guardrail at Post 7. Dimensions of the end terminal impact head measured 38 cm (15.0 in) in width and 71 cm (28.0 in) high. The extruder head's length was 50 cm (19.7 in) and the guide chute's length was 91 cm (35.8 in), producing a total overall length for the ET-Plus end terminal device of 141 cm (55.5 in). The width of the guide chute (Figure 7) was 10 cm (4.0 in).

Figure 7. Measurement of the guide chute width of the ET-Plus end terminal at the time of the SCI crash site inspection

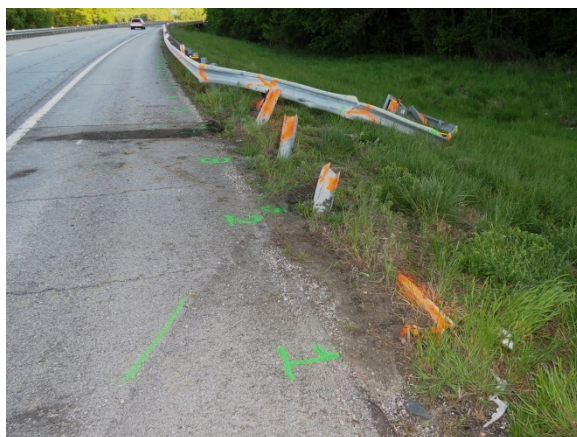
The first five posts were constructed of 10 x 15 cm (4 x 6 in) steel I-beam and deflected toward the southeast. Post 2 was deflected approximately 80 degrees from vertical, Post 3 was deflected approximately 55 degrees from vertical, Post 4 was deflected approximately 40 degrees from vertical and twisted approximately 60 degrees clockwise, and Post 5 was deflected approximately 70 degrees from vertical (Figure 8).

Figure 8. Southeast-looking view showing the damaged guardrail

The W-beam guardrail sustained damage from Post 1 to Post 6, with a total damaged length of 9.9 m (32.3 ft). Post 1 had separated from the base but remained attached to the impact head. The top surface of the base measured 8 cm (3.1 in) above ground level. Post 2 was partially sheared on its struck side slightly above ground level. The location of the shear was through the shear holes, located at ground level. A ground angle strut was originally installed between Post 1 and Post 2 on the field side. This strut tensioned the system and was bolted to the side of the Post 1 base sleeve and directly to Post 2. The angle strut was at ground level and remained in place post-crash. It did not appear to have sustained direct contact during the crash sequence.

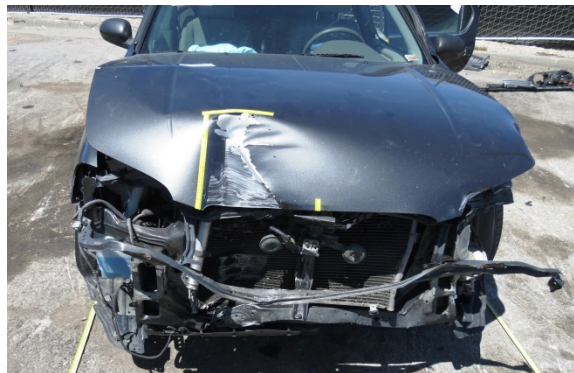
Figure 10. Front-plane view of the Nissan and location of the impact head direct contact (highlighted)

Direct contact damage on the front plane from the initial impact with the ET-Plus end terminal impact head began 10 cm (4.0 in) right of center and extended 24 cm (9.4 in) to the right (Figure 10). This damage was evidenced by vertically oriented impressions and crush that mirrored the side profile of the impact head. A second area of deformation to the front plane was visible on the lower radiator support, beginning 14 cm (5.5 in) right of center and extending 16 cm (6.3 in) to the right. This damage was attributed to Post 1. Engagement of the front of the Nissan with the guardrail, in conjunction with the vehicle's rotation, fractured and sheared the front bumper fascia, front bumper beam, front bumper beam mounts, grille, and both front headlight assemblies from the vehicle. Longitudinal deformation was sustained by both the upper and lower radiator supports, hood, and engine compartment components. The only deformation (crush) sustained by the lower radiator support was in the area of the Post 1 damage, which measured 5 cm (2.0 in).

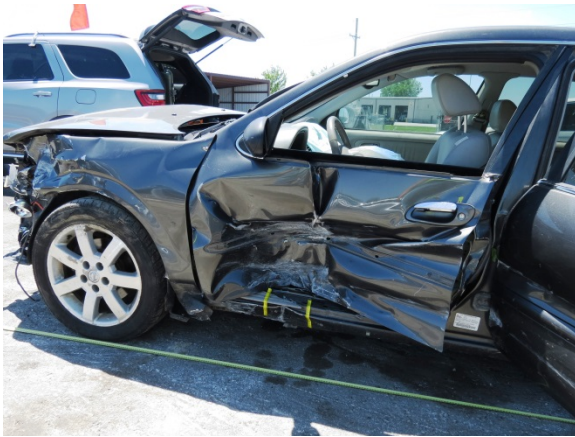
the vehicle's damage, Post 3 struck the center aspect of the left-front door at 74 cm (29.1 in) rearward of the left-front axle. Direct damage extended rearward 20 cm (7.9 in), and the maximum crush measured 19 cm (7.5 in). The door-sill differential measured 13 cm (5.1 in). Post 4 struck the rear aspect of the left-rear door in the area of the left C-pillar, 27 cm (10.6 in) forward of the left-rear axle position. Direct contact extended 20 cm (7.9 in) rearward. Along the entire left plane were longitudinal abrasions and minor deformation from contact with the W-beam guardrail. Figure 11 shows the forward aspect of the Nissan's left plane and the Post 3 damage.

Figure 11. Left view depicting the damage at the left-front door of the Nissan

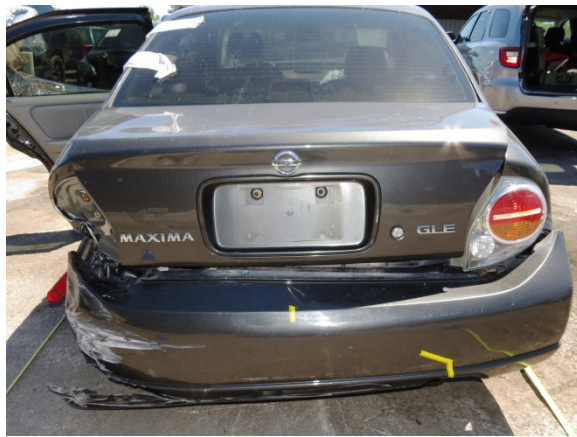
The back plane of the Nissan engaged the guardrail between Post 5 and Post 6. Damage from Post 5 was located at the left corner and included disintegration of the left taillight assembly with minor deformation to the left-rear fender and left-rear bumper corner. Direct contact on the back plane extended 119 cm (46.7 in) from the left-rear corner to 40 cm (15.7 in) right of center. In the damage pattern was deflection of the bumper fascia with surface scratches and abrasions. Figure 12 shows the rear-plane damage to the Nissan.

Figure 12. View of the Nissan's rear-plane damage

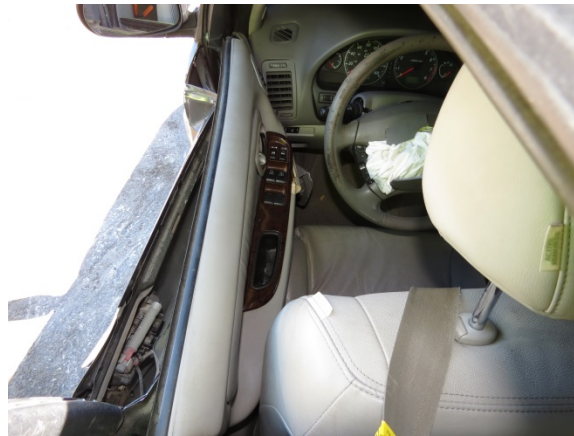
The Nissan's interior sustained damage that consisted of air bag deployment and occupant compartment intrusion. Damage to the left-front door from Post 3 impact resulted in the intrusion of all four door quadrants into the occupant compartment. The door was also jammed shut. The greatest intrusion of the door was located at its center aspect immediately above the sill, such that the intruded door was engaged against the seat cushion and adjustment controls of the driver's seat. Figure 13 shows the intruded left-front door. It is likely that minor intrusion occurred due to the Post 4 impact in the area of the left C-pillar. However, deformation to the left-rear door prevented it from re-latching, and there was no measurable intrusion of the left C-pillar. Measurements of the intrusion of the left-front door were as follows:

Figure 13. Overhead view of the intruded left front door engaged against the driver's seat of the Nissan

Quadrant	Magnitude	Direction
Forward Lower	11 cm (4.3 in)	Lateral
Rear Lower	8 cm (3.1 in)	Lateral
Forward Upper	2 cm (0.8 in)	Lateral
Rear Upper	1 cm (0.4 in)	Lateral

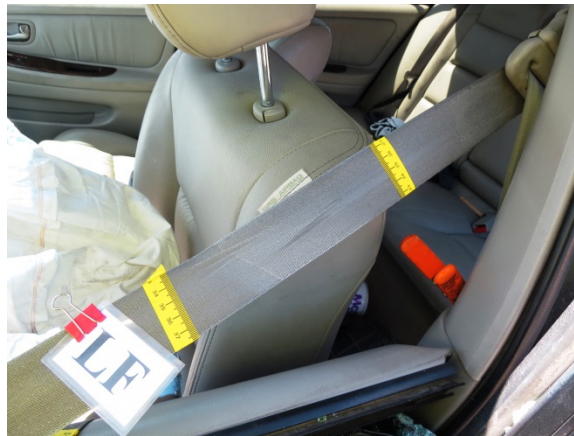
Inspection of the driver's seat belt system found the webbing slightly extended from the retractor. However, it spooled freely from the ELR. Historical wear was visible on both the latch plate and the webbing. There were two visible areas of abrasions and loading on the webbing. The first was located from 58 cm (22.8 in) to 64 cm (25.2 in) above the lower anchor and was attributable to latch plate loading. The second area, attributable to D-ring loading, was located from 143 cm (56.3 in) to 154 cm (60.6 in) above the lower anchor. This second area of loading is depicted in Figure 14. Based on its post-crash condition, the SCI investigator determined that the driver was restrained by the seat belt system at the time of the crash.

Figure 14. Area of D-ring loading to the Nissan driver's lap and shoulder seat belt system

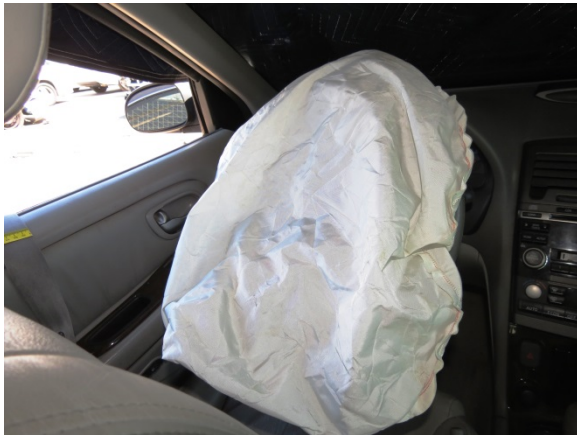
The driver's frontal air bag deployed from the module through the H-configuration cover flaps without damage or occupant contact to the module cover flaps. In its deflated state, the air bag measured 62 cm (24.4 in) in approximate overall diameter and extruded a maximum of 35 cm (13.8 in) rearward from the module. There were two 4 cm (1.6 in) vent ports located on the upper aspect of the back of the air bag. No visible occupant contact or crash related damage to the driver's frontal air bag was discernable. Figure 15 shows the Nissan driver's frontal air bag.

Figure 15. View of the deployed driver's frontal air bag in the Nissan

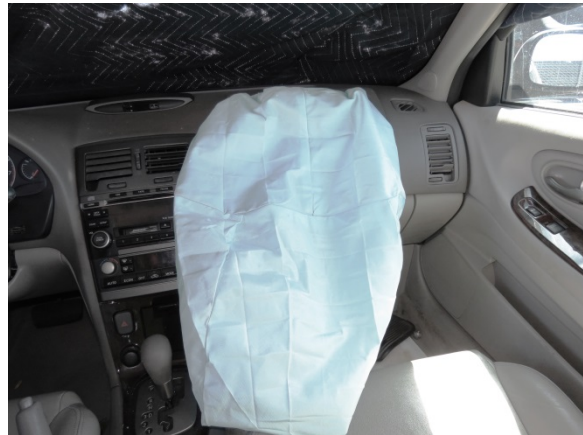
The passenger's frontal air bag also deployed from its module through the H-configuration cover flaps without damage to the air bag or cover flaps. The large air bag measured 40 cm (15.7 in) wide and 60 cm (23.6 in) tall in its deflated state. Maximum rearward excursion measured 40 cm (15.7 in) at the air bag's upper aspect. The air bag was vented on each side near its upper aspect

by a 4 cm (1.6 in) vent port. Inspection of the front right air bag was unremarkable. Figure 16 shows the large deployed air bag in its deflated state.

Figure 16. Deployed passenger's frontal air bag in the Nissan
