DOT HS 813 172

**Special Crash Investigations:  
Remote Vehicle Fire/Child  
Restraint System Investigation;  
Vehicle: 1995 GMC Suburban;  
Location: Minnesota;  
Crash Date: December 2015**

**Special Crash Investigations**  
**Remote Vehicle Fire/Child Restraint System Crash Investigation**  
**Case Number: DS19025**  
**Vehicle: 1995 GMC Suburban**  
**Location: Minnesota**  
**Crash Date: December 2015**

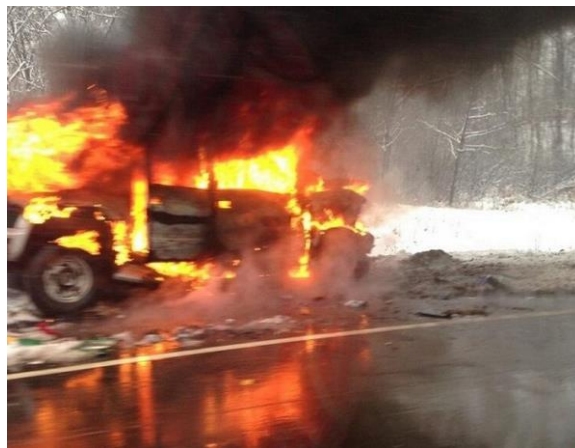
This report documents the remote vehicle fire/child restraint system (CRS) investigation of a 1995 GMC Suburban with a CRS-restrained child involved in a two-vehicle crash and subsequent post-crash fire (Figure 1). The investigation was intended to examine the events leading to the fire, how quickly the fire spread to the occupant compartment, the magnitude of the fire, the time in which emergency medical services (EMS) and other responders arrived on-scene, occupant restraint usage, demographics, injury data, and CRS usage. The crash was identified during a review of Fatality Analysis Reporting System (FARS) crash reports. The criteria for the crash type include a front or side plane impact, a fire that spreads to the occupant compartment, and at least one occupant seated in a CRS. The on-scene police photos were obtained, and the Special Crash Investigations (SCI) group of the National Highway Traffic Safety Administration assigned the case in August 2019. The fire incident report was obtained in September 2019; a non-redacted version of the police report was obtained in November 2019. Neither vehicle was supported by the Bosch Crash Data Retrieval system, and no Event Data Recorder (EDR) information was obtained.

*Figure 1. The 1995 GMC Suburban, looking east  
(police photo)*

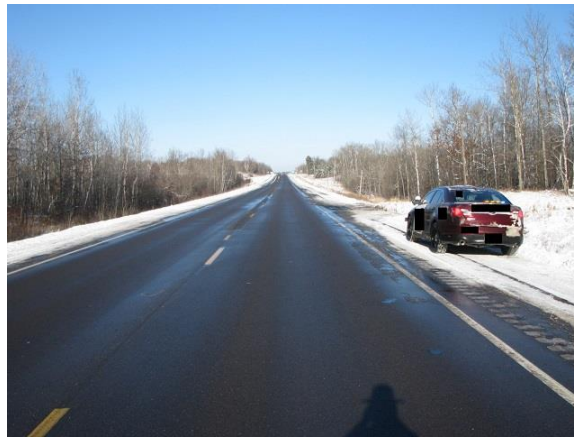
The crash site was an undivided, two-lane north/south State highway in rural Minnesota (Figure 2). The roadway, which was paved with asphalt in traveled condition, was straight and level. It had lanes measuring 3.8 m (12.5 ft) wide, bordered by paved shoulders measuring 3.8 m (12.5 ft) wide. The centerline was a dashed yellow painted stripe, and the fog lines were solid white painted stripes. The roadway had continuous rumble strips on the centerline, left shoulder, and right shoulder. The roadside was downward sloping ground, leading to drainage ditches. The speed limit was 89 km/h (55 mph). Conditions at the time of the crash were daylight, snowing, and wet with snow, ice, and water accumulation on the roadway. The temperature was 4.4 °C (24 °F), relative humidity was 88 percent, winds were northerly at 14 km/h (9 mph), and light snow was falling. A crash diagram is included at the end of this report.

*Figure 2. Crash site looking north (police photo)*

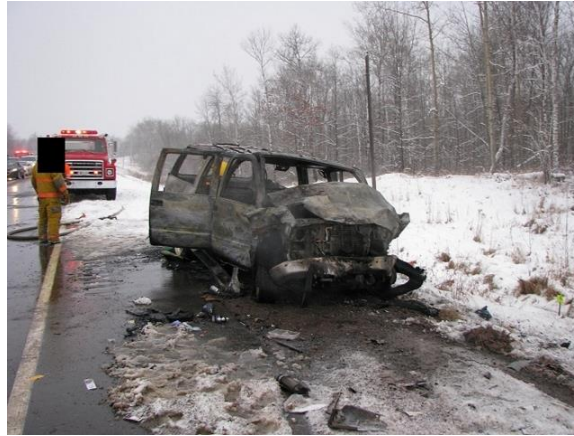
The front plane of the GMC struck the right plane of the Mazda (Event 1) in the passenger and rearward zones beginning at the right A-pillar and ending near the right D-pillar. The GMC initiated a post-impact, clockwise rotation and traveled to the east shoulder, where it came to rest facing south (Figure 3). Soon after the impact, the GMC caught fire from an unknown source (Event 2) and sustained major fire damage to the exterior and interior. The Mazda initiated a post-impact, clockwise rotation and departed the roadway on the east edge. It traveled down a descending embankment and came to rest facing west at a ditch line. During the crash, the unbelted 40-year-old female seated in the second-row right seat of the Mazda was fully ejected in an unknown manner and came to rest on the east roadside.

*Figure 3. The 1995 GMC Suburban looking north  
(police photo)*

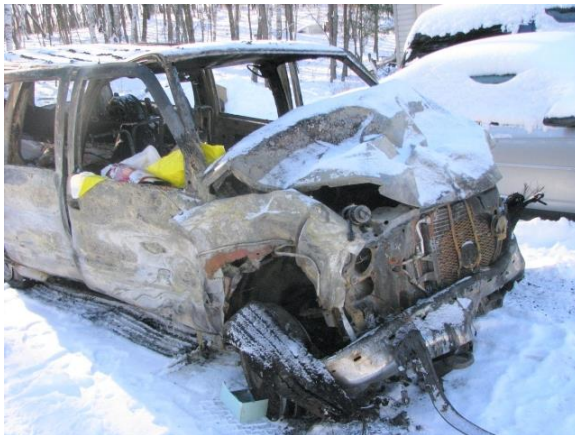
The GMC sustained major exterior damage to the front plane during the impact with the other vehicle and major severity damage to the entire vehicle during the fire. The front plane appeared to have sustained direct damage distributed from bumper corner to bumper corner (Figure 4). The left and right wheelbases appeared to have been shortened, and the front plane had an observed principal direction of force (PDOF) of 350°. The estimated Collision Deformation Classification (CDC) for the GMC in Event 1 was 12FDEW2.

*Figure 4. Front-plane damage, the 1995 GMC Suburban (police photo)*

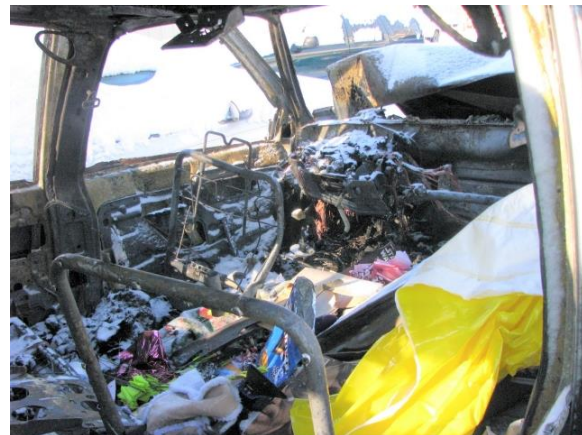
*Figure 5. Interior fire damage, the 1995 GMC Suburban (police photo)*

The police report and the fire incident reports were obtained. The police report stated that the GMC was engulfed by the fire and that all occupants exited the vehicle before it burned. The fire incident report stated that the fire was a result of the crash. The driver who was interviewed stated that the vehicle's electrical system was the cause of the fire and that no additional information regarding the cause or origin was available. The fire appeared to have started forward of the occupant compartment and quickly spread to the front row (Figure 5). The fire company alarm sounded 10 minutes after the crash. Eight fire personnel and an unknown number of apparatus arrived at an unknown time, and the last unit was cleared at approximately 4 hours 23 minutes after the crash. The fire report noted that no hazardous materials were released. The

report was brief and did not identify the fire's origin or cause. The fire company was a volunteer force, and no further data were available.

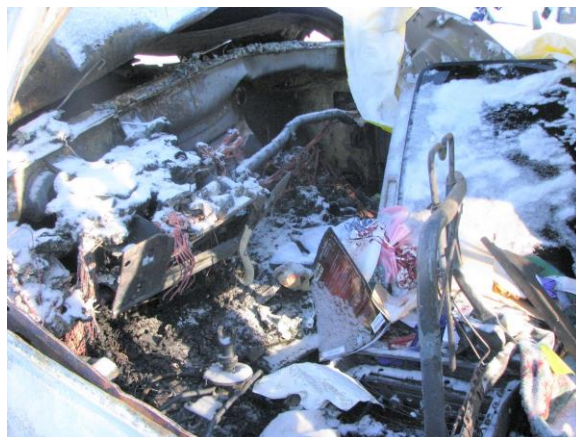
The GMC's interior sustained unknown impact damage and major fire damage. The front passenger who was interviewed stated that the engine intruded longitudinally into the front row (Figure 6). The magnitude of the intrusion was unknown. The windshield was fractured, and the front-row windows disintegrated at impact with the other vehicle. The left-front, left-rear, and right-front doors were jammed shut, and the right-rear door remained operational. All non-metal components appeared in police photos to have burned or melted in the fire.

*Figure 6. Front row showing longitudinal intrusion, the 1995 GMC Suburban (police photo)*

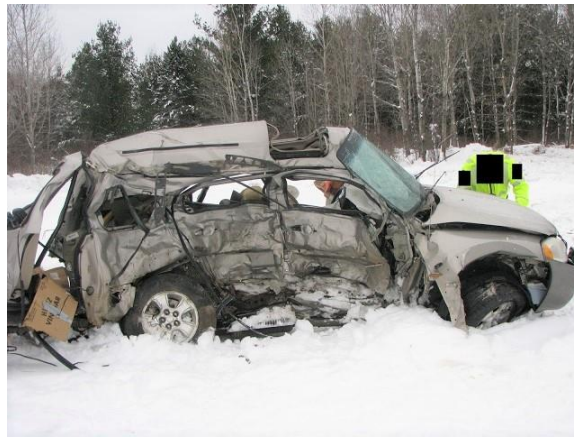
The Mazda sustained major damage to the right plane at impact with the other vehicle. Police photos indicated that maximum crush to the right plane measured 125 cm (49.2 in) and that the right plane had an observed PDOF of 80°. The estimated CDC for the Mazda in Event 1 was 03RZAW5.

*Figure 7. Right plane damage, the 2001 Mazda Tribute (police photo)*
