DOT HS 813 175

**Special Crash Investigations:  
On-Site Guardrail End Terminal  
Crash Investigation;  
Vehicle: 2007 Chevrolet HHR;  
Location: Missouri;  
Crash Date: June 2017**

**Special Crash Investigations**  
**On-Site Guardrail End Terminal Crash Investigation**  
**Case No.: IN17023**  
**Vehicle: 2017 Chevrolet HHR**  
**Location: Missouri**  
**Crash Date: June 2017**

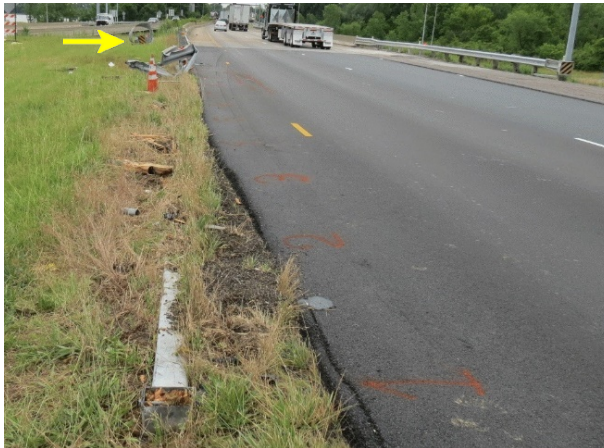
This on-site investigation documents a passenger vehicle impact to an ET-Plus 10 cm (4 in) model guardrail end terminal (Figure 1) that is of interest to the Federal Highway Administration (FHWA). This investigation was conducted on behalf of the FHWA. This crash was identified by an engineer with the Missouri Department of Transportation (MoDOT), who submitted images of the damaged guardrail end terminal and vehicle to the FHWA. The FHWA determined that the guardrail end terminal and crash type were of interest. This crash investigation was then initiated by the National Highway Traffic Safety Administration in June 2017 and assigned to the Special Crash Investigations (SCI) team at the Indiana University Transportation Research Center. This single-vehicle crash involved a 2007 Chevrolet HHR (Figure 2) in Missouri in June 2017 at night and was investigated by a local police agency. The vehicle, crash scene, and guardrail were inspected and documented in June 2017.

*Figure 1. Overview of damaged guardrail and final rest position of ET-Plus (arrow), view east*

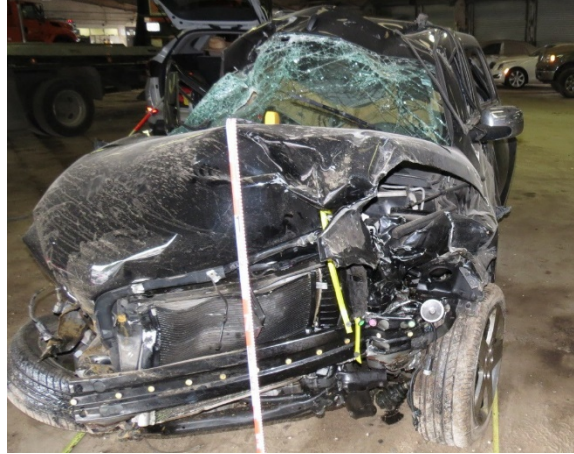
*Figure 2. The damaged 2007 Chevrolet HHR*

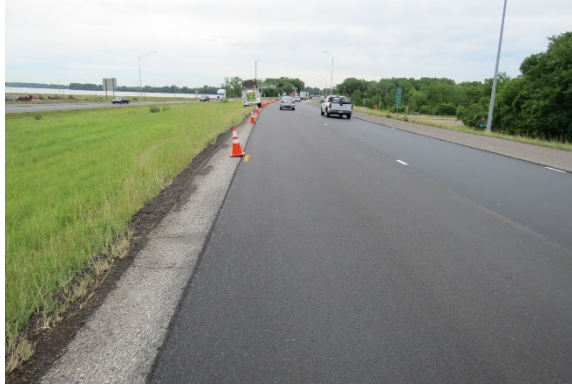
Figure 3. Eastbound approach of the Chevrolet to the right curve and roadway departure

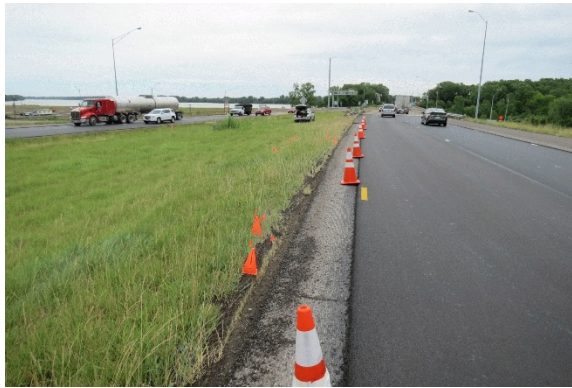
Figure 4. Location where the Chevrolet departed the roadway and entered the median, small orange cones shows path of left side tires

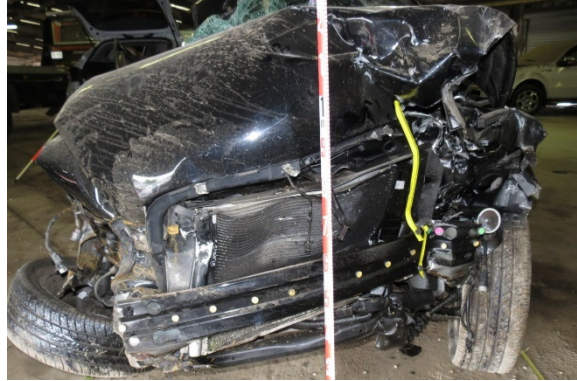
The left corner of the vehicle's front plane (Figure 5) struck the end terminal (Figure 6, Event 1) resulting in the extrusion of 9.0 m (29.5 ft) of guardrail to the field side. The speed of the vehicle at impact was calculated to be in a range of 161 to 164 km/h (100 to 102 mph) based on the EDR-reported speed of -168 km/h (104 mph) at -1.0 sec prior to AE and assuming a deceleration range of -0.20 to -0.08  $g^2$  for -1.0 sec. The force direction on the Chevrolet was within the 12 o'clock sector and the impact resulted in a stage one deployment of the driver's frontal air bag. The vehicle's EDR reported an extended crash pulse with the maximum longitudinal velocity change reaching -54.52 km/h (-33.88 mph) at 220 msec following AE, which was the end of recording. The maximum lateral velocity change was 5.46 km/h (3.39 mph) occurring at 130 msec following AE. WinSMASH could not be used to calculate delta V since an impact with a yielding object is out of scope for the program. However, WinSMASH was used to calculate a barrier equivalent speed (BES) of 46 km/h (29 mph) based on the crush to the front plane. The BES appeared reasonable.

*Figure 5. Damage to front plane from impact with ET-Plus*

**Exterior Damage Event 1:** The impact with the ET-Plus occurred at the left corner of the front plane and the front bumper, left headlamp/turn signal assembly, grille, hood, and left fender were directly damaged. The direct damage began at the left corner of the front bumper and extended 52 cm (20.5 in) to the right across the front plane. The Field L was 103 cm (40.6 in). Crush measurements were taken on the bumper bar and the maximum residual crush was 49 cm (19.3 in) occurring 76 cm (29.9 in) left of the vehicle's centerline. The crush values were:  $C_1 = 49$  cm (19.3 in),  $C_2 = 45$  cm (17.7 in),  $C_3 = 39$  cm (15.4 in),  $C_4 = 31$  cm (12.6 in),  $C_5 = 23$  cm (9.1 in),  $C_6 = 18$  cm (7.1 in).

**Damage Classification Event 1:** The Collision Deformation Classifications (CDC) was 12FYEW3 (0 degrees). The severity of the damage was moderate.

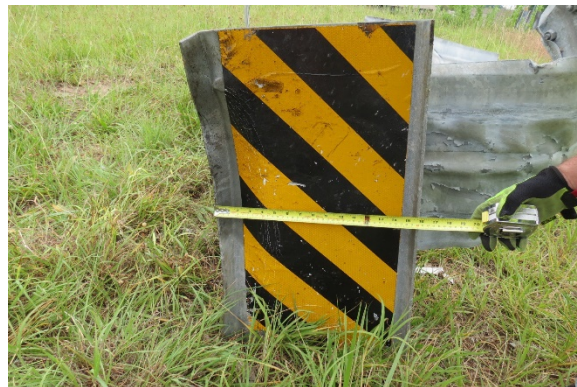
*Figure 6. Direct damage to the face of the ET-plus*

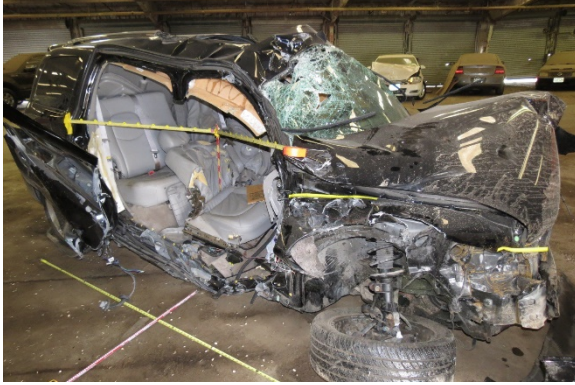
The vehicle rotated counterclockwise as the guardrail deformed and the right plane, beginning at the right front corner (Figure 7), struck the deformed guardrail (Event 2). This impact resulted in extensive intrusion of the right front door and right B-pillar into the occupant compartment as well as intrusion of a section of the deformed guardrail, which penetrated diagonally through the front right, second row center, and second row left seating positions (Figure 8). The vehicle then rolled over (Event 3), right side leading, three quarter turns. The top plane struck the guardrail (Event 4) during the second quarter turn and the left plane struck the guardrail (Event 5) during the third quarter turn as the vehicle came to final rest on the left plane on top of the guardrail heading northwest (Figure 9). The distance traversed during the rollover is not known.

*Figure 7. Damage to the right plane of the Chevrolet from impact with the deformed guardrail*

**Exterior Damage Event 2:** The right plane sustained an impact with the guardrail as the guardrail was deformed. The direct damage began 313 cm (123.2 in) forward of the right rear axle and extended 267 cm (105.1) rearward from the front corner of the right plane onto the right fender, A- and B-pillars, and both doors. The Field L was 276 cm (108.7 in). Crush measurements were taken at the upper-door level and the maximum residual crush was 58 cm (22.8 in) occurring 112 cm (44.1 in) forward of the right rear axle. The crush to the right plane was estimated using a tape measure attached to the vehicle to represent an approximate crush profile based on judgement and the damage. This approach was taken since both doors and the B-pillar were separated from the vehicle. The crush measurements are only an attempt to provide an estimation of the crush to the right side plane and do not reflect the penetration of the guardrail into the occupant compartment. A second set of crush measurements was taken at the sill as required by the crush measurement protocol since there was striker and hinge separation of

***Damage Classification Event 2:*** The CDC was 02RYHW9. The extent zone reflected is based upon the damage observed by the right front door. The guardrail intruded into the passenger compartment starting at the right front passenger position traveling diagonally across the passenger compartment and impacting the left C-pillar at the left second row seating position. The severity of the damage was severe.

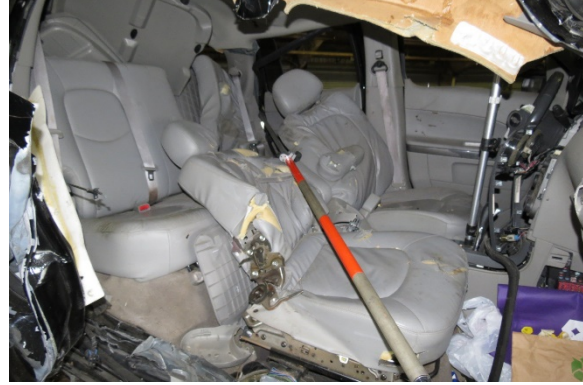
*Figure 8. Pole shows path of guardrail penetration into Chevrolet's occupant compartment*

The interior of the Chevrolet sustained severe damage from intrusion of the right front door, right B-pillar, and guardrail. The right front door and B-pillar were estimated to have intruded laterally a total of 65 cm (25.5 in) and 20 cm (7.9 in) into the front row. It was necessary to estimate the intrusion since each component had been removed from the vehicle by emergency responders. The guardrail penetrated diagonally through the front row right seating position and contacted and deformed the driver's seatback. It then penetrated diagonally through the second-row center and left seating positions and contacted and damaged the left rear door. So, the guardrail

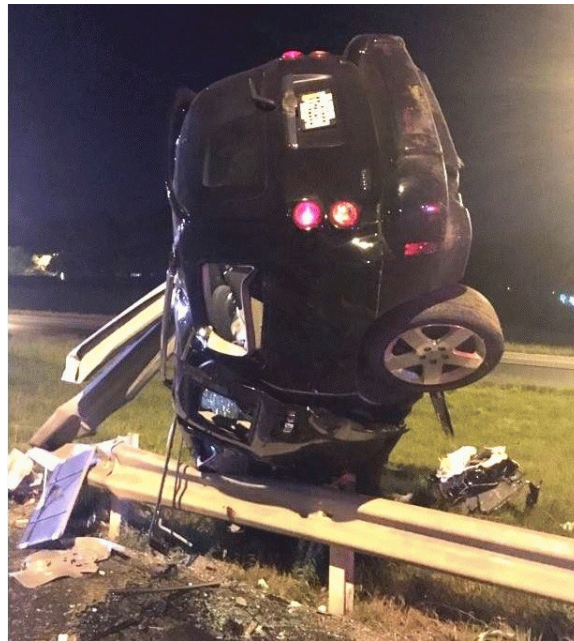
*Figure 9. MoDOT-provided photo of Chevrolet at final rest*

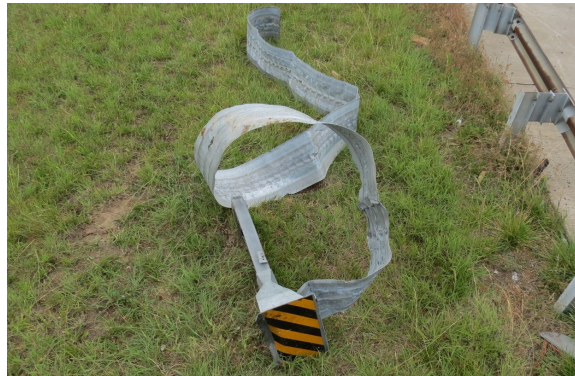
The front plane impact of the Chevrolet to the end terminal extruded 9.0 m (29.5 ft) of guardrail to the field side (Figure 10). The crash damaged 21.1 m (69.2 ft) of guardrail and separated the end terminal from the guardrail projecting it 38.1 m (125.0 ft) downstream where it came to final rest on the field side of the guardrail. Wooden posts 1 to 8 were fractured and destroyed. Posts 9 to 12 were constructed of steel and had steel offset blocks. Post 9 was bent downstream approximately 70 degrees off vertical. The offset block remained attached to the post and the mounting bolt was pulled through the guardrail. Post 10 was also bent downstream approximately 70 degrees off vertical. The offset block remained attached to the post and the mounting bolt was pulled through the guardrail. Post 11 was slightly displaced and twisted. The offset block and guardrail remained attached to the post. Post 12 was slightly damaged but was not displaced. The offset block and guardrail remained attached to the post. The guardrail was kinked in seven locations (Figure 11). The width of the feeder channel was 10 cm (4.0 in) and the guide chute exit height was 39 cm (15.5 in). The connection of the feeder channel to the head was not damaged. The bottom welds on the connection between the feeder channel and extruder head were fractured. The anchor cable was disconnected from its anchor and was not found during the SCI crash scene investigation. The height of the undamaged guardrail was 70 cm (27.5 in). The FHWA guardrail form is attached to the end of this report as Appendix B.

*Figure 10. The damaged ET-Plus and extruded guardrail*

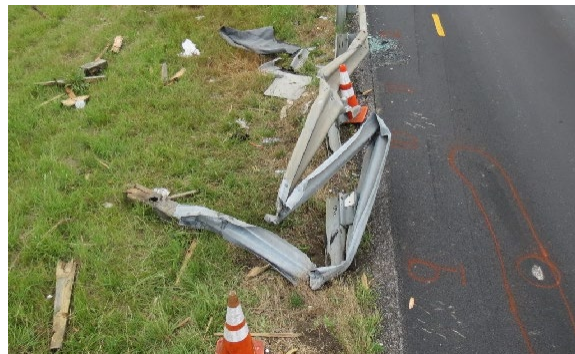
*Figure 11. Kinks in the damaged guardrail*

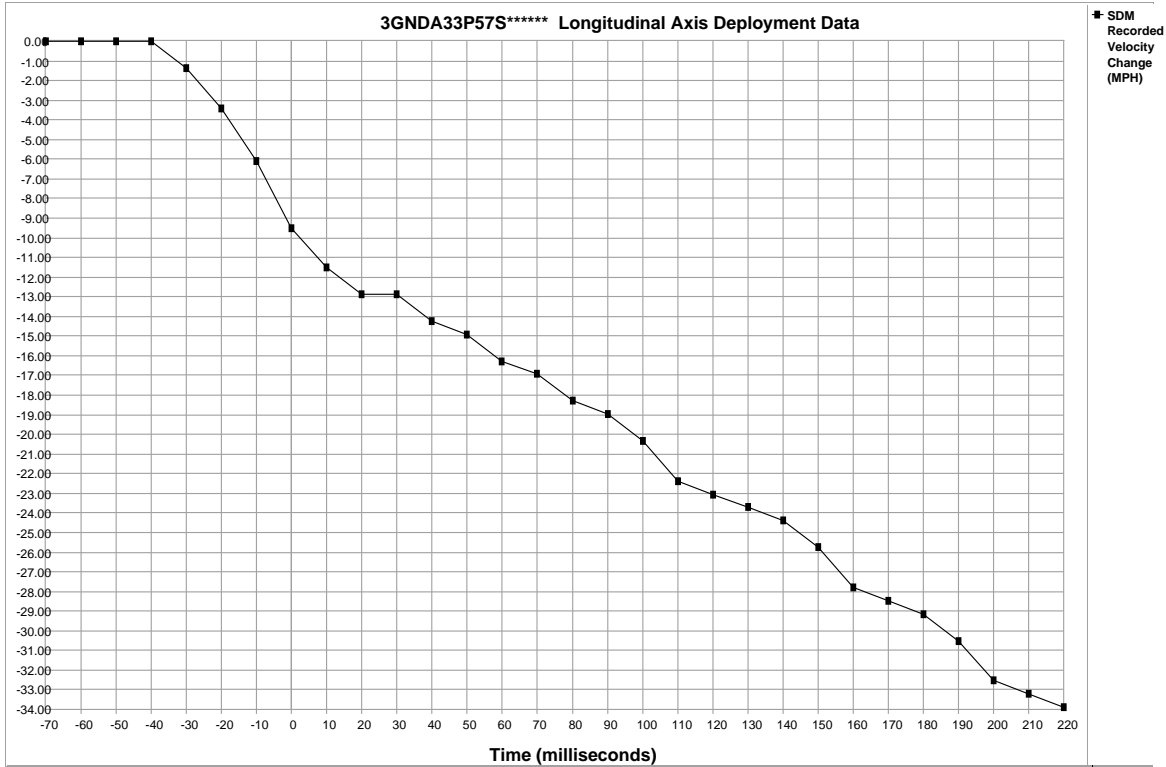
Time (milliseconds)	-70	-60	-50	-40	-30	-20	-10	0	10	20	30	40	50	60	70
SDM Longitudinal Axis Recorded Velocity Change (MPH)	0.00	0.00	0.00	0.00	-1.36	-3.39	-6.10	-9.49	-11.52	-12.88	-12.88	-14.23	-14.91	-16.26	-16.94
Time (milliseconds)	80	90	100	110	120	130	140	150	160	170	180	190	200	210	220
SDM Longitudinal Axis Recorded Velocity Change (MPH)	-18.30	-18.98	-20.33	-22.36	-23.04	-23.72	-24.40	-25.75	-27.79	-28.46	-29.14	-30.50	-32.53	-33.21	-33.88

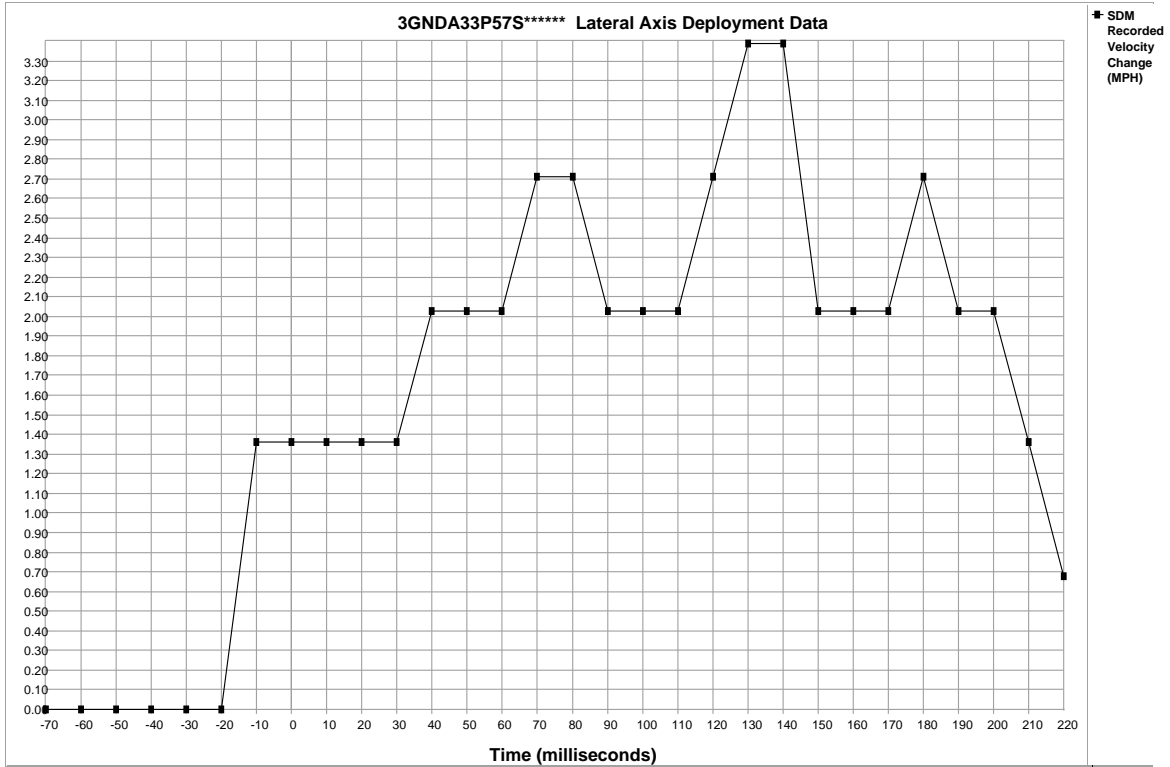
Time (milliseconds)	-70	-60	-50	-40	-30	-20	-10	0	10	20	30	40	50	60	70
SDM Lateral Axis Recorded Velocity Change (MPH)	0.00	0.00	0.00	0.00	0.00	0.00	1.36	1.36	1.36	1.36	1.36	2.03	2.03	2.03	2.71
Time (milliseconds)	80	90	100	110	120	130	140	150	160	170	180	190	200	210	220
SDM Lateral Axis Recorded Velocity Change (MPH)	2.71	2.03	2.03	2.03	2.71	3.39	3.39	2.03	2.03	2.03	2.71	2.03	2.03	1.36	0.68
