DOT HS 813 193

**Special Crash Investigations:
On-Site Guardrail End Terminal
Crash Investigation;
Vehicle: 2003 Nissan Maxima;
Location: Missouri;
Crash Date: May 2018**

Special Crash Investigations
On-Site Guardrail End Terminal Investigation
Case Number: IN18008
Vehicle: 2003 Nissan Maxima
Location: Missouri
Crash Date: May 2018

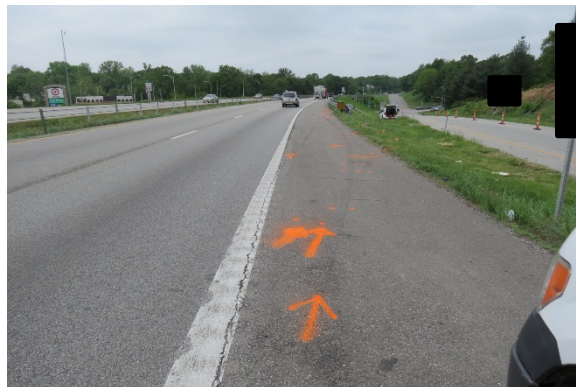
The Nissan was traveling in a southerly direction in the right travel lane at an unknown speed as the driver attempted to negotiate the right curve. He stated in the medical records and crash report that he dozed off. The vehicle drifted to the right and overrode the rumble strips (Figure 2). The driver apparently awoke and applied a rapid counterclockwise steering maneuver and braked in an attempt to regain the travel lane. This maneuver initiated a counterclockwise yaw evidenced by right front, right rear, and left front yaw marks on the south shoulder. The right-front tire yaw mark was 17 m (55.8 ft) in length prior to the first impact event. The yaw marks supported 50 degrees of counterclockwise rotation leading to the impact with the luminaire.

Figure 2. Southwest view of Nissan's roadway departure

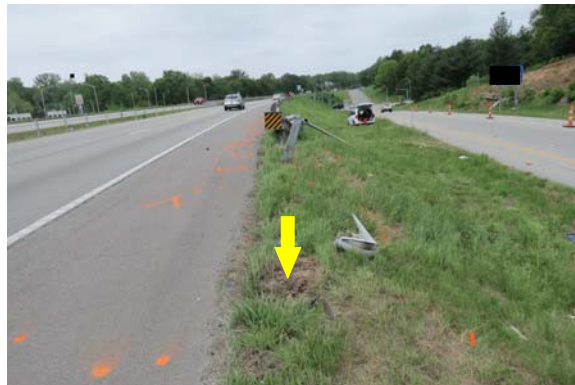
The right plane of the Nissan, at the right-front door location, struck and fractured the breakaway base of a luminaire 18 cm (7.1 in) in diameter (Figure 3, Event 1). The force direction on the Nissan was in the 2 o'clock sector. The vehicle continued west for 4.4 m (14.4 ft) while continuing to rotate. The damaged right-front door area struck the end terminal of the W-beam guardrail system (Event 2). The force direction on the Nissan was in the 3 o'clock sector. The end terminal was displaced by the vehicle's center of mass and in line with the guardrail system. The SKT end terminal extruded 4.5 m (14.8 ft) of guardrail to the field side and damaged a total length of 7.6 m (25.0 ft) of guardrail as the Nissan remained engaged with the end terminal. Due to the lack of EDR data, it is unknown if the frontal air bags deployed during Event 1 or Event 2.

Figure 3. Southwest view, impact with luminaire

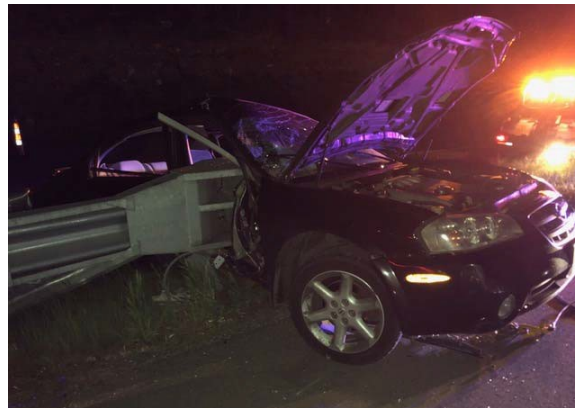
The Nissan came to rest with its right plane fully engaged against the SKT end terminal (Figure 4). The driver unbuckled his seat belt, opened the left front door, and exited the vehicle unassisted. The police were notified of the crash and arrived on scene 7 minutes later. Rescue and medical personnel also responded. The driver sustained police-reported “B” (non-incapacitating) injuries and was transported by ambulance to a local hospital, where he was treated for his injuries and released. The Nissan was towed from the crash site to a local tow yard, where it was inspected for this investigation.

Figure 4. Northerly view, on-scene image of the Nissan at final rest

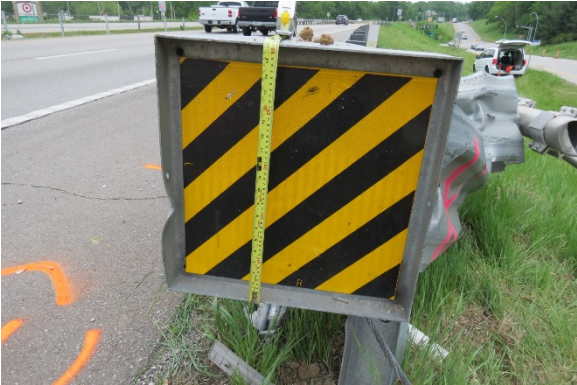
The right plane of the Nissan struck the end terminal and displaced the end terminal downstream. Approximately 4.5 m (14.8 ft) of guardrail was extruded toward the field side. The end terminal intruded into the vehicle and remained engaged with the vehicle at final rest. The impact face measured 51 cm (20.1 in) square and sustained minor damage (Figure 5). Post 1 became separated from its base. Post 2 collapsed downstream to the ground from its pivot base. Post 3 was collapsed downstream approximately 20 degrees, detached from the guardrail, and the composite offset block became partially detached from the post. Post 4 rotated slightly clockwise but remained attached to the composite offset block and guardrail. Posts 5 to 12 were not damaged and remained attached to the composite offset blocks and guardrail. The length of total damaged guardrail measured 7.6 m (24.9 ft) and there were no kinks downstream of the end terminal. Figure 6 is a view of the damaged guardrail section. The FHWA guardrail form is attached in Appendix A.

Figure 5. Southerly view, head of end terminal

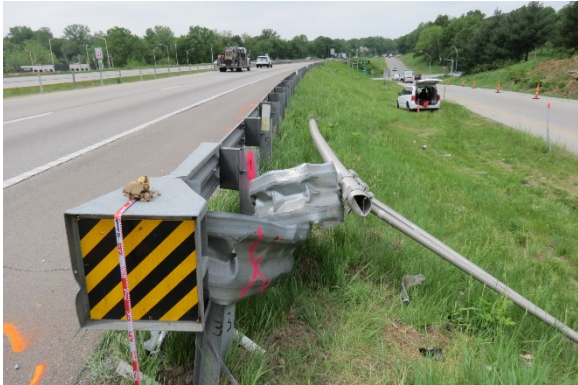
Figure 6. Southerly view of damage to the guardrail system and displaced luminaire

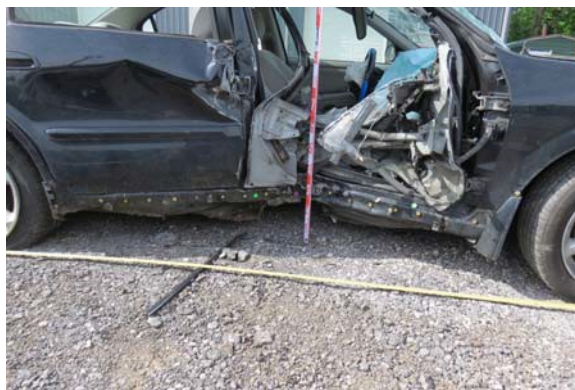
The Nissan sustained damage to the right plane during the impact with the luminaire (Figure 7). The right front door, roof side rail, and sill were directly damaged. The direct-contact damage began 110 cm (43.3 in) rearward of the right front axle and extended 32 cm (12.6 in) rearward. Maximum crush was 39 cm (15.5 in) located on the sill 126 cm (49.6 in) rearward of the right

Figure 7. Right plane sill damage from luminaire impact

front axle. Crush measurements, documented at the sill level by total station, were as follows: C1 = 0 cm, C2 = 6 cm (2.4 in), C3 = 23 cm (9.1 in), C4 = 36 cm (14.2 in), C5 = 14 cm (5.5 in), and C6 = 3 cm (1.2 in). It should be noted that the sill crush was representative of the Event 1

damage, caused solely by the luminaire. WinSMASH could not be used to calculate delta V since impacts with yielding objects are out of scope for the program. However, WinSMASH was used to calculate a barrier equivalent speed of 22 km/h (13.7 mph) based on crush to the sill. The Collision Deformation Classification was 02RPAN3 (50 degrees).

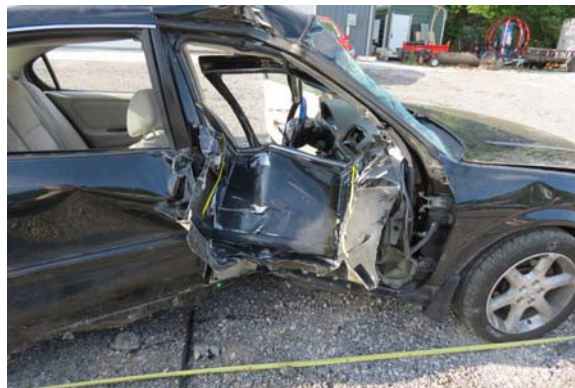
The right plane of the Nissan struck the SKT end terminal. The specific location involved the right front door, the B-pillar, and the leading edge of the right rear door, above the level of the sill. This impact damage overlapped the damage incurred to the right front door from the Event 1 luminaire impact (Figure 8). The direct damage began 74 cm (29.1 in) rear of the right front axle and extended 66 cm (26.0 in) rearward. Maximum crush was estimated at 60 cm (24.0 in) at the mid-level of the door due to separation of the components. The upper hinge of the right front door pulled through the sheet metal frame of the door. The lower hinge and door latch remained intact. The side impact door beam separated from its pocket mount at the aft aspect. Due to the overlapping damage at the door location, this crash event was outside the scope of the WinSMASH program. The Collision Deformation Classification was 03RPEW4 (80 degrees). The extent of the damage was estimated to be severe.

Figure 8. Right plane damage from the guardrail head impact (door sheet metal placed on by researcher)
