DOT HS 813 201

**Special Crash Investigations:
On-Site Alleged Brake Failure
Crash Investigation;
Vehicle: 2015 Nissan Rogue;
Location: Arizona;
Crash Date: October 2020**

Special Crash Investigations
On-Site Alleged Brake Failure Crash Investigation
Office of Defects Investigation
Case Number: DS20016
Vehicle: 2015 Nissan Rogue
Location: Arizona
Crash Date: October 2020

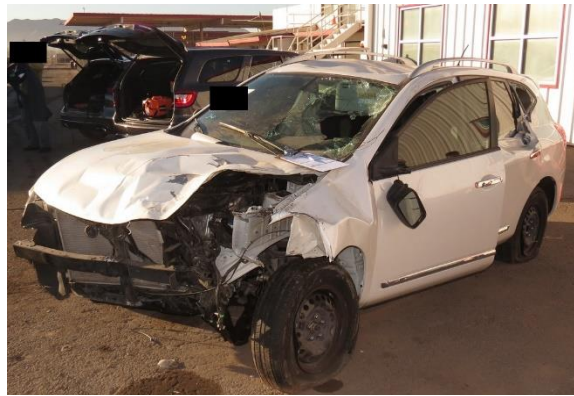
This report documents the on-site investigation of the alleged unintended failure of the brake assembly in a 2015 Nissan Rogue (Figure 1). The vehicle inspection documented the vehicle damage, the restraint system, and the brake pedal assembly. This investigation was initiated by the Office of Defects Investigation in response to a driver notification. The Special Crash Investigations (SCI) group of the National Highway Traffic Safety Administration assigned the case to Dynamic Science, Inc., in October 2020. The vehicle inspection was conducted in November 2020. Representatives from Nissan participated in the inspection. A representative from the involved insurance company and a relative of the driver were present as observers. The vehicle was supported by the Bosch Crash Data Retrieval system, and the Event Data Recorder (EDR) was imaged during the inspection. The brake assembly was removed with the permission of the owner and taken into SCI's possession. It was then shipped to the ODI group for further inspection/analysis. After ODI's part inspection and analysis, there was no defect determination made for the brake pedal assembly. Based on the on-scene, vehicle, and EDR evidence, it is probable that the cause of the crash was pedal misapplication.

Figure 1. The 2015 Nissan Rogue

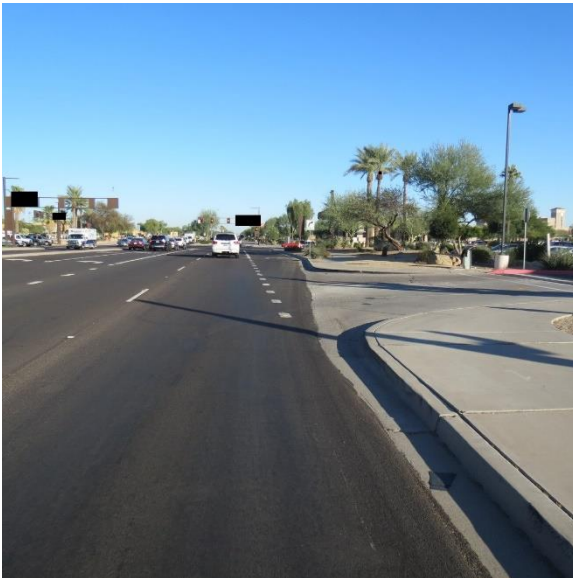
The crash site was in the eastbound lanes of a median-divided 5-lane urban roadway approaching a four-leg intersection (Figure 2). The asphalt roadway was straight and level. The roadway was configured with two left turn lanes, two through lanes, and one right turn lane. The posted speed limit was 64 km/h (40 mph). The roadway was intersected on the right by a two-lane driveway leading into a shopping center. The east curb of the driveway measured 10 cm (3.9 in) in height and was composed of concrete. South of the roadway there was an area of landscaping that included sidewalks, multiple trees and plants, and a gravel surface. The landscaped area was between the main road and a parking lot. Along the path to the tree impact, the landscaped area changed elevations in undulating fashion (Figure 3). The slope measured -14 percent as the path approached the north/south sidewalk and 26 percent as it departed the sidewalk. The height difference between the tops of the slopes and the sidewalk was 49 cm (19.2 in). At 2.5 m (8.2 ft) east of the sidewalk, the slope changed to -17 percent and continued downward to the struck tree. The struck tree measured 20 x 60 cm (7.8 x 23.6 in). The weather at the nearest reporting station was 27 °C (82 °F), 16 percent humidity, winds out of south southeast at 11 km/h (7 mph), and clear. A crash diagram is included at the end of this report.

Figure 2. Eastbound approach, driveway on right

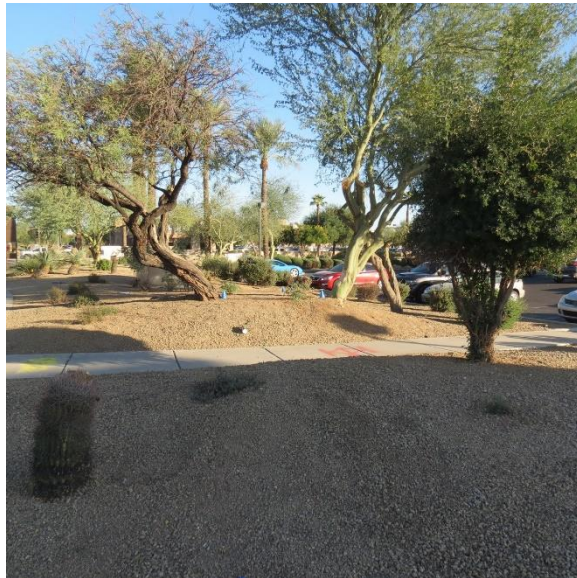
Figure 3. Landscape elevation changes, looking east

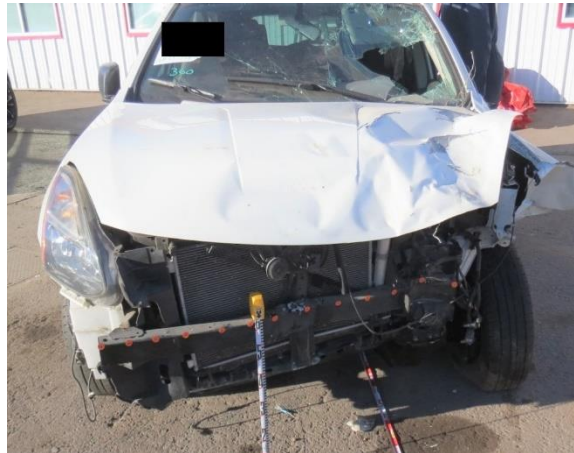
The vehicle sustained front plane damage from the impact with a 20 x 60 cm (7.8 x 23.6 in) tree (Event 5). The direct damage began at the left front bumper corner and extended 36 cm (14.1 in) to the right (Figure 4). The direct contact extended under the reinforcement bar and onto the left engine cradle. Thirteen measurements were taken at the bumper reinforcement bar by the Nikon Total Station, and the Faro Blitz program computed crush measurement in six increments as follows: C₁ = 31 cm (12.2 in), C₂ = 38 cm (14.9 in), C₃ = 32 cm (12.5 in), C₄ = 21 cm (8.2 in), C₅

= 8 cm (3.1 in), and $C_6 = 0$ cm. The maximum crush was located 12 cm (4.7 in) right of the left front bumper corner and measured 38 cm (14.9 in). The CDC was 12FLEE2.

Figure 4. The 2015 Nissan Rogue, front plane damage

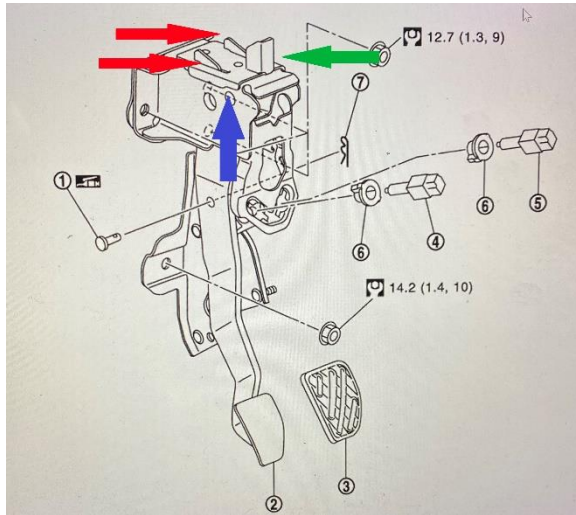
This investigation was initiated in response to a driver notification of an alleged brake failure. The driver reported that she pressed the brake pedal to the floor and that the vehicle did not stop. A relative later provided a video showing that the pedal was moving freely. The brake assembly was removed with the permission of the owner and taken into SCI's possession. It was then shipped to the ODI group. At the time of the SCI inspection, the pedal position was 10 cm (3.9 in) above the floor when pressed forward and 15 cm (5.9 in) above the floor when pulled rearward. The pedal did not return to the fully upward position when released and also was clearly not actuating the brake master cylinder. The brake pedal assembly was attached to the vehicle by four bolts and connected to the pushrod by a cotter pin. The component parts of the assembly include the stop lamp and brake pedal position switches, pedal, slide plate, slide plate horn, sub bracket and sub bracket claws, and main bracket (Figures 5-6).

Figure 5. The 2015 Nissan Rogue, service manual image. Red arrow: sub bracket claws; Blue arrow: slide plate; Green arrow: slide plate horn.

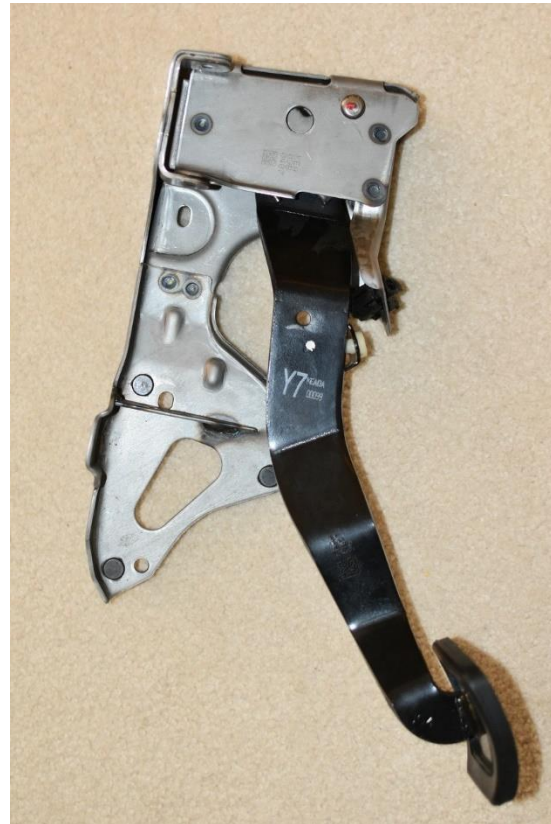
Figure 6. The 2015 Nissan Rogue, brake assembly

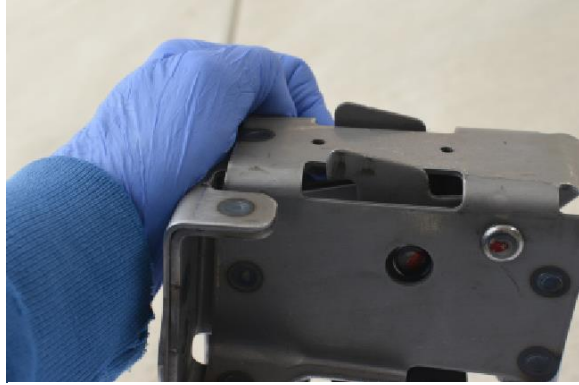
The sub bracket is enclosed in the main bracket and has an internal pivot point. The sub bracket claws extend through the top of the bracket (Figure 7) and then through the slide plate (Figure 8). There is an impact bracket located aft of the assembly at the instrument panel. When a frontal collision causes sufficient damage or intrusion to move the brake pedal assembly rearward, by manufacturer design the slide plate horn comes into contact with the impact bracket thereby pushing the slide plate forward and releasing the sub-bracket claws. Once the sub-bracket claws are released, the pedal can no longer exert a force on the driver's lower leg (or the master cylinder actuation rod) thereby enhancing occupant safety by reducing the risk of lower leg injury (Figure 9). Nissan has indicated that the assembly was equipped with an injury mitigation feature designed to allow the brake pedal arm to rotate and move during a collision and that the feature performed as designed in this crash. Based on this safety design assessment, there was no attempt to manually manipulate the braking system using the pushrod. There was no evidence of fracture to the assembly. The slide plate horn appears to have been deformed during this crash sequence.

Figure 7. The 2015 Nissan Rogue, sub bracket claws

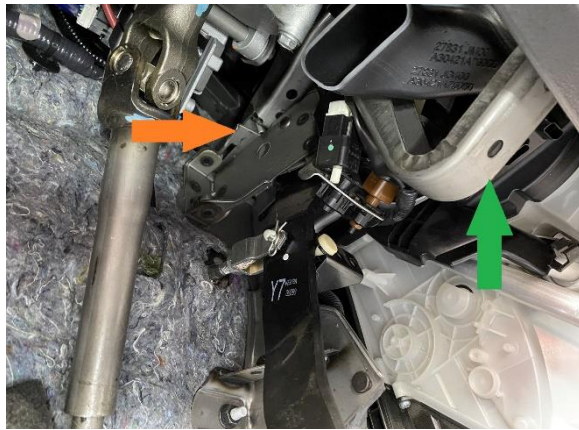
Figure 9. The 2015 Nissan Rogue. Green arrow: impact bracket; Orange arrow: slide plate.

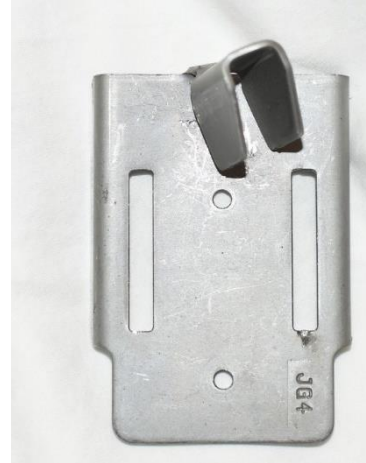
Figure 8. The 2015 Nissan Rogue, slide plate
