DOT HS 813 202

October 2021

# **Special Crash Investigations: On-Site Crash Avoidance Technology Crash Investigation; Vehicle: 2019 Honda Pilot EXL; Location: Florida; Crash Date: December 2019**

**Special Crash Investigations**  
**On-Site Crash Avoidance Technology Crash Investigation**  
**Case Number: CR20002**  
**Vehicle: 2019 Honda Pilot EXL**  
**Location: Florida**  
**Crash Date: December 2019**

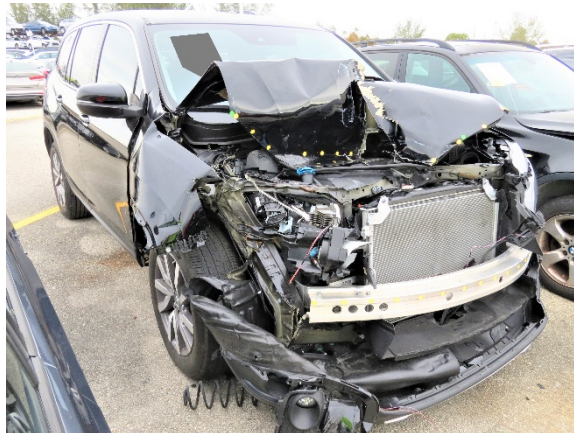
This report documents the on-site investigation of a front-to-rear crash involving a 2019 Honda Pilot EXL (Figure 1) and a 2006 Isuzu NPR single-unit delivery truck. The Honda had several crash avoidance (CA) systems, which included derivations of forward collision warning (FCW) with crash imminent braking (CIB), lane departure warning (LDW) with lane keeping assist, and adaptive cruise control (ACC). The crash occurred while the Honda was following the Isuzu on a limited-access roadway. The Isuzu was traveling at a slower speed than the Honda when it began to decelerate further in response to merging traffic in front of it. The belted 32-year-old female driver of the Honda did not detect the slower moving Isuzu, and the Honda was unable to avoid the crash. The front of the Honda struck and underrode the rear, left corner of the Isuzu. No injuries resulted from the crash.

*Figure 1. Right front oblique view of the Honda*

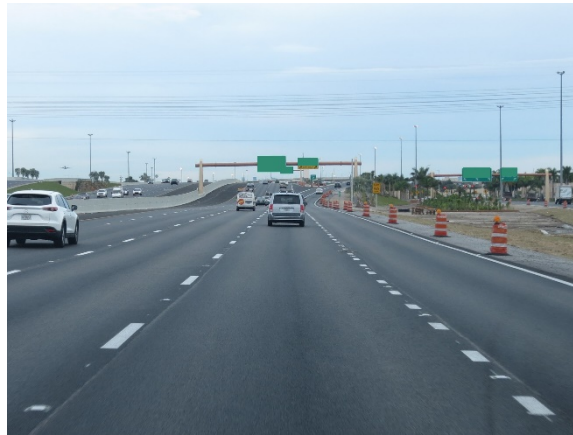
*Figure 2. Eastbound view of the Honda's pre-crash approach to the crash site*

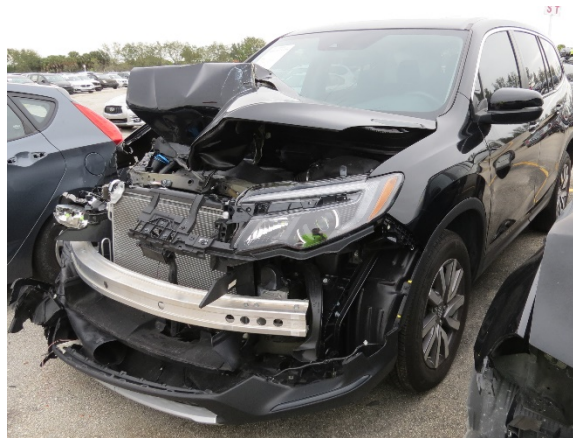
*Figure 3. Left front oblique view of the 2019 Honda Pilot during the SCI vehicle inspection*

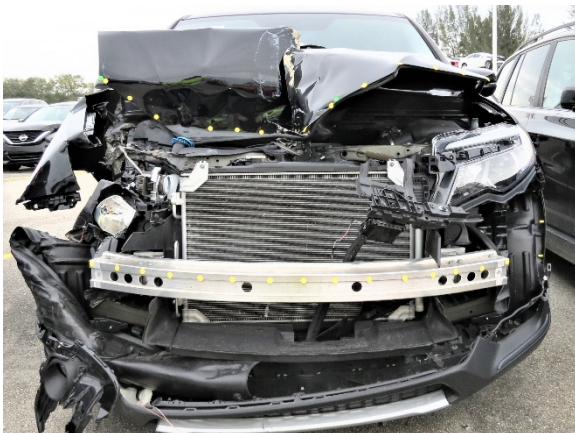
This crash involved the front of the Honda, and the damage pattern resembled an off-set underride profile to the right front aspect of the vehicle. Although the bumper fascia and grille were completely separated from the vehicle, there was no discernable deformation or direct contact to the exposed bumper beam.

Extending almost exactly on the centerline of the vehicle was a distinct tear in the hood, where the right aspect was deformed and swiped rearward by the underside of the Isuzu truck's cargo box body. The right headlight assembly was disintegrated, and the right aspect of the upper radiator support and the right front fender were deformed by the underride impact. Figure 4 shows the damage pattern from a horizontal frontal perspective, while Figure 5 shows the underride front damage profile from an overhead perspective.

*Figure 4. Front plane damage to the Honda as documented during the SCI vehicle inspection*

Direct contact on the hood began directly on the centerline and extended 73 cm (28.7 in) to the right front corner. A residual crush profile was documented to the front bumper beam, with a second profile documented to the leading edge of the Honda's hood. The corresponding direct and induced damage width (Field-L) was 146 cm (57.5 in). There was no crush at bumper level, and, accounting for free-space, the averaged resultant crush profile measurements included: C1 = 0 cm (0 in), C2 = 0 cm (0 in), C3 = 0 cm (0 in), C4 = 26 cm (10.2 in), C5 = 23 cm (9.1 in), and C6 = 18 cm (7.1 in). Maximum crush measured 51 cm (20.1 in) and was observed immediately right of the vehicle's centerline. A corresponding collision deformation classification of 12FZMW4 was assigned to the Honda's front plane damage profile.

The damage algorithm of the WinSMASH model was used to calculate the severity of the crash. The total calculated vehicle velocity change (delta V) was 25 km/h (16 mph), with specific longitudinal and lateral components of -25 km/h (-16 mph) and 0 km/h (0 mph), respectively. Based on SCI expertise and observed vehicle damage, these borderline results were slightly

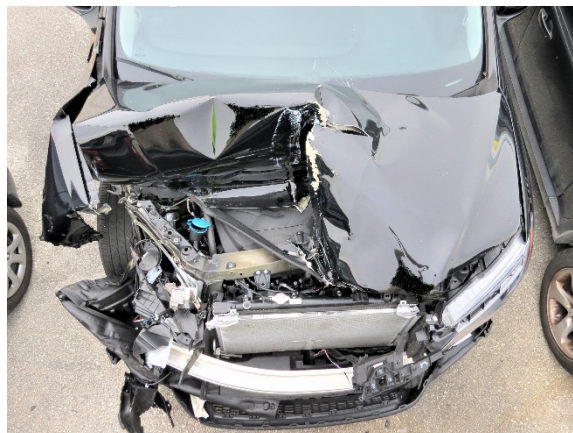
*Figure 5. Underride profile to the Honda's front plane as observed from an overhead perspective*

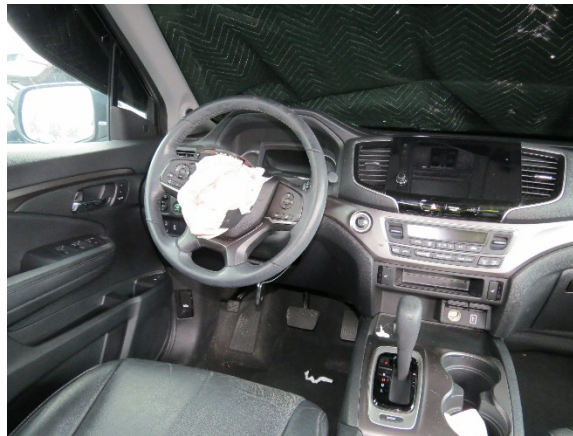
There was no loss of integrity to the interior occupant compartment of the Honda associative to the crash. All doors remained closed and were operational post-crash. Only the windshield was cracked by the displacement of the hood during the underride crash; all other glazing remained intact and was not damaged or contacted by the driver. The only discernable evidence in the Honda’s interior from occupant contact was loading of the seat belt, as described in the Manual Restraint Systems section of this report. There was no discernable occupant contact to interior surfaces of the Honda at the time of the SCI vehicle inspection. Figure 6 shows the driver’s position of the Honda and the surrounding components.

*Figure 6. View of the interior of the Honda during the SCI vehicle inspection*

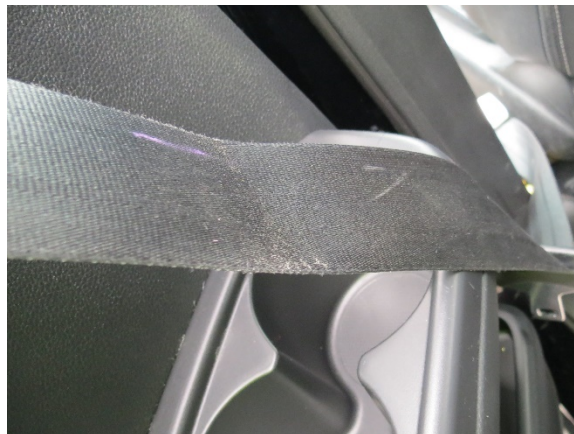
An area of polymer transfer and apparent loading (Figure 7) was observed from 76-81 cm (29.9-31.9 in) below the D-ring. The SCI investigator also observed a polymer transfer on the webbing from the D-ring. There was 152 cm (59.8 in) of exposed webbing, representative of an excess of 90 cm (35.4 in) in comparison with the length of exposed webbing when the system was stowed (measurement comparison with unused/stowed right front system). Based on the post-crash condition of the driver's seat belt system, it was apparent that the driver was belted at the time of the crash.

*Figure 7. Latch plate loading evidence on the driver's seat belt system in the Honda*

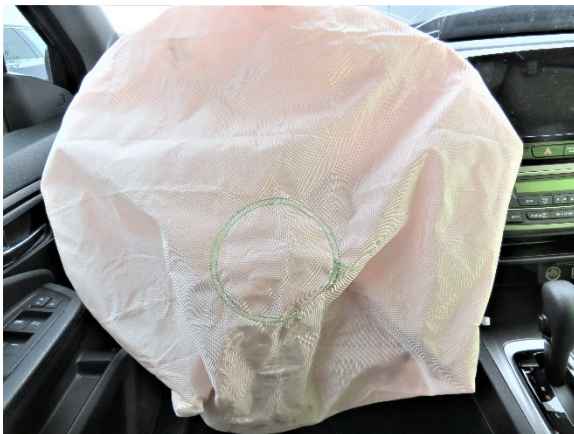
The driver's frontal air bag deployed from the steering wheel hub-mounted module and through the cover flaps without damage. In its deflated state, the driver's frontal air bag measured approximately 60 cm (23.6 in) in overall diameter. It had an 11 cm (4.3 in) wide circular center stitch pattern, to which internal tethers were affixed. The air bag was vented on its rear aspect by a pair of 4 cm (1.6 in) diameter vent ports, located at the 11 o'clock and 1 o'clock positions. There was no discernable occupant contact evidence or other crash-related damage to the Honda's deployed driver's frontal air bag. The Honda's right IC air bag deployed downward from the roof side rail mounting location through the edge of the headliner. It extended the full length from the right A-pillar to the right D-pillar and provided outboard protection for the full glazing height from the roof side rail to below the beltline. A fabric tether attached the lower aspect to the A-pillar.

*Figure 8. View of the deployed driver's frontal air bag in the Honda at the time of the SCI inspection*

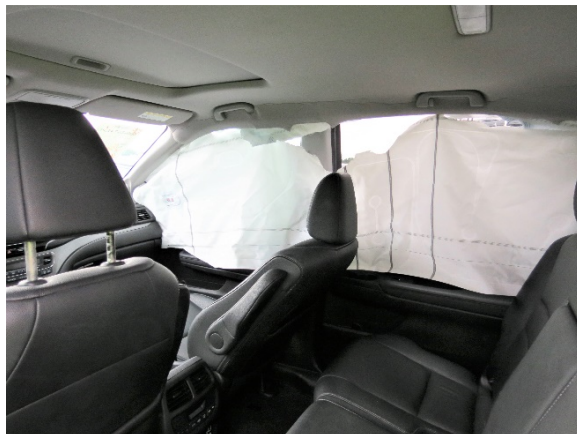
The right IC air bag had been cut post-crash by an unknown individual, presumably to gain unobstructed access to the vehicle's interior. There was no discernable occupant contact to the right IC air bag. Figure 8 shows the deployed driver's air bag at the time of the SCI inspection, while Figure 9 shows the deployed right IC air bag.

*Figure 9. View from the second row of the deployed right IC air bag in the Honda*

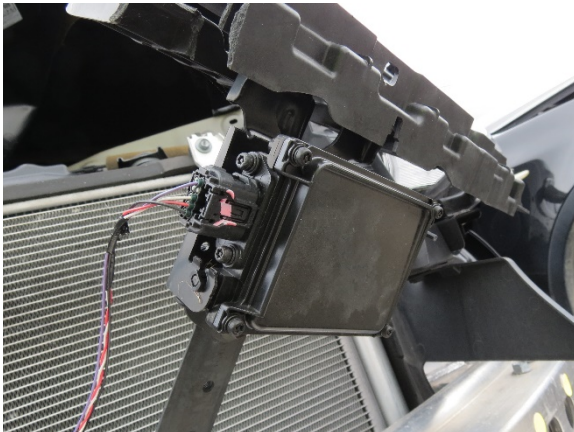
The Honda was equipped with several crash avoidance (CA) systems that were designed to assist/support the driver in both avoiding a potential crash and/or reducing the severity of a crash event should a collision become imminent. The Honda's CA systems used two distinct sensors to support their functionality, including a radar sensor and an optical camera sensor. The radar sensor was located in the front grille (Figure 10), while the optical sensor was located on the interior of the windshield in front of the rearview mirror (Figure 11).

*Figure 10. View of the Honda's front radar sensor for the FCW system*

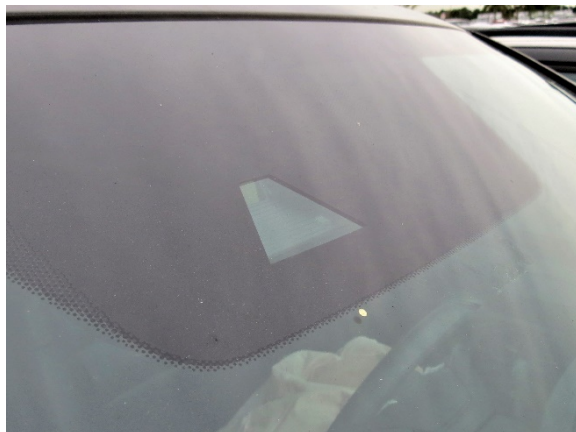
*Figure 11. View of the Honda's optical sensor for the FCW and LDW systems*

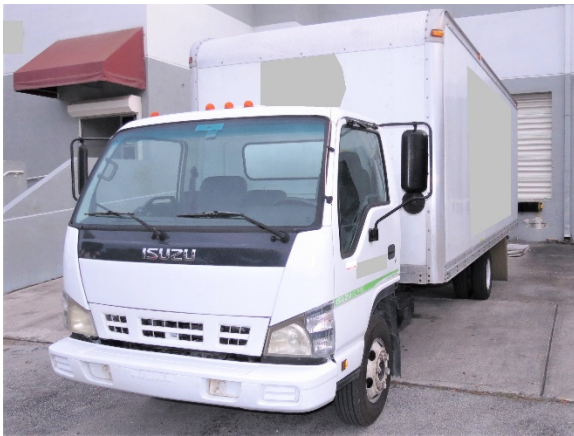
The 2006 Isuzu NPR (Figure 12) was identified by the VIN JALB4B16867xxxxxx. It was a single-unit straight truck with a 447 cm (176.0 in) wheelbase. It was powered by a 5.2-liter, inline, 4-cylinder, diesel engine. The truck had a 6.1 m (20.0 ft) long enclosed cargo box 244 cm (96.0 in) wide and 213 cm (84.0 in) tall. The bottom of the cargo box was approximately 86 cm (34.0 in) above ground level. The truck was configured for local delivery and transport; it was not used for long-distance operation. It had a GVWR of 6,350 kg (14,000 lb).

*Figure 12. Left front oblique view of the 2006 Isuzu NPR truck at the time of the SCI inspection*

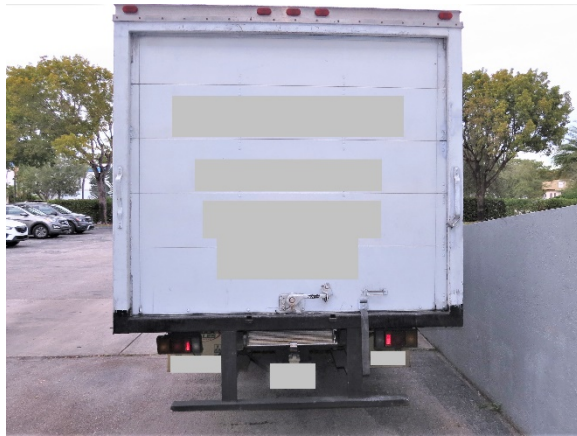
*Figure 13. Back plane view of the Isuzu truck*

The Isuzu truck was inspected at the facility of its owner. Figure 13 shows the back plane of the Isuzu. According to the owner, the rear impact guard of the truck had been “repaired” following the crash. However, the SCI investigator observed that the left taillight assembly was held in place by plastic ties, and there were minor scratches in the matte black paint. Additionally, the surface rust and color of the underride guard and rear plane components matched the surface rust and color of the overall vehicle and body. It was apparent to the SCI investigator that the truck had not sustained significant damage and that no work had been done to the truck since the crash, with the exception of using plastic ties to hold up the left taillight. Based on the dimensional height of the Isuzu and its back plane, the height of the bottom of the rear underride guard was higher in relation to the height of the bumper beam of the Honda. That is, the bumper beam of the Honda and the underride guard of the Isuzu were not in dimensional alignment.

The measurements obtained by the SCI investigator indicated that the Honda’s front bumper beam would have passed directly below the Isuzu’s rear underride guard when the crash occurred. This further supported the SCI investigator’s conclusion that no repair to the Isuzu had occurred.

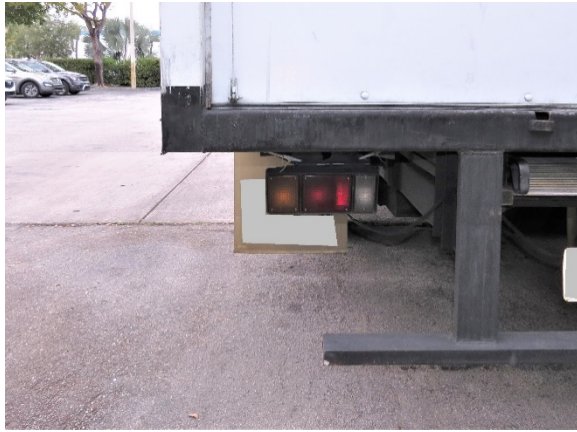
Figure 14 is a close-up of the area of impact to the Isuzu by the Honda, while Figure 15 shows the undercarriage and unrepaired left taillight. Note the scratching on the lower left edge of the underride guard in Figure 14, and the uniformity of the coloration and rust to the underride guard, sill, undercarriage, and frame in Figure 15.

*Figure 14. Area of impact to the rear plane of the Isuzu*

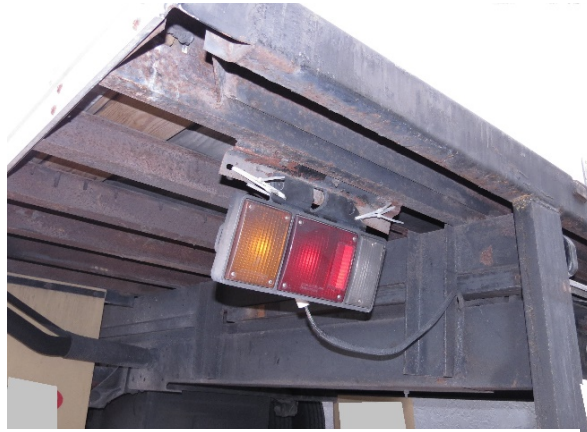
*Figure 15. Damaged left rear taillight of the Isuzu*
