DOT HS 813 203

**Special Crash Investigations:  
On-Site Alleged Unintended  
Acceleration Crash Investigation;  
Vehicle: 2009 Toyota Camry;  
Location: Maryland;  
Crash Date: October 2017**

**Special Crash Investigations**  
**On-Site Alleged Unintended Acceleration Crash Investigation**  
**Office of Defects Investigations**  
**Case Number: CR17035**  
**Vehicle: 2009 Toyota Camry**  
**Location: Maryland**  
**Crash Date: October 2017**

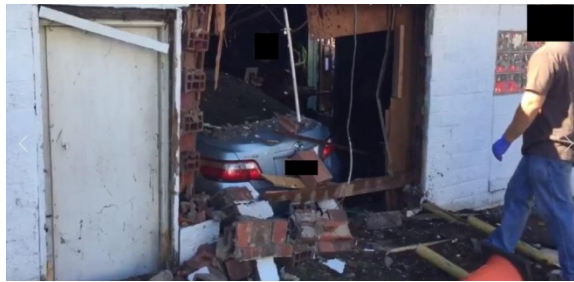
The interest in this on-site investigation was the alleged unintended acceleration (UA) of a 2009 Toyota Camry that departed a roadway and then penetrated a restaurant (Figure 1), resulting in the fatality of a 73-year-old male patron. The 55-year-old female driver of the Toyota initially claimed a brake malfunction as a causal factor for the crash. After the police brake-inspection ruled out a malfunction as a causal factor, the driver then alleged that an unintended acceleration caused the crash.

*Figure 1. East-facing view of the Toyota at final rest in the commercial building. (Image obtained from an internet news source)*

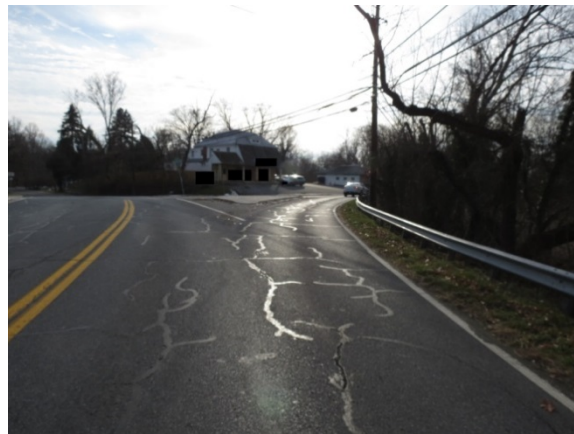
The crash occurred on the roadside adjacent to a three-leg Y-intersection in a suburban area during daylight (Figure 2). At the time of the crash, the National Weather Service reported clear conditions with a temperature of 21.4 °C (70.5 °F), 58 % humidity, and winds out of the south-southwest at 24 km/h (15 mph). The driver approached the crash site traveling south on a two-lane road that was posted with a 64 km/h (40 mph) speed limit. She attempted a right turn onto the intersecting road that also was composed of two lanes. A designated right turn lane transitioned southbound traffic onto the intersecting roadway. The curved turn lane was 4.3 m (14 ft) in width. A yield sign was posted at the end of the turn lane to regulate traffic flow with any northbound left-turning traffic that would proceed westbound on the roadway. A curbed concrete gore separated the westbound lane of the intersection from the southbound right turn lane. A second curbed gore separated the eastbound lane of the intersecting roadway from a designated right turn lane onto the southbound travel lanes. Located beyond the intersecting street at the south roadside was a large asphalt-surfaced parking lot that serviced two commercial buildings. The grade of the parking lot immediately south of the intersecting roadway was +7% percent. This physical plant is depicted on the Crash Diagram included at the end of this report.

*Figure 2. Southwest trajectory view of the Toyota's approach to the crash site*

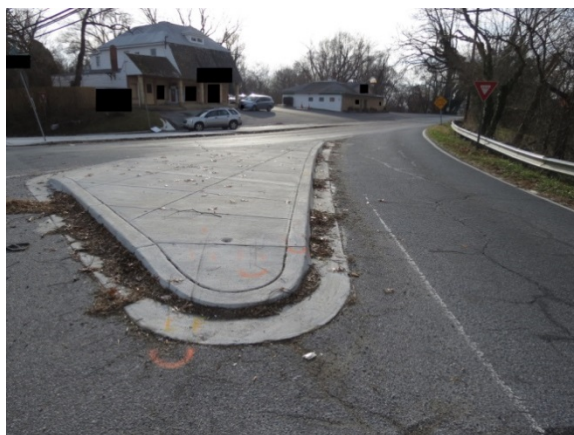
The left front tire of the Toyota entered the curb cutout at the concrete gore located at the southwest corner of the intersection. As the Toyota continued on a southwesterly trajectory, the front center undercarriage contacted the concrete surface of the gore (Event 1). The right front tire and alloy wheel subsequently struck and overrode the 15 cm (6 in) curb of the gore, causing a probable air-out of the tire (Event 2). The rear tires tracked over the front tires as the Toyota traversed the gore and crossed the west and eastbound lanes of the intersecting roadway.

*Figure 3. Southwesterly view of the intersection and the initial gore impacts, Events 1 and 2*

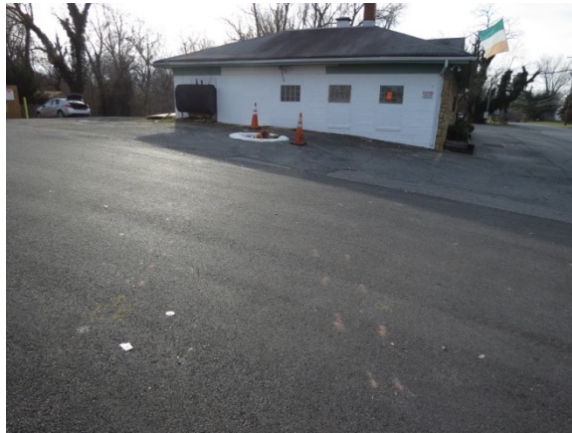
The Toyota traveled approximately 27 m (88.6 ft) across the parking lots on a trajectory toward the east wall of the restaurant (Figure 4). The front plane of the Toyota struck and displaced three concrete-filled pipe bollards (Events 6, 7, and 8) that protected a pad-mounted heat pump. These impacts did not alter the trajectory of the vehicle. As the Toyota continued forward, the front plane struck the heat pump (Event 9). These fixed-object impacts were closely spaced and within 1 to 1.5 m (3 to 4 ft) of the building. The full front plane of the Toyota struck and penetrated the block wall of the building (Event 10). The EDR-recorded speed of the Toyota at impact with the building was 82 km/h (51 mph).

*Figure 4. West-facing view of the Toyota's rotating tire marks (paint highlights) en route to impact with the bollards and the building*

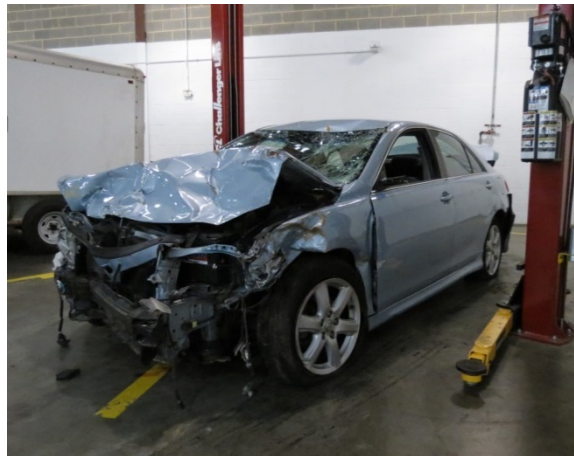
The exterior of the Toyota sustained damage to the undercarriage, front, top, and both side planes from this multiple event crash. The most severe damage occurred from impacts with the bollards, heat pump, and the wall of the building, Events 6 to 10. The direct-contact damage across the front plane could not be isolated for each event; therefore, a singular damage profile was documented for the front plane damage (Figure 5). Direct-contact damage was distributed across the full width of the bumper fascia with multiple fractures of the fascia and separation of the left aspect. The bumper beam was crushed, which yielded a combined direct and induced damage length of 114 cm (45 in) extending from corner to corner. Maximum crush was 34 cm (13.5 in) located 29 cm (11.5 in) right of the vehicle’s centerline. A crush profile documented at the level of the bumper beam was as follows: C1 = 6 cm (2.3 in), C2 = 13 cm (5.0 in), C3 = 20 cm (8.0) in, C4 = 27 cm (10.8 in), C5 = 29 cm (11.5 in), and C6 = 23 cm (9.0 in). The severity of the combined impact calculated by the WinSMASH program was 31 km/h (19 mph). The longitudinal and lateral components of the delta V were -29 km/h (-18mph) and -10 km/h (-6 mph), respectively. This calculation was considered borderline due to the overlapping damage.

*Figure 5. Front left oblique view of the damage to the 2009 Toyota*

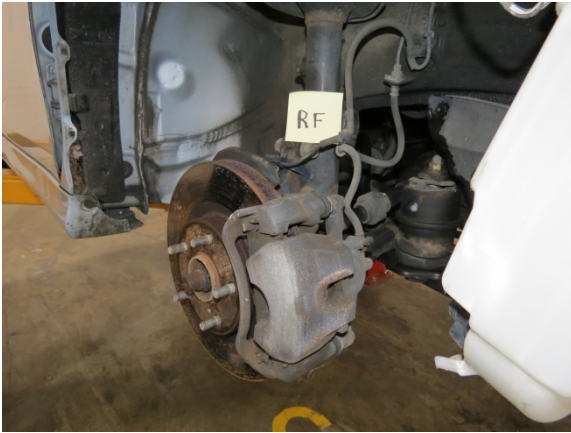
During the joint SCI and Toyota inspection conducted in December 2017, the braking system was again thoroughly examined and documented. Figure 6 is a view of the right front brake assembly. The brake fluid reservoir of the master cylinder was full to the full level line. Pumping of the brake pedal without vacuum assist yielded firm pedal pressure. Three of the four tires and wheels were removed from the Toyota. A lug nut at the right rear position was rounded off; therefore, it could not be removed without destructive efforts. A thorough inspection of the brake calipers, slides, brake pads, and lines was conducted at each wheel position. There were no fluid leaks in the system. All calipers moved freely on the slides. The rotors were free of scoring. The front axle brake pads measured 10 mm (0.4 in) in thickness. The pads at the left rear position measured 5 mm (0.2 in). The outer pad at the right rear position measured 4 mm (0.15 in).

*Figure 6. Right front brake assembly of the Toyota*

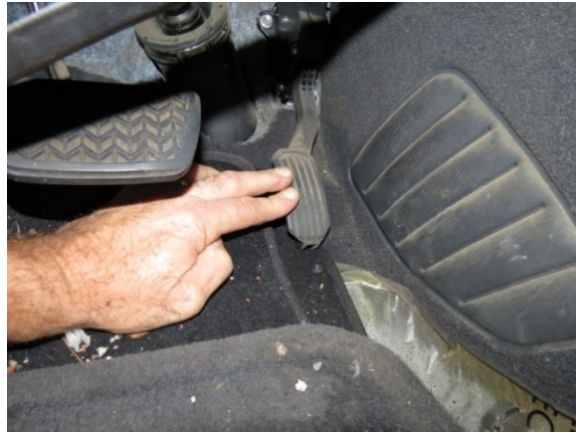
The Toyota was equipped with a Denso electronic accelerator pedal and a conventional brake pedal that was connected to a linkage arm direct to the vacuum booster unit of the power-assisted brake system. The Denso pedal in this 2009 Toyota was subjected to an earlier NHTSA/Toyota recall and had been serviced. The lower aspect of the accelerator pedal was cut off and rounded to prevent interference and capturing by floor mats. The overall length of the pedal was 9 cm (3.4 in) with a width of 4 cm (1.6 in). The pedal was fully depressed during the inspection, and it did not engage the carpeted floor mat or OEM carpeting (Figure 7).

*Figure 7. Recall-modified Denso accelerator pedal fully depressed against the carpeted floor mat*

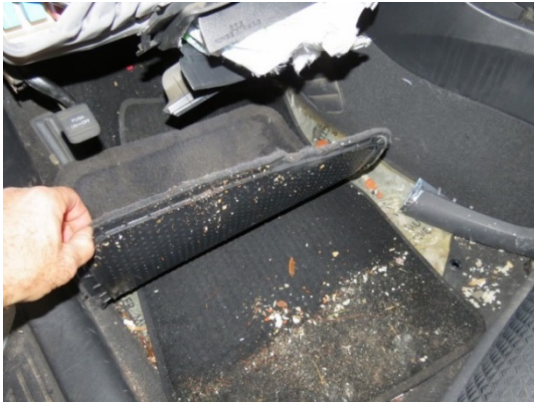
The driver of the Toyota operated the vehicle with three loosely installed aftermarket floor mats in the front left position (Figure 8). The vehicle was equipped with pins in the OEM carpet to secure OEM-type floor mats. These pins were not used as the aftermarket mats did not contain holes for the pins.

Installed over the OEM carpet was a stick-down plastic film that was installed to protect the OEM carpet prior to sale. It was suspected that this plastic film was installed prior to the auction sale of November 23, 2009. The three aftermarket mats consisted of a carpeted bottom mat that measured 64 cm (25 in) in length x 42 cm (16.5 in) at the widest point and 35 cm (13.8 in) at the opposite end. The wide portion of this mat was positioned forward at the toe pan. This mat was on top of the plastic temporary protectant film. The middle aftermarket mat was a sister mat to the bottom mat but reversed in orientation with the narrow portion at the toe pan. The third mat measured 44 cm (17.25 in) square and was positioned with two-thirds of the mat on the floor pan and the forward third on the toe pan. These mats did not interfere with the operation of the recalled and modified accelerator pedal.

*Figure 8. Driver floor mats of the Toyota*

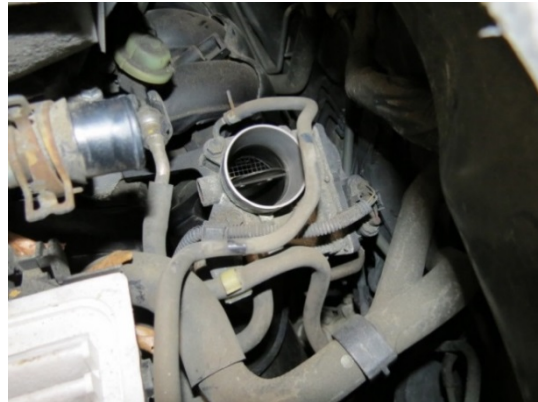
*Figure 9. Throttle plate of the Toyota fully open during the check-out*

The air box was removed from the engine compartment to view the position and observe the status of the throttle body. The initial observation of the throttle plate was in the fully closed position. Toyota representatives tested the status of the throttle. With the ignition key turned to the run-position, the system does a self-diagnostic check and rapidly opens (Figure 9) and closes the throttle plate. The system operated properly during this check-out.
