DOT HS 813 215

**Special Crash Investigations:
On-Site Air Bag Non-Deployment
Crash Investigation;
Vehicle: 2014 Chevrolet Traverse;
Location: New York;
Crash Date: November 2017**

Special Crash Investigations
On-Site Air Bag Non-Deployment Crash Investigation
Office of Defects Investigation
Case Number: CR17032
Vehicle: 2014 Chevrolet Traverse
Location: New York
Crash Date: November 2017

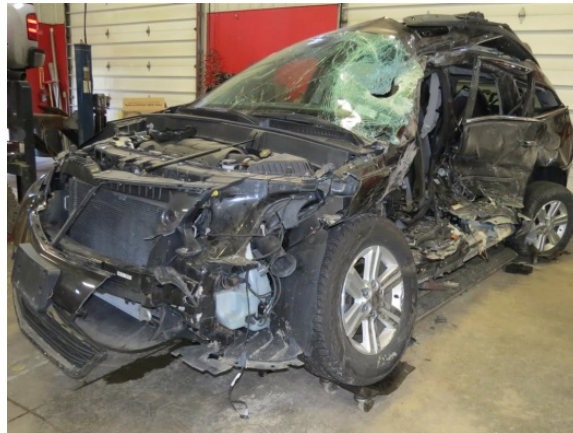
This report documents the on-site investigation of the non-deployment of the air bag systems in a 2014 Chevrolet Traverse (Figure 1) and the fatality of its belted 56-year-old female driver. The Chevrolet was involved in a left-side-impact crash when it initiated a left turn across the southbound trajectory of a 2005 Mack three-axle dump truck and was struck by its front plane. The Chevrolet was equipped with front seat belt pretensioners, Certified Advanced Compliant (CAC) frontal air bags, front seat-mounted side impact air bags, roof side rail-mounted inflatable curtain (IC) air bags, and a driver seat-mounted center air bag (intended to mitigate front row occupant-to-occupant interaction). None of the Chevrolet's supplemental restraint devices actuated or deployed in the crash.

Figure 1. Oblique left side view of the Chevrolet Traverse

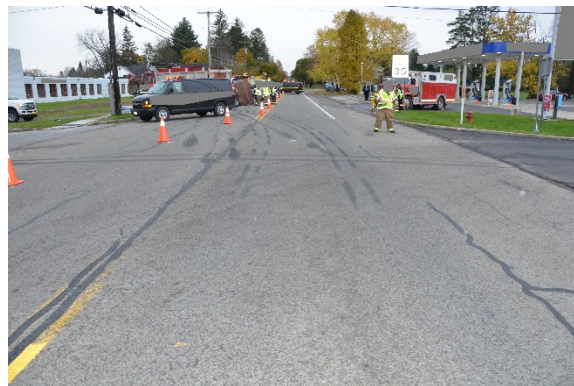
The SCI reconstruction of the crash determined that the Chevrolet was approximately 35 degrees into its left turn when the left plane of the Chevrolet was struck by the front plane of the Mack in a 10/12 o'clock impact configuration (Event 1). The impact was approximately centered in the area of the Chevrolet's left B-pillar. Tire marks from both vehicles (Figure 4) evidenced the location of the impact.

Figure 4. South-facing on-scene image depicting the vehicles' post-impact tire marks (on-scene law enforcement image)

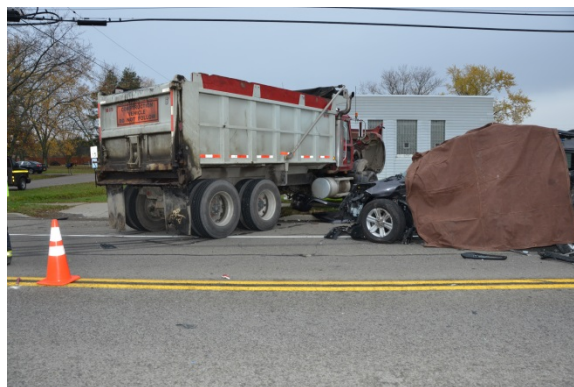
The front of the Mack departed the east edge of the roadway and struck a “No Parking” sign, shearing the non-breakaway post at ground level (Event 2). The Mack came to final rest facing southeast and straddling the east road edge, with its center of mass approximately 30.2 m (99.1 ft) southeast from its impact location. Figure 5 is an on-scene law enforcement image depicting the final rest positions of the vehicles.

Figure 5. East-facing view of the vehicles at final rest (on-scene law enforcement image)

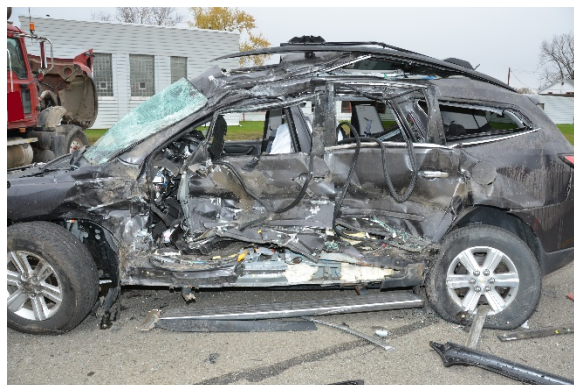
Figure 7. On-scene view of the left plane impact damage to the 2014 Chevrolet Traverse, prior to the removal of the left front door (image provided by the investigating law enforcement agency)

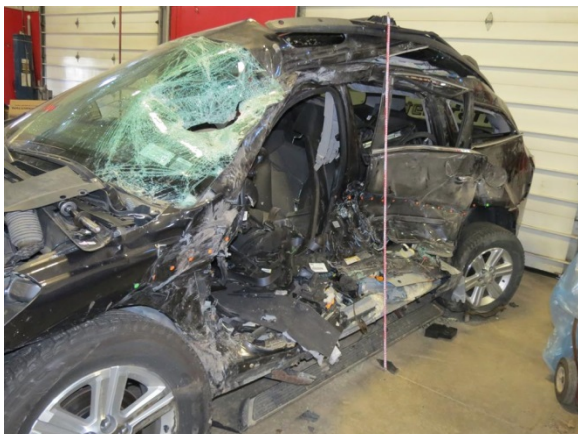
The Chevrolet sustained left plane damage consistent with the crash. Direct contact began 15 cm (5.9 in) aft of the left front axle and extended 282 cm (111.0 in) rearward. It ended 4 cm (1.6 in) aft of the left rear axle position. The left A-, B-, and C- pillars were directly involved in the impact damage. The left front door of the Chevrolet was removed from the vehicle during the law enforcement's vehicle inspection. On-scene images shown that the latch and striker had remained engaged during the crash; however, the hinges had separated at the A-pillar due to overload (Figure 7). A crush profile documented during the SCI inspection using a Nikon Nivo 5M+ Total Station produced the following resultant measurements: C1 = 8 cm (3.1 in), C2 = 48 cm (18.9 in), C3 = 66 cm (26.0 in), C4 = 52 cm (20.5 in), C5 = 33 cm (13.0 in), and C6 = 9 cm (3.5 in). Figure 8 shows an oblique view of the damage profile while Figure 9 shows the

overhead view of the damage profile. The Collision Deformation Classification (CDC) assigned to the left damage pattern was 10LDAW4.

Figure 8. Oblique left view depicting the impact deformation of the Chevrolet

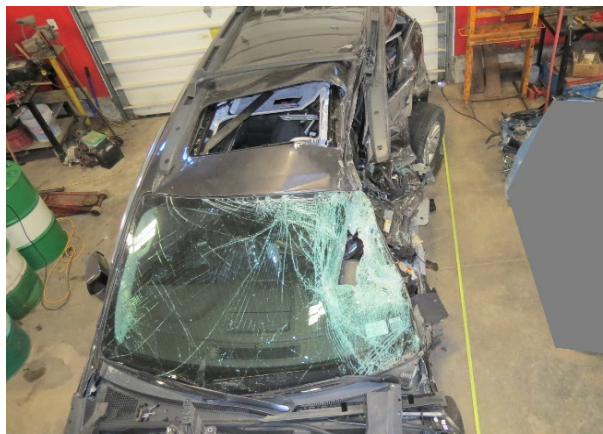
Figure 9. Overhead perspective view of the impact damage pattern to the left plane of the Chevrolet

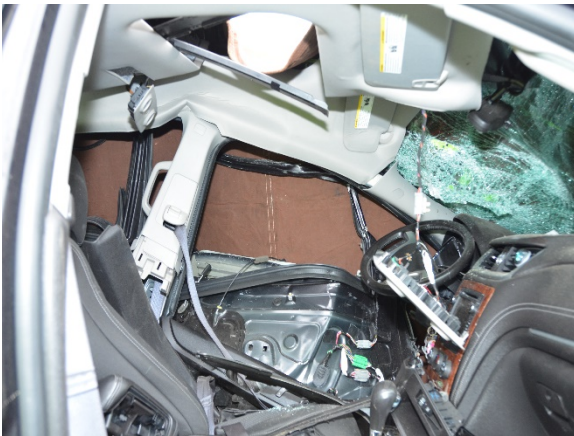
The interior of the Chevrolet sustained moderate-to-severe intrusion at the driver’s position as a result of the impact. Spot welds along the left plane structure released from overload, which separated the floor pan and lower aspect of the B-pillar from the sill. Significant intrusion of the driver’s door, sill, and B-pillar displaced the floor, left instrument panel, steering wheel, and driver’s seat to the right. The intruded left plane components (Figure 10) deformed the driver’s seat and fractured the steering wheel adjustments. The instrument panel was compressed laterally at least 13 cm (5.1 in) by the intrusion (Figure 11), and the right displacement of the driver’s seat deformed the center console.

Figure 10. Left-facing view of the intruded driver’s door prior to its removal (image provided by the investigating law enforcement agency)

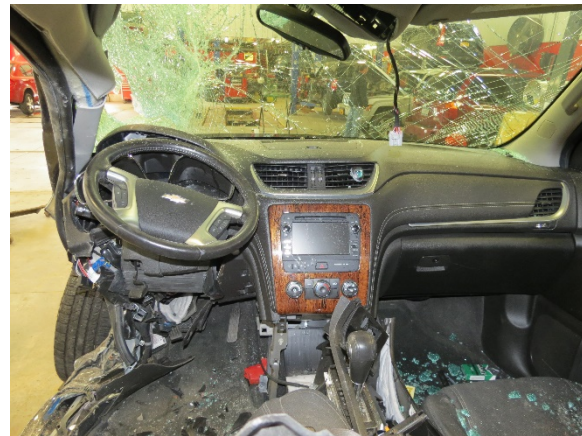
Figure 11. Forward-facing view of the deformed steering wheel and left A-pillar/left instrument panel deformation at the time of the SCI inspection

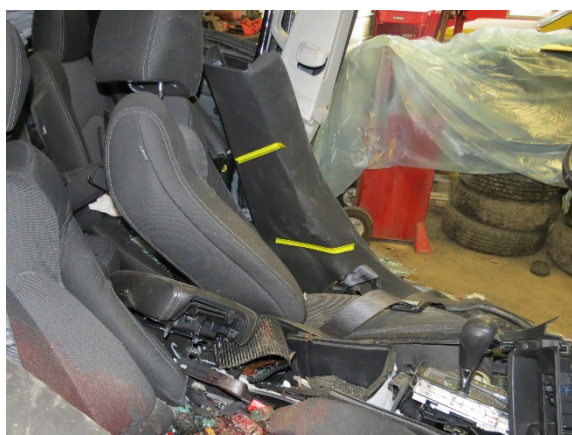
The severe intrusion of left side components resulted in direct contact with the driver and her displacement to the right during the impact engagement. Although completely fractured by the crash forces, the interior panel of the left door was directly contacted with the driver's left flank. The driver's left chest and left abdomen also contacted and loaded the interior fascia of the left B-pillar. This contact was highlighted and documented during the SCI vehicle inspection. Intrusion of left side components displaced the driver's seat cushion to the right, and also displaced the seat back rearward and to the right while rotating it counterclockwise. The driver's seat back also engaged and deformed the center console. Figure 12 shows the driver's contact to the left B-pillar, as well as the deformation and displacement of the driver's seat as observed during the SCI vehicle inspection.

Figure 12. Interior image depicting the driver's seat belt in the Chevrolet

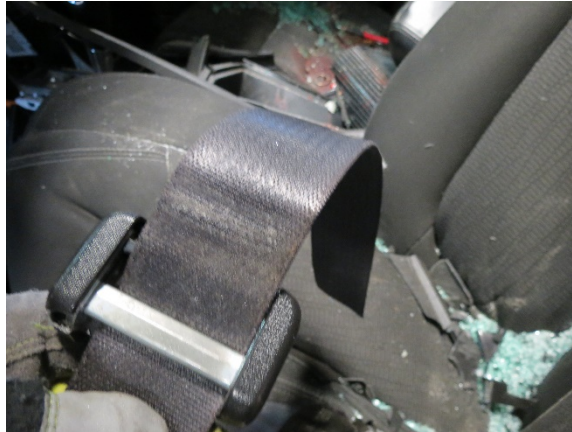
At the time of the SCI inspection, the driver's seat belt was found cut into several pieces and lying loosely on the driver's seat. The latch plate remained engaged in the buckle stalk with a 48 cm (18.9 in) section of webbing through the belt path. Examination of the webbing remnants revealed striations and evidence of loading throughout its exposed length. A distinct area of

abrasions from the latch plate (Figure 13) was also observed. It was apparent the driver was belted at the time of the crash, based on the observations of the SCI inspection in conjunction with the data imaged from the vehicle's EDR and the on-scene images taken by the law enforcement agency during their documentation of the crash.

Figure 13. Interior image depicting the driver's seat belt in the Chevrolet

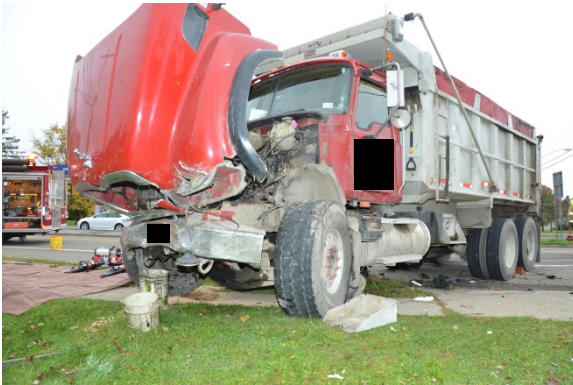
Figure 14. Left front oblique view of the Mack at final rest (on-scene law enforcement image)

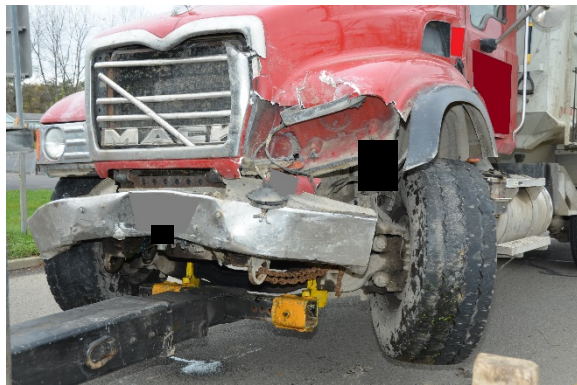
On-scene law enforcement images showed damage across the full width of the Mack's front bumper, extending vertically onto the hood. The left aspect of the hood, left headlamp assembly, and center grill were fractured, with visible deformation to the front bumper beam (Figure 15). The left front axle was displaced rearward an estimated 10 cm (4 in). Based on a review of the images of the Mack, the CDC assigned to the damage pattern was 12FDEW1.

Figure 15. View of the Mack's front plane damage pattern (on-scene law enforcement image)

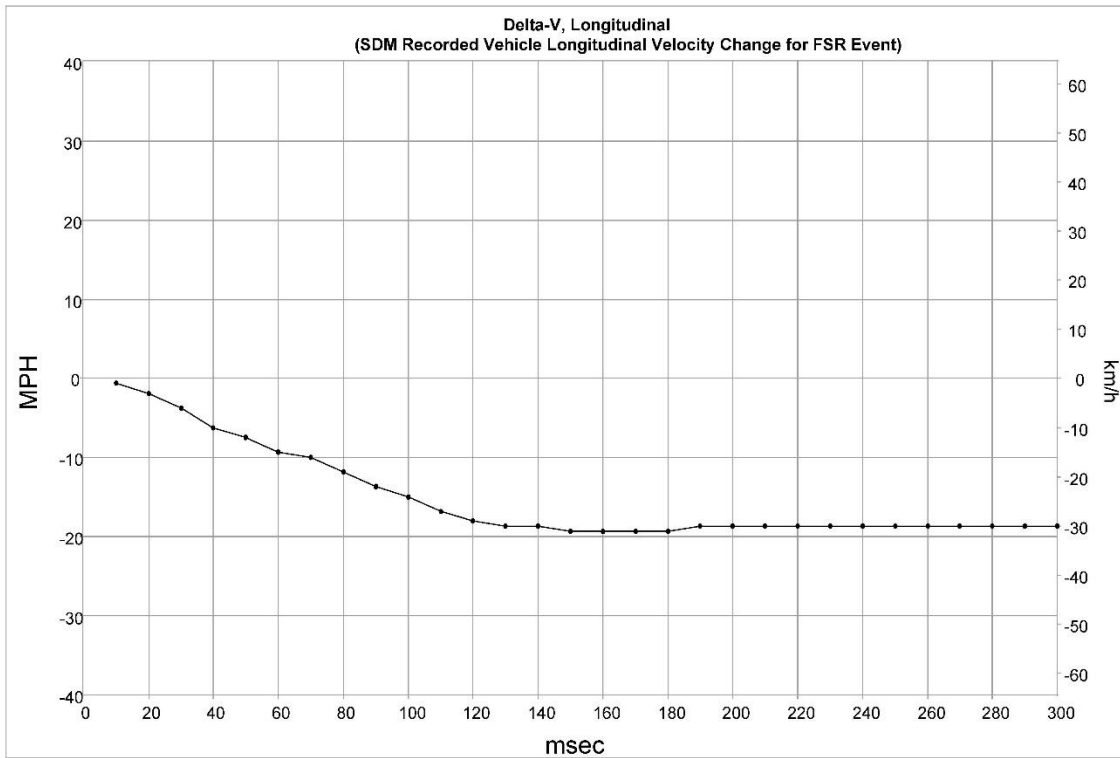
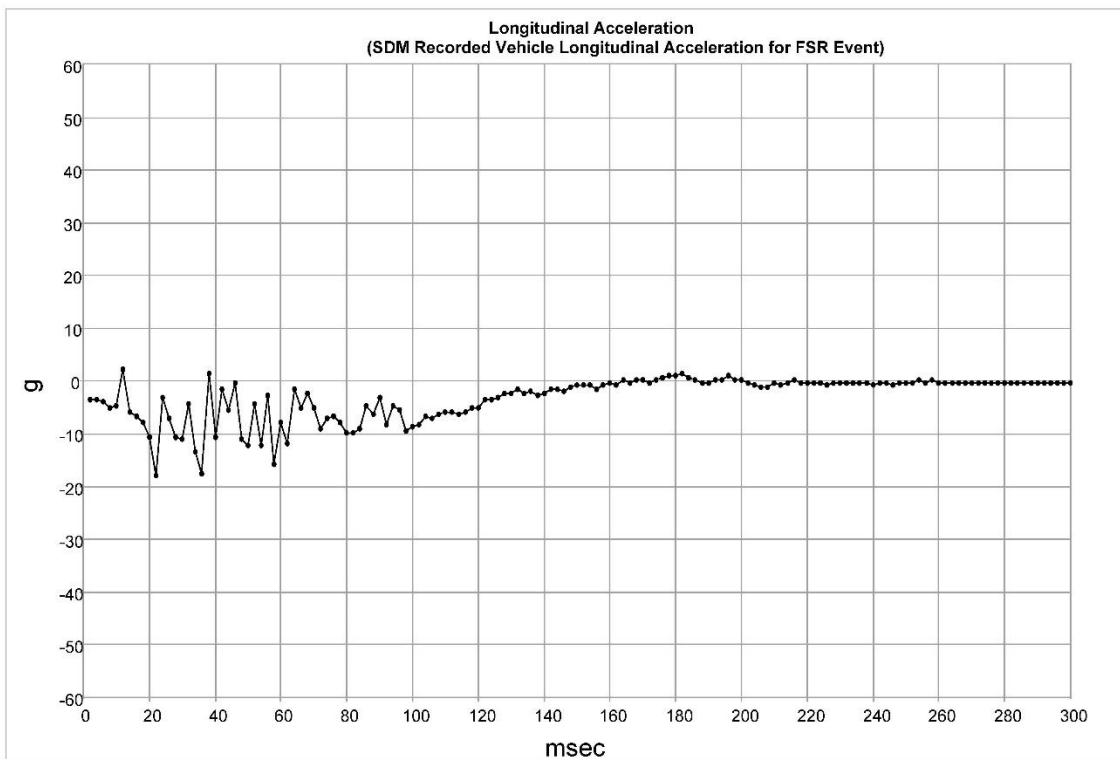
Longitudinal Crash Pulse (Event Record 2)

This non-deployment event occurred and was recorded on ignition cycle 7,395. It was consistent with the dynamics of the side impact crash that was the subject of this investigation. At the time of event recording, the driver’s seat belt was buckled, and the air bag warning lamp was off. There were no active DTCs. The event was indicated as an OnStar Notification (post-collision emergency system) event.

The front, side, and rollover algorithms of the module were active for the event; however, there was no command issued by the SDM for either pretensioner actuation or air bag deployment. The maximum recorded longitudinal delta V was -31 km/h (-19 mph) at 162 milliseconds, and the maximum recorded lateral delta V was 59 km/h (37 mph) at 182 milliseconds. The reported pre-crash vehicle parameters associated with Event Record 2 were as follows:
