**National Highway
Traffic Safety
Administration**

DOT HS 813 222

**Special Crash Investigations:
On-Site Guardrail End Terminal
Crash Investigation;
Vehicle: 2007 Pontiac G5;
Location: Missouri;
Crash Date: January 2017**

Special Crash Investigations
On-Site Guardrail End Terminal Crash Investigation
Case Number: IN17010
Vehicle: 2007 Pontiac G5
Location: Missouri
Crash Date: January 2017

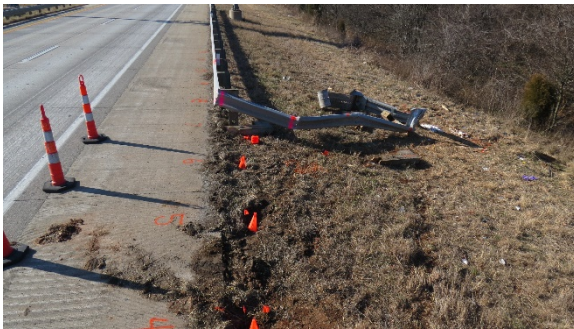
Figure 1. The damaged guardrail and guardrail head, view west

The front plane impact of the Pontiac to the SKT extruded 2.0 m (6.6 ft) of guardrail to the field side (Figure 9) and damaged and displaced seven wooden posts. The full height and width [71 cm (27.9 in) and 38 cm (14.9 in)] of the face of the SKT was directly damaged. The guardrail was displaced from posts 1 to 6, which were fractured and separated from the ground. Post 7 was slightly displaced in the ground but remained secured to the guardrail. The bolts at posts 7 to 9 remained secured to the guardrail. The bolts at posts 10 and 11 were pulled through the guardrail. It's not known if the displacement of the bolts at posts 10 and 11 was related to the assembly or movement of the guardrail during the crash. The guardrail was kinked in seven locations. Five of the kinks were in the first section of guardrail with the remaining two kinks occurring in the second section of guardrail. The width of the feeder channel at the impact head was 10 cm (4.0 in) and the guide chute exit height was 38 cm (15.0 in). The connection of the feeder channel to the head was not damaged and the anchor cable was present but disconnected from its anchor. The "In-Service End Treatment Evaluation Data Collection Form" is attached to the end of this report as Appendix A.

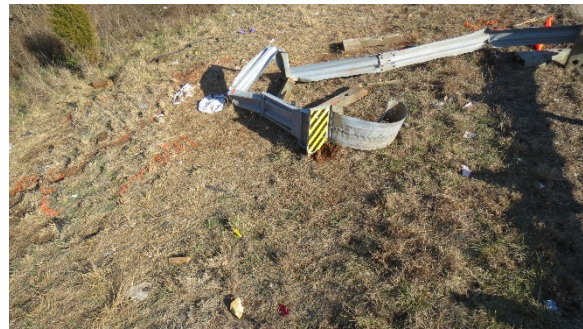
Figure 2. The damaged guardrail and guardrail head, view east

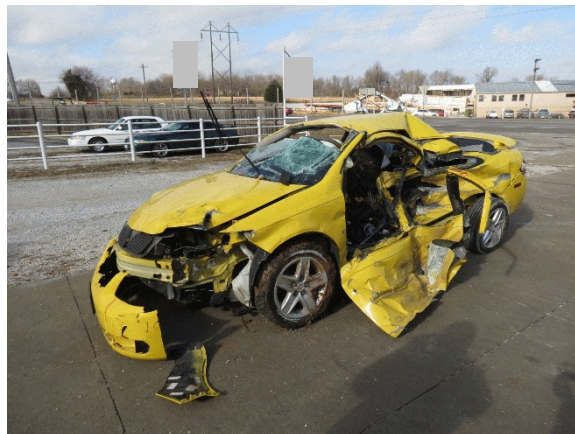
Figure 3. The damaged 2007 Pontiac G5

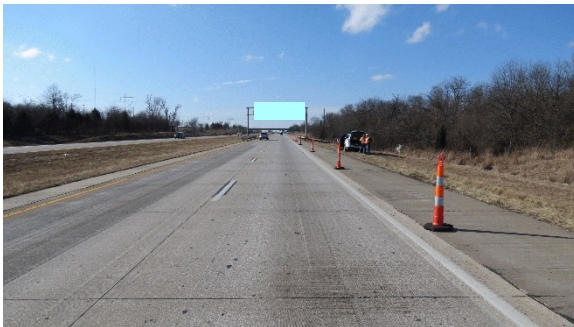
The Pontiac was traveling west in the right westbound lane (Figure 4) at an EDR-reported speed of 126 km/h (78 mph) at -5.0 sec prior to algorithm enable (AE). The antilock brake system was reported as active beginning at -3.0 sec prior to AE and remaining active to -1.0 sec (the end of the pre-crash recording), at which point the reported speed of the vehicle was 84 km/h (52 mph). The driver told police following the crash that she lost control on the rain-slick roadway and the EDR-reported antilock brake activity is consistent with the driver attempting to regain control of the vehicle. Yaw tire marks were found on the north shoulder (Figure 5) during the SCI crash scene inspection, indicating that the vehicle was yawing clockwise as it departed the roadway onto the shoulder and approached impact with the guardrail head.

Figure 4. Westbound approach of the Pontiac

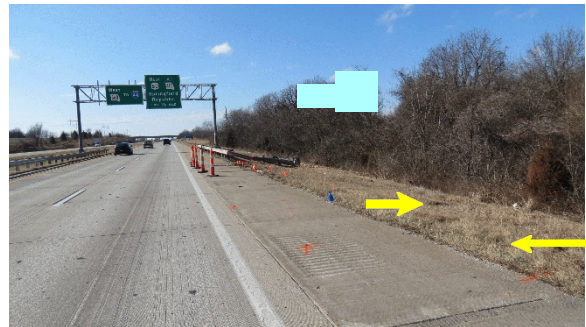
Figure 5. Approach of the Pontiac to impact with the guardrail head, arrows show yaw tire marks on shoulder, view northwest

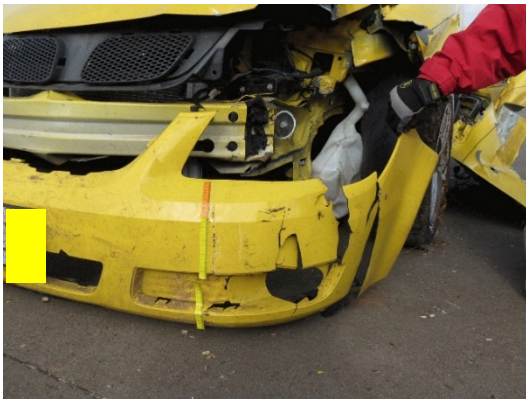
Figure 6. Damage to the front left corner of the Pontiac from the impact with the guardrail head

Exterior Damage Event 1: The Pontiac sustained direct and induced damage to the front plane during the impact with the guardrail head. The left portion of the front bumper, left headlamp/turn signal assembly, and left fender were directly damaged. The direct damage began at the left corner of the front bumper and extended 26 cm (10.2 in) to the right across the bumper. The Field L was 112 cm (44.1 in). Crush measurements were taken on the bumper bar and the maximum residual crush was 15 cm (5.9 in), occurring at the left-front bumper-corner. The crush values were: $C_1 = 15$ cm (5.9 in), $C_2 = 7$ cm (2.8 in), $C_3 = 0$ cm, $C_4 = 0$ cm, $C_5 = 0$ cm, $C_6 = 0$ cm.

Damage Classification Event 1: The Collision Deformation Classification (CDC) was 10FLEE2 (310 degrees). The WinSMASH program could be used to calculate minimal aspects of the delta V since an impact with a yielding object is out of scope for the program. However, WinSMASH was used to calculate a barrier equivalent speed (BES) of 11 km/h (7 mph) based on the crush to the front plane.

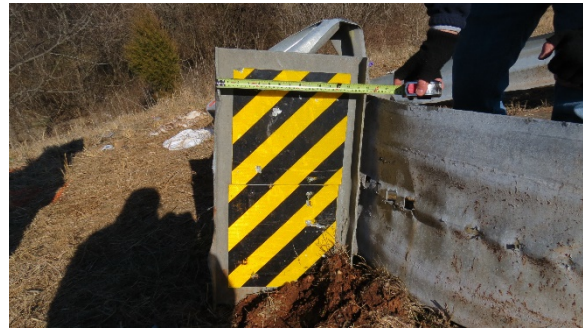
The front plane of the Pontiac (Figure 6) struck the guardrail head (Figure 7, Event 1) at a calculated¹ speed of 64 km/h (40 mph). The vehicle's EDR reported the maximum longitudinal and lateral velocity changes -7.62 km/h (-4.74 mph) and 31.62 km/h (19.65 mph). The force direction on the vehicle was within the 10 o'clock sector and the impact resulted in a stage two deployment of the driver's frontal air bag. The impact displaced and deformed the guardrail and the left plane of the vehicle struck a kink in the deformed guardrail (Event 2). The impact with the guardrail kink resulted in 45 cm (17.7 in) of lateral intrusion of the left front door and 31 cm (12.2 in) of lateral intrusion of the left B-pillar into the driver seating area. The intruding components contacted the driver's seat deforming and displacing the seat 28 cm (11.0 in) to the right (Figure 8). The guardrail kink also penetrated through the intruded side panel rear of the left B-pillar an estimated 15 cm (5.9 in) into the second row. The crash damaged a total of 11.4 m (37.4 ft) of guardrail and fractured and displaced wooden posts 1 to 6 and slightly displaced wooden post 7.

Figure 7. The face of the guardrail head struck by the Pontiac

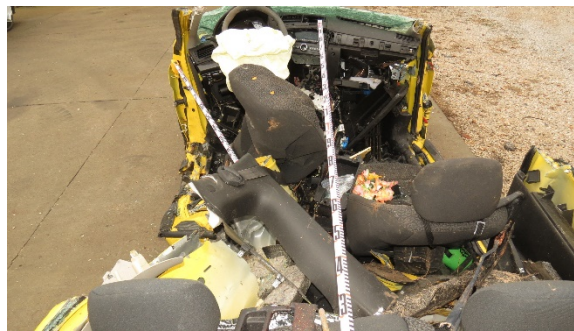
Figure 8. Intrusion into the Pontiac driver's seating area and displacement of the driver's seat

The interior of the Pontiac sustained severe damage from intrusion when a kink in the guardrail struck the left plane. The most severe intrusion into the driver's seating area involved the rear upper quadrant of the left front door and B-pillar, which intruded 45 cm (17.7 in) and 31 cm (12.2 in), respectively. The door intrusion was approximate since the door was jammed shut during the crash and removed by emergency responders. The right front door remained closed during the crash and was also removed by emergency responders. The left front and left rear glazing were probably disintegrated during the crash since this area of the vehicle was directly struck by the guardrail. The right front and right rear glazing were probably not damaged since the right plane of the vehicle was not struck. The windshield and backlight could have been damaged during the crash; however, their status could not be determined since the roof had been cut and removed by emergency responders.

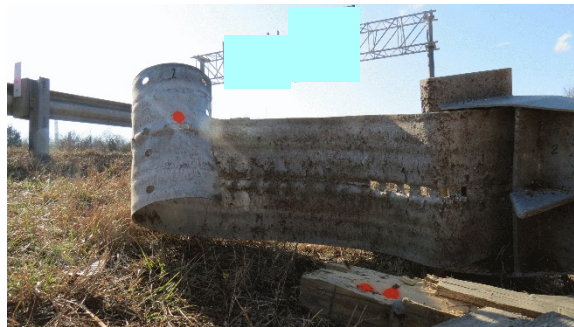
Figure 9. Extruded guardrail from guardrail head
