DOT HS 813 235

**Special Crash Investigations:
On-Site Steering Malfunction
Crash Investigation;
Vehicle: 2010 Nissan Versa;
Location: Colorado;
Crash Date: February 2020**

**Special Crash Investigations
On-Site Steering Malfunction Crash Investigation
Office of Defects Investigation
Case Number: DS20006
Vehicle: 2010 Nissan Versa
Location: Colorado
Crash Date: February 2020**

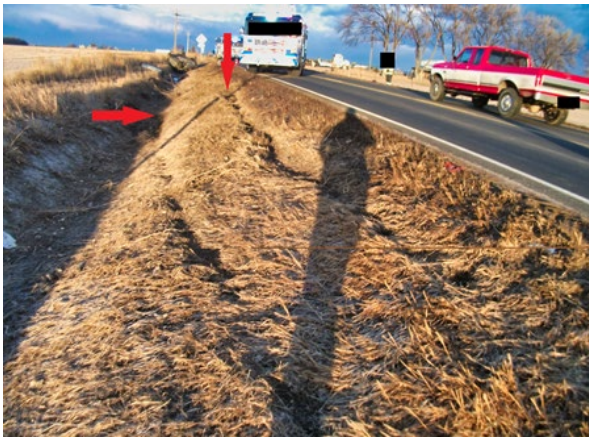
The police noted two marks on the eastbound fog line and, based on their appearance and distance between them, surmised that the vehicle was rotating clockwise prior to departing the roadway. The vehicle traveled off the south side of the roadway in a continuing clockwise rotation for approximately 20.2 m (66.3 ft). The vehicle rotated 90 degrees with a speed loss of approximately 49 km/h (31 mph) before tripping (Figure 3). The vehicle then began a left-plane-leading rollover. The vehicle appeared to have rolled six quarter-turns over a distance of 32.5 m (106.7 ft) with a speed loss of approximately 64 km/h (40 mph)² and came to rest on its roof (Figure 4). The combined speed loss for the road departure and overturn sequence was approximately 82 km/h (51 mph).

Figure 3. Path to trip points, looking west (police image)

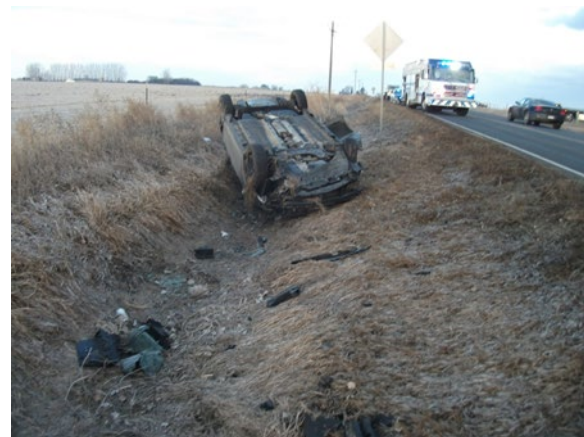
Figure 4. Final rest, the 2010 Nissan Versa (police image)

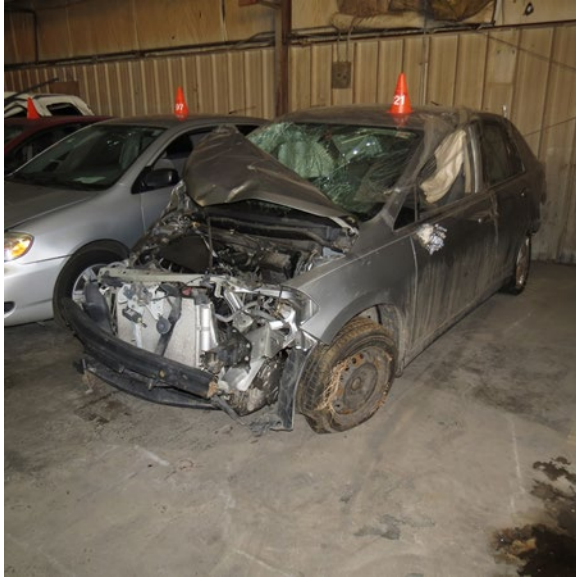
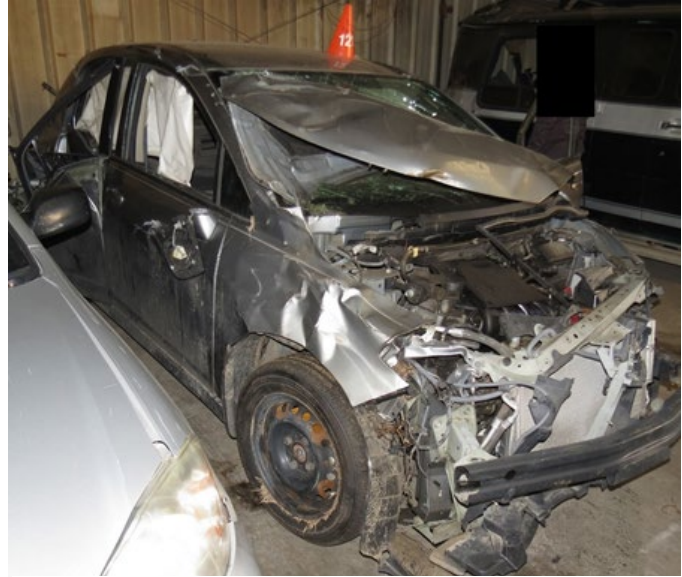
The Nissan sustained minor damage to all planes during the six-quarter-turn rollover event (Figures 5–6). The damage to the roof began at the windshield header and measured 146 cm (57.4 in) in length by 106 cm (41.7 in) in width. The maximum crush was located on the roof and measured approximately 2 cm (0.8 in). The direct damage to the right plane began at the front right bumper corner and extended 90 cm (35.4 in) to the rear with a measured depth of 28 cm (11.0 in). There was damage to the right rear quarter panel that was 40 cm (15.7 in) wide and 20 cm (7.8 in) deep. The damage to the left plane was located along the left roof rail and at the left rear quarter panel. The panel damage was 57 cm (22.4 in) wide and 24 cm (9.4 in) deep. The trunk lid was displaced and shifted to the right. The hood and radiator support were displaced rearward, 95 cm (37.4 in) on the right and 38 cm (14.9 in) on the left. The bumper fascia was displaced from the vehicle but did not have any direct contact damage. The Collision Deformation Classification (CDC) was 00TDDO2. The right rear door was damaged during the extrication of the driver.

The left front tire was flat and de-beaded; the right front tire was restricted, the sidewall was cut, the rim was bent, and the wheel was displaced rearward 5 cm (2.0 in) reducing the wheelbase by the same length. The rear tires and wheels were unremarkable.

Figure 5. The 2010 Nissan Versa, front left oblique view

Figure 6. The 2010 Nissan Versa, front right oblique view

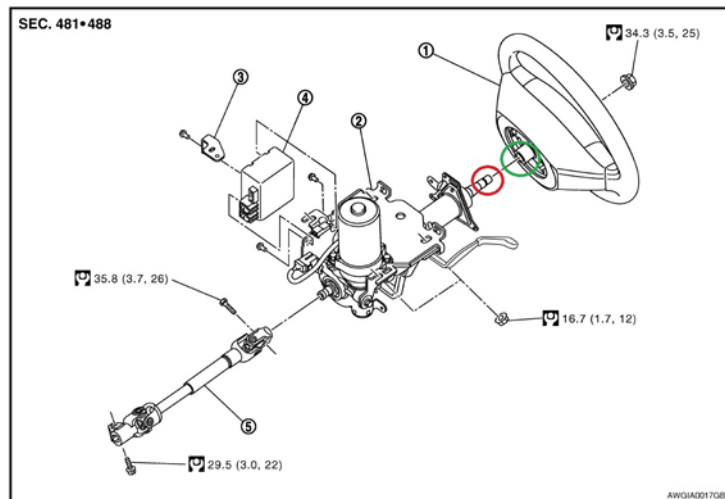
Figure 7. Steering column, the 2010 Nissan Versa, column spline (red), wheel spline (green)

Police investigators noted during their inspection that the steering wheel could be spun freely and that the front wheel did not respond. They indicated that the wheel made a light rumble noise and that they could feel a light vibration. The police visual inspection did not reveal any broken components or any occupant contact-related damage. They removed the air bag assembly so they could see the steering wheel connection to the column. When rotating the steering wheel, they could see that the wheel nut did not spin with the wheel. The officer was able to spin the nut with his finger. He removed the nut and steering wheel, and it came off with no resistance. The spline of the steering wheel (Figure 8) and the spline on the column (Figure 9) both had a small section of the spline that appeared to be worn down and flattened. The splines should be of uniform height across the entire spline length. The officer threaded the nut back onto the steering wheel shaft and used a socket wrench to turn the shaft. Both front wheels responded when the shaft was turned.

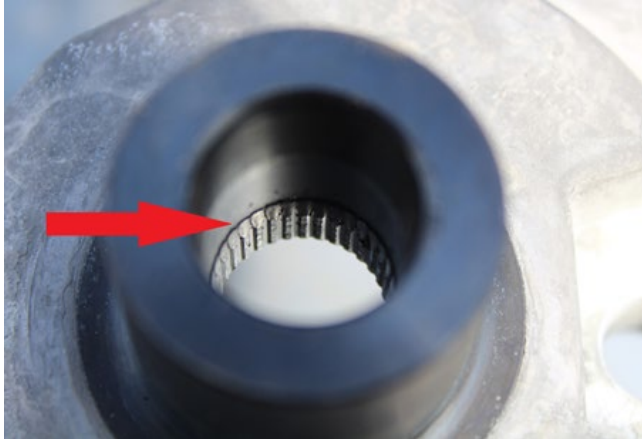
The threads on the steering wheel shaft appeared to be undamaged. The two areas of spline damage would have been the two areas first in contact as the steering assembly was reassembled per the Takata repair. The splines appear to have been misaligned during this recall repair assembly.

Figure 8. Steering wheel spline damage, the 2010 Nissan Versa

The cause of the loss of steering was likely from the failure to tighten the steering nut during the recall repair process for NHTSA recall number 20V008000.

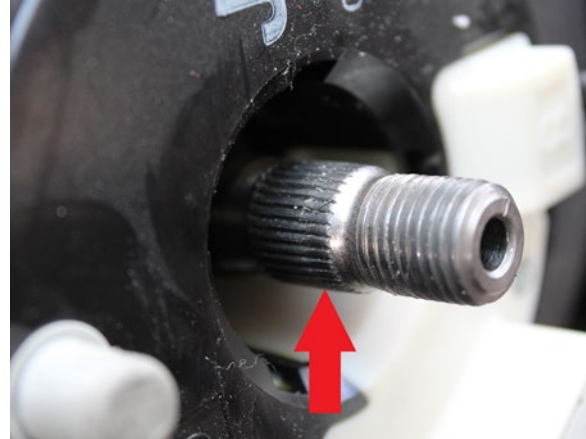
Figure 9. Steering column shaft damage, the 2010 Nissan Versa
