DOT HS 813 256

**Special Crash Investigations:  
On-Site Hazardous Materials Fatality;  
Vehicle: 2006 Porsche Cayenne;  
Location: Florida;  
Incident Date: June 2016**

**Special Crash Investigations**  
**On-Site Hazardous Materials Fatality Investigation**  
**Office of Defects Investigation**  
**Case Number: CR16026**  
**Vehicle: 2006 Porsche Cayenne**  
**Location: Florida**  
**Incident Date: June 2016**

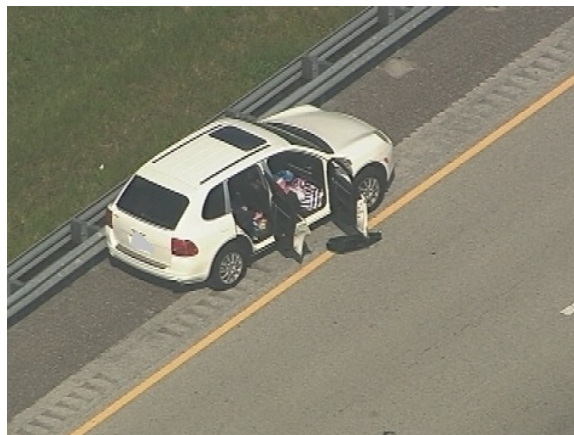
*Figure 1. Aerial view of the Porsche at the incident scene (image obtained from an online news source)*

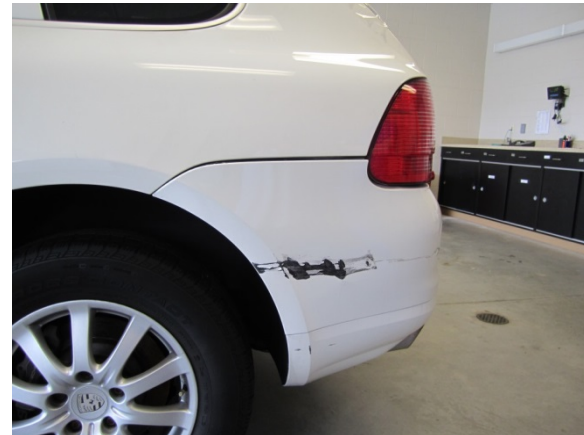
Figure 3. Sideswipe damage to the left aspect of the rear bumper fascia

The exterior damage to the Porsche was limited to the wrap around aspect of the bumper fascia aft of the left rear axle (Figure 3). The damage consisted of a linear abrasion and minor displacement to the lower fascia below the body structure at the C-D pillar. The damage was

consistent with sideswiping contact to the guardrail. Dimensionally, the damage measured 48 cm (19.0 in) in length and began 33 cm (13.0 in) aft of the left rear axle. The elevation of the abrasion measured 74 cm (29.0 in) above the ground. This damage was cosmetic in nature and did not involve any structure of the vehicle. The collision deformation classification assigned to the damage pattern was 12LBLS2.

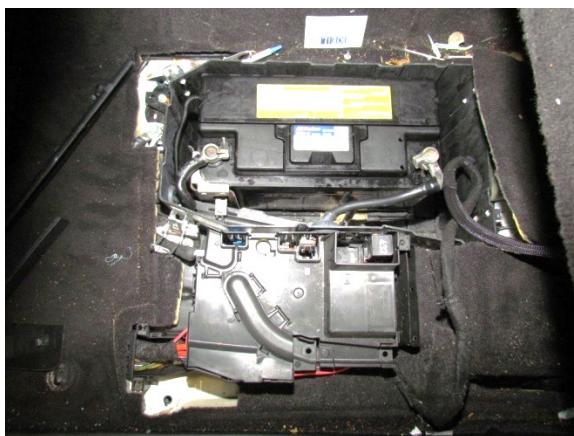
The battery specified for the 2004-2006 Porsche Cayenne with the 3.2-liter V6 engine is a Group Number 94R, Model No. 450RC/950CCA, based on the Battery Council International's "Battery Replacement Book." The battery was located in a well below the floor under the driver seat (Figure 4), mounted longitudinally with the negative terminal positioned forward. A polymer cover concealed the battery tray; however, the cover contained a filter on the top surface. The overall dimensions of the well were approximately 45 cm long x 19 cm wide x 19 cm deep (17.8 in x 7.5 in x 7.5 in). The well vented to the atmosphere outside the vehicle by a single 6 mm (0.25 in) port at the forward aspect. The vent is shown by the arrow in the image below (Figure 5).

*Figure 4. Battery positioned in the well under the driver's seat*

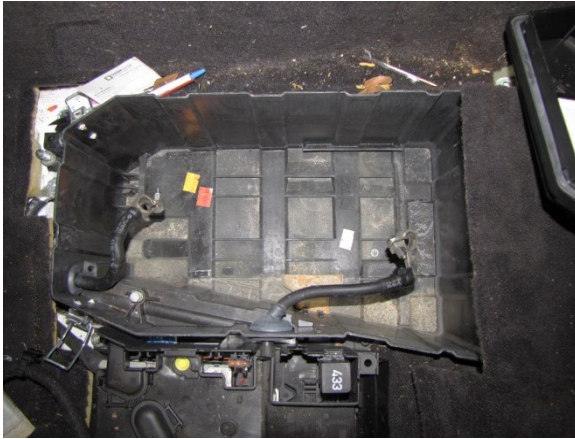
*Figure 5. Overhead view of the battery well in the Porsche with the battery removed*

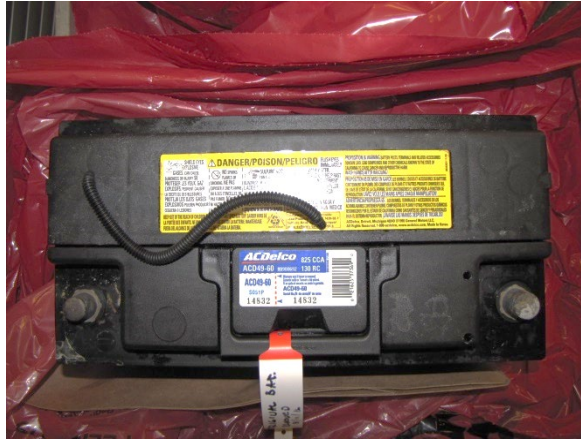
The battery found in the vehicle at the time of this incident was an AC-Delco 60 Series Group 49 (Figure 6), Model No. 130RC/825CCA. It was in the possession of the medical examiner at the time of the SCI inspection. Its nominal dimensions were 36 cm long x 18 cm wide x 19 cm high (14 in x 7 in x 7.5 in). It fit in the battery well without alteration. Note that this battery was the wrong Group number. The correct Group number was 94R. The battery installed in this Porsche was specified for the 2003-2006 Porsche Cayenne equipped with the 4.5-liter V8 engine. This battery had two vents located on the ends of its top cap.

*Figure 6. Image of the AC-Delco 60 series Group 49 12-volt battery found in the Porsche*

The police inspection of the vehicle occurred six days after the event. The driver's seat was removed, and the battery compartment was opened. The report stated that the battery had "exploded." The top of the battery was wet, and it appeared to have overflowed. A pH test found the liquid to be acidic. Only one of the battery's vents was connected to the vent port in the battery compartment. This connection vented to the atmosphere beneath the vehicle. The second vent port on the battery vented to the battery well and, over time, to the occupant compartment of the Porsche.

Inspection of the AC-Delco battery removed from the Porsche determined that it weighed approximately 17.7 kg (39.08 lb) and had a measured reading of 1.8 volts. The exemplar battery supplied by the AC-Delco representative weighed approximately 20.8 kg (45.8 lb). The battery voltage was 11.8 volts prior to the starting of the vehicle and was 14.1 volts while the engine was running. There were no noted fault messages on the instrument cluster display.

- The battery in the Porsche at the time of the event did not meet the manufacturer's specifications for a Porsche Cayenne equipped with the 3.2-liter V6 engine.

- The battery appeared to have an overcharging event which overflowed the electrolyte and produced hydrogen sulfide gas. Based on the occupants' outcome, the gas appeared to have infiltrated the occupant compartment.

- The disparity in the weight of the vehicle's battery and the exemplar battery indicated that the vehicle's battery may have boiled dry.
- The driver possibly recognized that she was in distress and attempted to stop the Porsche on the left shoulder prior to losing consciousness, thus precipitating contact with the guardrail. Alternatively, the driver may have released the accelerator and allowed the vehicle to coast and drift to the left without input due to her incapacitation, precipitating contact with the guardrail.
