DOT HS 813 265

**Special Crash Investigations:
On-Site Air Bag Inflator Rupture
Investigation;
Vehicle: 2004 BMW 325i;
Location: Arizona;
Crash Date: September 2020**

**Special Crash Investigations
On-Site Air Bag Inflator Rupture Investigation
Office of Defects Investigation
Case Number: DS20015
Vehicle: 2004 BMW 325i
Location: Arizona
Crash Date: September 2020**

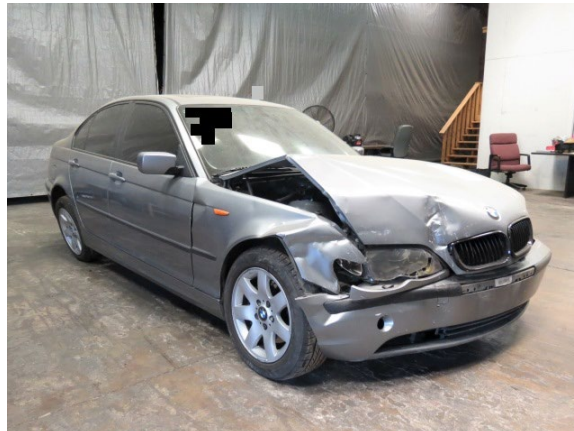
This report documents the on-site investigation of the inflator rupture of the driver's frontal air bag in a 2004 BMW 235i (Figure 1) involved in a crash with another vehicle. The unbelted 16-year-old male BMW driver was struck by at least one metal fragment from the ruptured inflator and sustained fatal injuries.

Figure 1. The 2004 BMW 325i

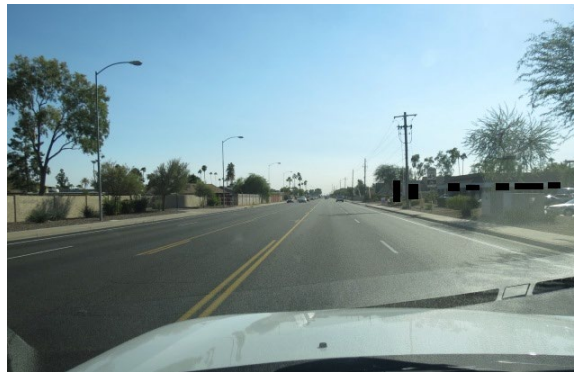
The crash site was a two-way roadway with a continuous left turn lane located in an urban area of Arizona (Figure 2). The roadway was oriented north and south. It was paved with asphalt and was straight and level. The posted speed limit was 72 km/h (45 mph), and conditions at the time of the crash were daylight, clear, and dry. The roadway had two through lanes for each direction separated by a center, two-way, left turn lane, and included bike lanes along the east and west curbs. The travel lanes measured 3.3 m (10.8 ft) in width, and the bike lanes including gutters measured 1.7 m (5.6 ft) in width. The through lanes were separated by dashed white painted stripes and were bordered on the right by white painted fog lines. The center, two-way, left turn lane was bordered by solid and dashed yellow painted stripes.

Figure 2. The 2004 BMW 235i driver's perspective in approach to crash site looking south

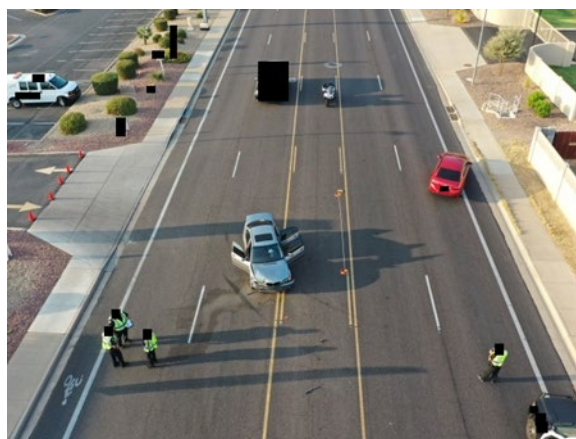
Figure 3. Area of impact (Event 1) looking north; the BMW on left, the Toyota on right (police photo)

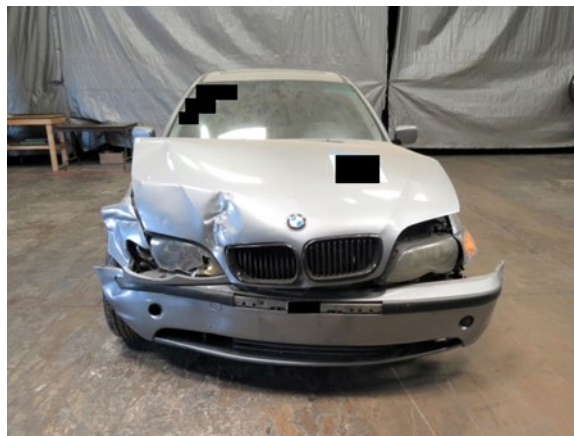
The BMW struck the Toyota in a front plane to left plane configuration (Figure 4). Direct damage to the front plane measured at bumper level began 30 cm (11.8 in) right of the front left bumper corner and extended 124 cm (48.8 in) to the right ending at the front right bumper corner. The field L was distributed from bumper corner to bumper corner and measured 154 cm (60.6 in). Eighteen measurements were taken at bumper level using the Nikon total station, and the Faro Blitz tool calculated six crush measurements as follows: $C_1=0$ cm, $C_2=0$ cm, $C_3=3$ cm (1.2 in), $C_4=9$ cm (3.5 in), $C_5=17$ cm (6.7 in), and $C_6=15$ cm (5.9 in). Maximum crush was located 50 cm (19.7 in) left of the front right bumper corner, and the Collision Deformation Classification (CDC) for the BMW in Event 1 was 01FDEW1.

Figure 4. Front plane damage, the 2004 BMW 325i

The left front tire was flat and de-beaded. The right front tire was restricted, the sidewall was cut, the rim was bent, and the wheel was displaced rearward 5 cm (2.0 in), reducing the wheelbase by the same length. The rear tires and wheels were unremarkable.

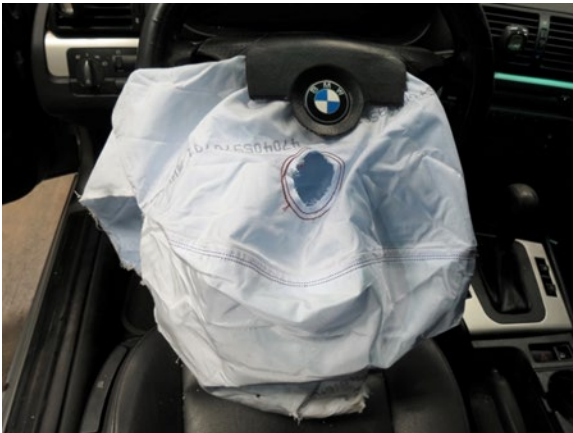
The driver's frontal air bag deployed at impact with the Toyota (Figure 5). The air bag had one vent port at the upper aspect of the back panel and did not have tethers. It was circular in shape and measured 50 cm (19.7 in) from seam to seam. At least one known metal fragment displaced from the ruptured inflator penetrated the air bag, causing a tear in the fabric. Other tears and holes suggested that more than one fragment may have exited the air bag. One tear located on the lower right quadrant of the front panel measured 9 cm (3.5 in); two small holes measuring 1 cm (0.4 in) in diameter were located in this area. Two tears located in the lower left and right aspects of the back panel measured 4 cm (1.6 in) and 3 cm (1.2 in), respectively. Additionally, the front panel was torn vertically from the top seam to the bottom seam (Figure 6). Given the driver's unbelted status and the probable movement at impact relative to the direction of force, the driver likely loaded the air bag with his chest and abdomen. Slight blood deposits were present on the lower aspect of the front panel. The upper and lower cover flaps appeared to have opened normally and were unremarkable. The vehicle's other air bags did not deploy, and none of the seat belt pretensioners actuated.

Figure 5. Deployed driver's frontal air bag, the 2004 BMW 325i

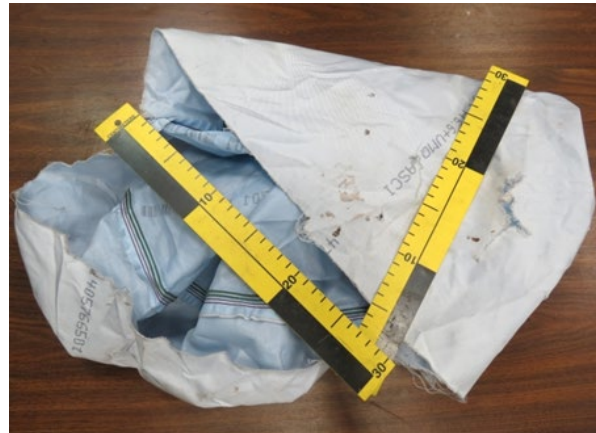
Figure 6. Deployed driver's frontal air bag, the 2004 BMW 325i

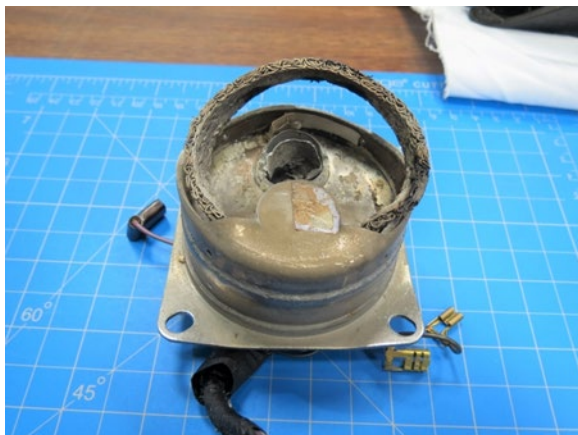
The air bag inflator ruptured during deployment. At least three metal fragments displaced from the area of the metal inflator cap of the inflator were recovered following the crash. Police responding on-scene found two fragments measuring 5 x 3 cm (2.0 x 1.2 in) located inside the deployed air bag. The third fragment identified by Takata as a booster tube and measuring 4 x 3 cm (1.6 x 1.2 in) in size passed through the air bag fabric. It penetrated and entered the driver's abdomen, causing lacerations to the stomach, small bowel, liver, right kidney, inferior vena cava, and right psoas muscle, with associated extensive intra-abdominal hemorrhage. The fragment was recovered by the medical examiner from the soft tissue of the driver's back during the autopsy.

The Takata inflator had two booster tubes. The second appeared to be undamaged and remained in place on the inflator. The advanced air bag had two stages of deployment, and according to the OEM technician who attended the inspection, the post-deployment state of the inflator indicated that it deployed the first stage only.

Figure 7. Ruptured air bag inflator, the 2004 BMW 325i

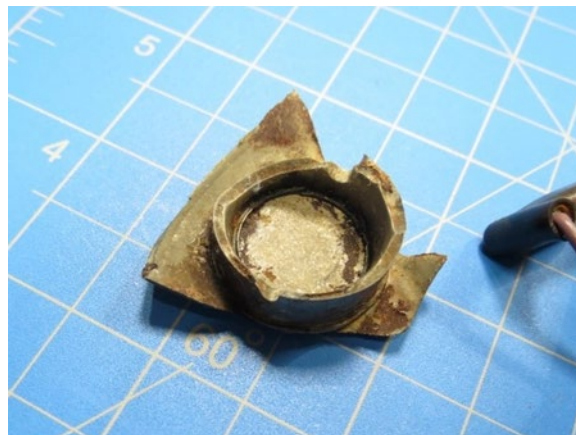
(PSDI)-4 manufactured in its La Grange, Georgia, facility in 2004. They did so by identifying a circular feature on the back side of the fragment that they referred to as a “booster tube” (Figure 8). In an undamaged inflator, the booster tube would be located in the area of the metal cap, and it would be inserted into the base. A vehicle history report in which the most recent record was July 2018 included no record of any air bag service or replacement. Damage to the air bag and related data is discussed further in the Supplemental Restraints System section of this report.

Figure 8. Air bag inflator “booster tube” fragment, the 2004 BMW 325i

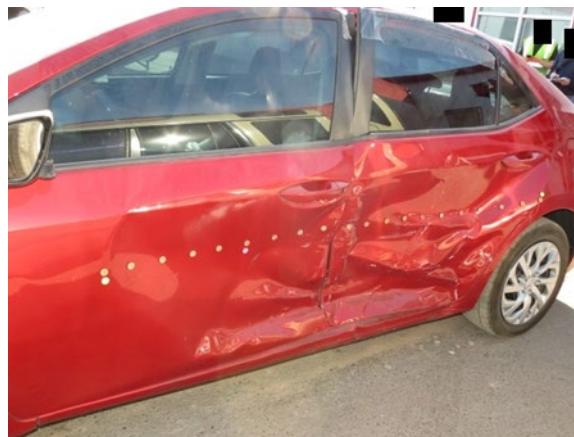
The Toyota sustained direct and induced damage to the left plane during the impact with the BMW. Direct damage to the left plane measured at mid-door level began at the left rear bumper corner and extended 230 cm (90.6 in) ending 50 cm (19.7 in) aft of the left A-pillar. The Field L began at the left C-pillar and extended 179 cm (70.5 in) ending 50 cm (19.7 in) aft of the left A-pillar. Twenty measurements were taken at mid-door level using the Nikon total station, and the Faro Blitz tool calculated six crush measurements as follows: $C_1=3$ cm (1.2 in), $C_2=5$ cm (2.0 in), $C_3=7$ cm (2.7 in), $C_4=8$ cm (3.1 in), $C_5=5$ cm (2.0 in), and $C_6=1$ cm (0.4 in). Maximum crush was located on the second row left door panel at 10 cm (3.9 in) aft of the B-pillar, and the CDC for the Toyota in Event 1 was 09LZEW1 (Figure 9).

Figure 9. Left plane damage, the 2018 Toyota Corolla

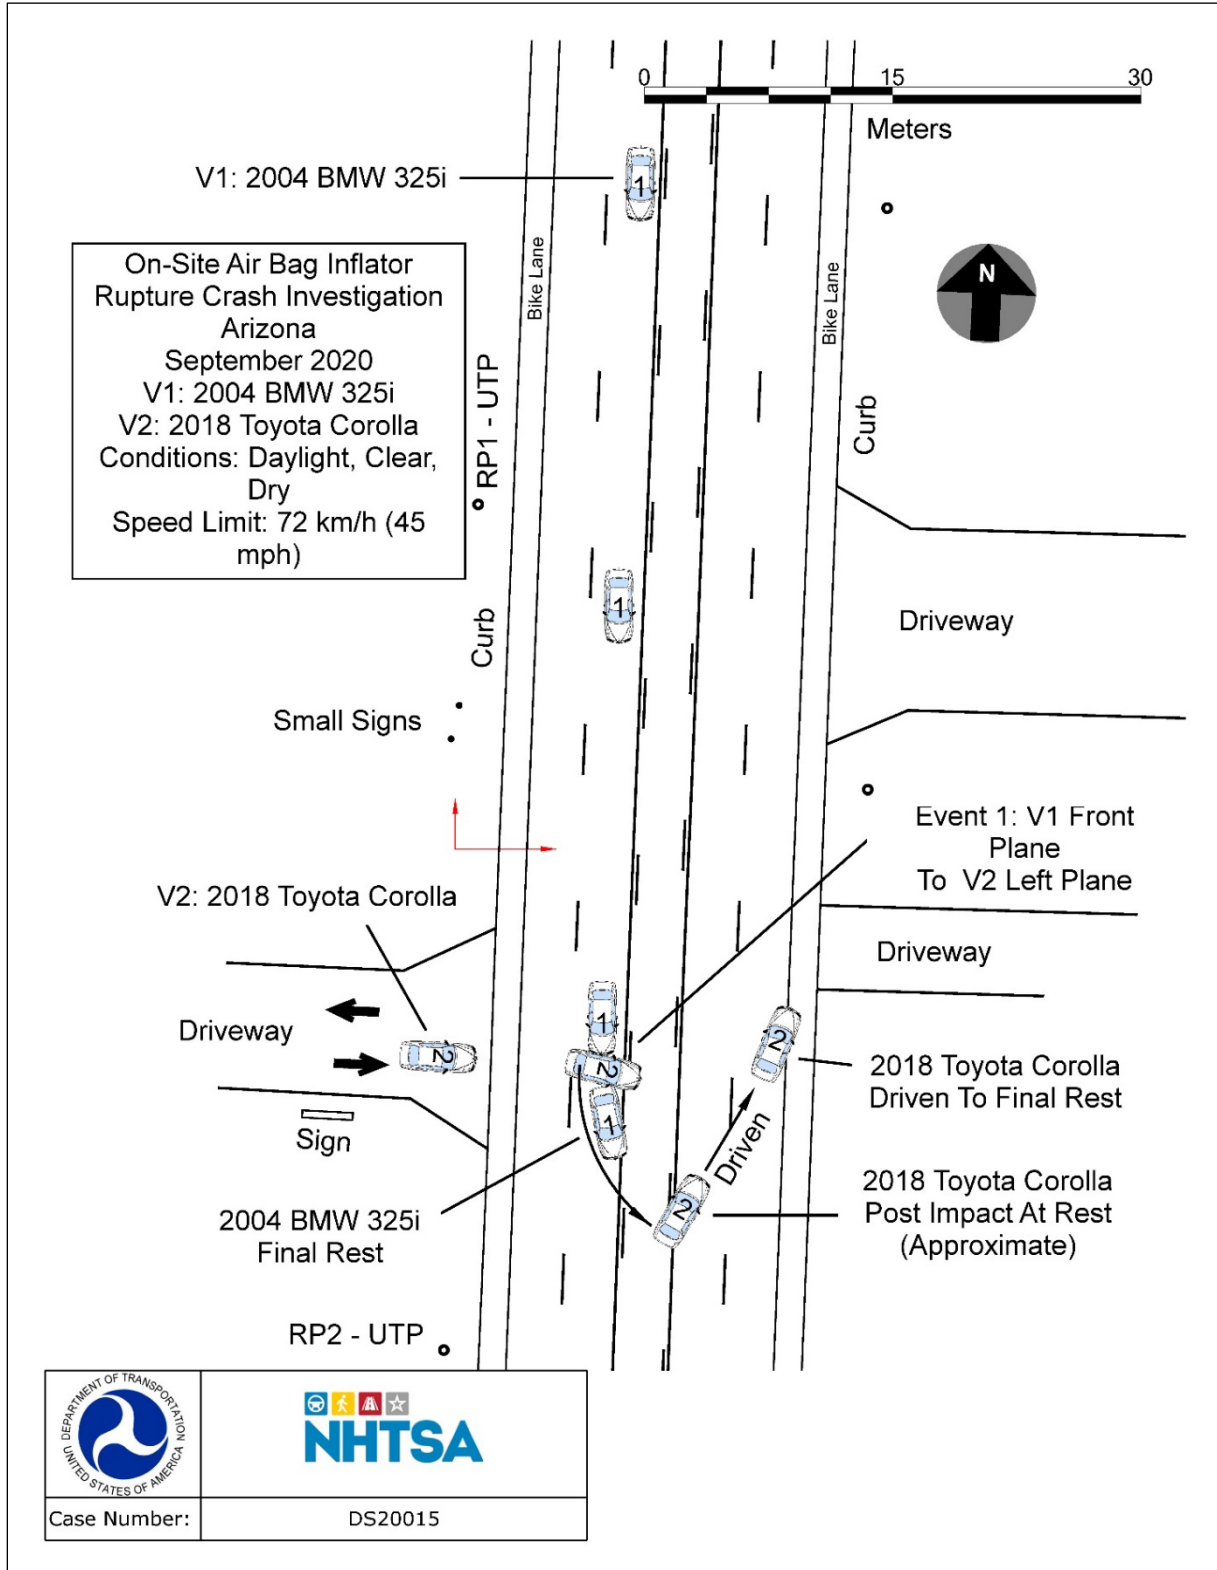
Crash Diagram

A shopping center parking lot was located on the west side of the roadway. A driveway, oriented east and west and measuring 7.7 m (25.3 ft) in width, intersected the southbound lanes near the area of impact. A crash diagram is included at the end of this report.
