DOT HS 813 272

**Special Crash Investigations:
On-Site Reported Unintended
Acceleration Crash Investigation;
Vehicle: 2006 Honda Civic;
Location: New Jersey;
Crash Date: January 2017**

Special Crash Investigations
On-Site Reported Unintended Acceleration Crash Investigation
Office of Defects Investigation
Case Number: CR17005
Vehicle: 2006 Honda Civic
Location: New Jersey
Crash Date: January 2017

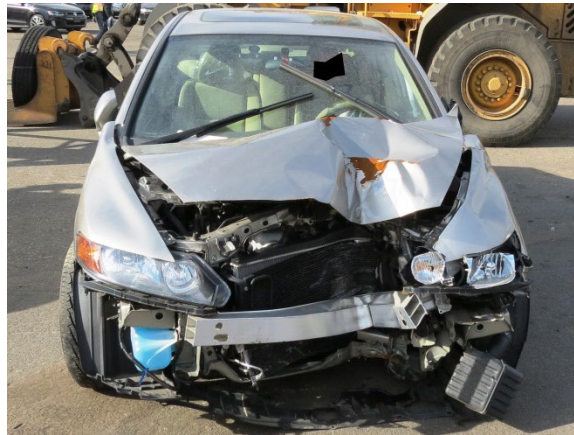
*Figure 1. Front plane view of the 2006 Honda Civic
at the time of the SCI inspection*

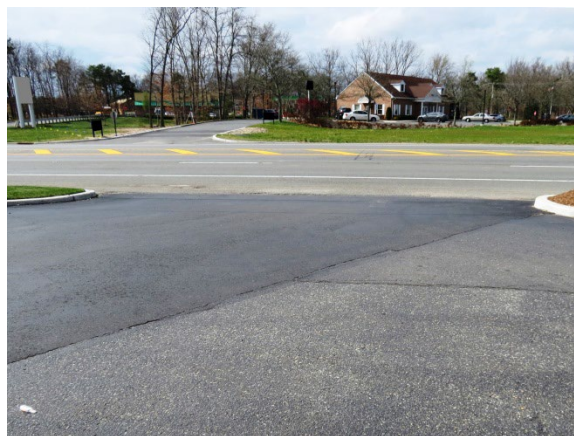
A commercial driveway 9.6 m (31.5 ft) wide intersected the roadway from the south. Figure 2 shows a north-facing view of the roadway and crash site from the south intersecting driveway, in the initial travel trajectory of the Honda. A commercial driveway 7.7 m (25.3 ft) wide was located on the opposite side of the road, with grass areas on both sides populated by several small objects. This included a small commercial sign that measured 1.2 m (3.9 ft) wide by 1.3 m (4.3 ft) tall and was supported by a pair of 10x10 cm (4x4 in) non-breakaway hardwood posts, as well as a 2.0 m (6.7 ft) tall red octagonal STOP sign with additional No Left Turns sign. There was also a large gas station sign, supported by two 50 cm (19.7 in) diameter, non-breakaway steel I-beam posts that were covered with a stainless-steel casement. The northernmost post was the focal point of impact and final rest location for the Honda. A crash diagram is included at the end of this report.

Figure 2. North-facing view of the physical environment at the crash site

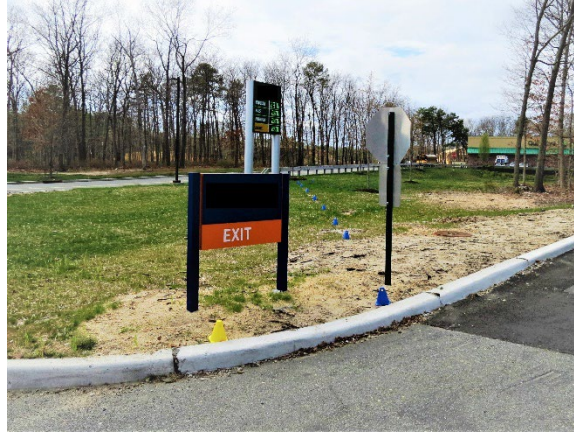
The first and second crash events occurred nearly simultaneously as the Honda's left front and right front tires struck and overrode the west curb return of the north intersecting commercial driveway (Events 1 and 2). The location of the impacts and their low severity likely were of insufficient magnitude to induce injury to the Honda's driver or result in supplemental restraint system actuation/deployment. However, the first impact likely contributed to the air-out of the left front tire, and both impacts were evidenced by marks on the concrete curb's surface. The Honda continued along its errant trajectory and struck the small commercial sign (Event 3). The sign itself engaged the left bumper corner, while the northernmost non-breakaway post engaged the bumper beam. This sheared the post and deflected the sign westward. The right front corner aspect of the Honda then struck the STOP sign (Event 4).

Figure 3. Northwest-facing view of the points of impact by the Honda at the crash site

Impact forces sheared the sign's metallic non-breakaway post at ground level and displaced it toward the northwest. Neither of the impacts (Event 3 nor Event 4) produced significant damage to the vehicle, and they likely were of insufficient magnitude to induce occupant injury. Figure 3 shows a northwest-facing view of the curb return, small commercial sign, and STOP sign at the time of the SCI inspection, following replacement of the struck signs. In the image, yellow marking cones highlight the Honda's left side tire marks, while blue marking cones highlight the right side tire marks. The Honda continued on an errant trajectory through the grass swale with a northwest heading. It ultimately struck the large-diameter, non-breakaway post (Event 5). Associated crash forces induced moderate front plane deformation to the Honda and were the likely source of deployment for the Honda's inflatable supplemental restraint systems. The vehicle rotated approximately 10 degrees counterclockwise and came to final rest against the post.

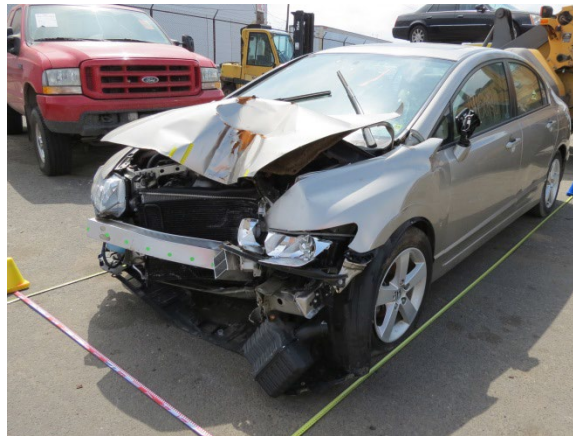
The 2006 Honda Civic (Figure 4) was identified by the VIN 1HGFA16826Lxxxxxx. It was manufactured in March 2006. The electronic odometer reading could not be obtained during the SCI vehicle inspection due to inoperability of the instrument cluster display. The front-wheel drive Honda had a 270 cm (106.3 in) wheelbase and powered by a 1.8-liter, inline, 4-cylinder gasoline engine. It had a center-console-mounted shifter for its 5-speed automatic transmission. The vehicle's gross vehicle weight rating was 1,695 kg (3,737 lb), with front and rear gross axle weight ratings of 895 kg (1,973 lb) and 800 kg (1,764 lb). The vehicle manufacturer's recommended tire size and pressure were P205/55R16 at 221 kPa (32 PSI) for all four axle positions. The tires were of the recommended size, with specific tire data at the time of the SCI inspection that included the following.

Figure 4. Left front oblique view of the 2006 Honda Civic EX at the time of the SCI vehicle inspection

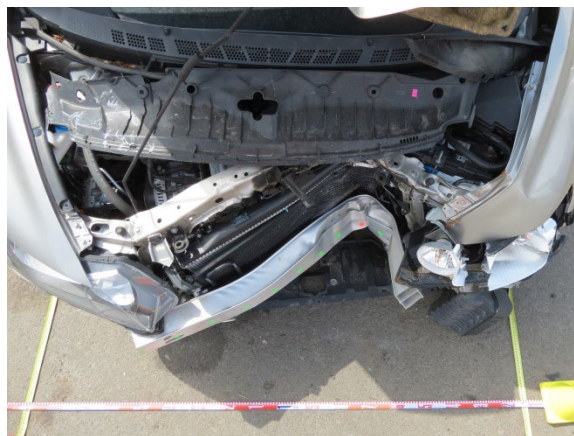
Damage from the third and fourth impact events with the small commercial sign and STOP sign were overlapped by the subsequent fifth event impact with the large-diameter, non-breakaway post. Furthermore, the front bumper fascia of the Honda was completely separated and not with the vehicle at the time of inspection. This further hindered SCI's identification of the direct contact damage patterns. However, based on the width of the Honda and the location of its tire marks at the crash site, the SCI investigator was able to determine that the impact with the small commercial sign (Event 3) occurred at the left front corner of the Honda, while the impact with the STOP sign (Event 4) occurred at the right front corner. Neither of these impacts were of sufficient magnitude to produce significant discernable deformation patterns to the vehicle's underlying frontal components. The CDCs assigned to the Honda for Event 3 and Event 4 were 12FLEN1 and 12FREN1, respectively. No delta V calculations could be computed due to the lack of residual deformation/damage.

Figure 5. Overhead view of the damage profile to the Honda's front plane associative to the Event 5 impact

The final impact (Event 5) with the large-diameter pole was the most severe event in the crash sequence, and likely was the only event associated with supplemental restraint system actuation/deployment commands. Direct contact damage began 6 cm (2.4 in) right of center on the Honda's hood and extended to the left front corner. The approximate horizontal width of the direct contact damage profile (Figure 5) measured 35 cm (13.8 in) and corresponded to the diameter of the non-breakaway pole. A residual crush profile was documented using a combined direct and induced damage length of 126 cm (49.6 in) across the Honda's entire deformed front bumper beam width. Resultant measurements were as follows: C1 = 17 cm (6.7 in), C2 = 47 cm (18.5 in), C3 = 35 cm (13.8 in), C4 = 21 cm (8.3 in), C5 = 12 cm (4.7 in), and C6 = 0. Maximum crush was located 25 cm (9.9 in) right of the left front bumper corner, immediately inboard of the left frame rail end. The CDC assigned to the Honda for the Event 5 impact was 12FYEN3.

A reconstruction of the impact was calculated using the barrier algorithm of the WinSMASH model for analysis purposes. The total delta V was 41 km/h (25 mph), with a longitudinal component of -41 km/h (-25 mph) and a lateral component of zero. These results appeared reasonable

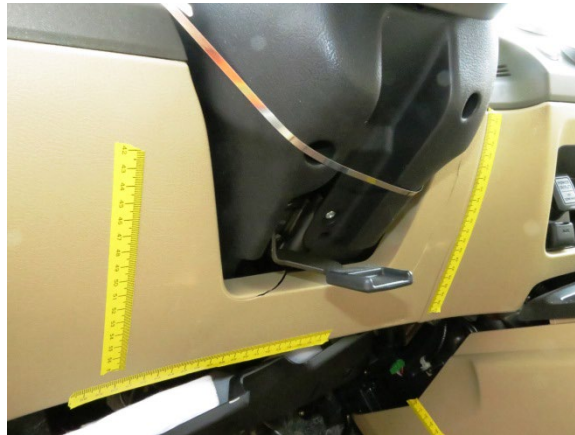
Figure 6. Driver knee contact to the left lower instrument panel in the Honda

There were two particular areas of certain occupant contact identified in the Honda, and one area of possible contact. The first certain area consisted of deformation and displacement of the left lower instrument panel/knee bolster. The polymer panel beneath the steering column was fractured and deformed forward, which was determined to have resulted from loading by the driver's knees during the Event 5 impact (Figure 6). The second area of certain contact was the deployed driver's frontal air bag, which had evidence consisting of body fluid transfer stains. This contact is described in the Supplemental Restraint Systems section.

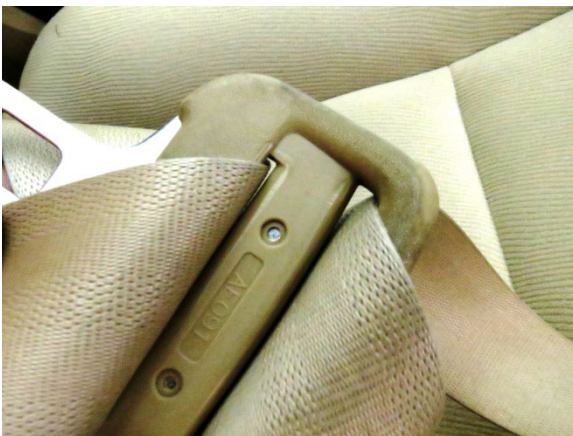
At the time of the SCI vehicle inspection, the driver's seat belt was extended from the retractor and locked. The retractor did not freely spool. Discernable loading evidence was observed on the latch plate, and both pretensioners were actuated.

Based on the condition of the driver's seat belt at the time of the SCI inspection (Figure 7), and as corroborated by the interpreted EDR data, it was certain that the system was in use by the driver at the time of the crash. Following a review of the medical record documentation concerning the driver and his injuries, the SCI investigator concluded that the seat belt was possibly routed beneath the driver's arm and across his chest at the time of the crash, rather than over his shoulder. For further discussion, see the Driver's Kinematics section of this report. The passenger's seat belt remained functional and was loosely stowed against the B-pillar; it was not in use at the time of the crash. The same was true of all three of the second row seat belts.

Figure 7. Latch plate loading evidence on the Honda's driver seat belt system

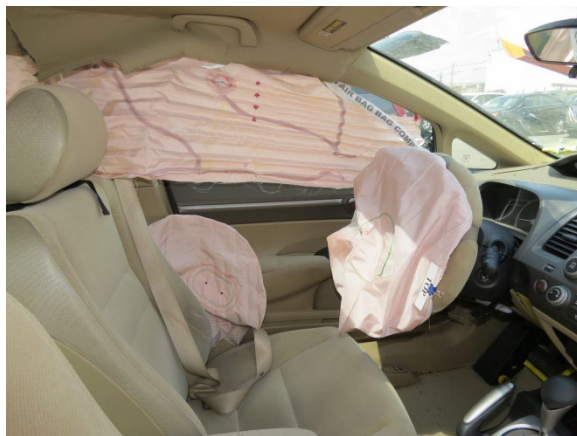
Figure 8. Deployed supplemental restraint systems in the Honda at the time of the SCI vehicle inspection

and left IC air bags deployed (Figure 8) during the crash in response to the fifth and final impact (Event 5) with the large-diameter, non-breakaway pole. The driver's frontal air bag deployed from the steering wheel hub-mounted module without damage or occupant contact to the module cover flaps. In its deflated state, the air bag measured 64 cm (25.2 in) in overall diameter. There was a 17 cm (6.7 in) diameter center stitch pattern, to which internal tethers were affixed. Small 6 cm (2.4 in) diameter vents were located on the rear aspect of the driver's air bag at the 10 o'clock and 2 o'clock positions. An area of body fluid transfer indicative of possible occupant contact was located on the lower aspect of the air bag's face, right of center.

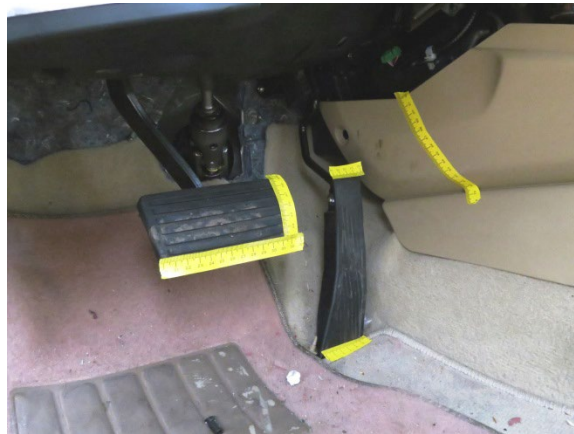
Figure 9. Brake pedal (left) and accelerator pedal (right) with the original floor mat and secondary aftermarket floor mat in the Honda at the time of the SCI vehicle inspection

The accelerator pedal was mounted to the floor on its bottom aspect, with a suspended arm attached to its upper aspect that was linked to the throttle control. Figure 9 shows the Honda's driver foot controls at the time of the SCI inspection, with the original floor mat and secondary aftermarket floor mat visible. The pedal rotated forward about the floor-mounted hinge. The trapezoidal-shaped accelerator pedal was 20 cm (7.9 in) tall, measured 4 cm (1.6 in) wide at the top, and was 6 cm (2.4 in) wide at the bottom. Clearance between the top of the accelerator pedal and the bottom of the left lower instrument panel measured 15 cm (5.9 in). In its resting, non-depressed position, a maximum of 11 cm (4.3 in) of space was present behind the pedal. Space between the pedal and the center tunnel measured 3 cm (1.2 in) at the bottom, 5 cm (2.0 in) at the center, and 2 cm (0.8 in) at the top. There was a 10 cm (4.0 in) gap between the left edge of the accelerator pedal and the right edge of the brake pedal. The brake pedal was a suspended pedal design, with a 15 cm (5.9 in) gap between the bottom aspect of the pedal and the floor below. The surface area of the brake pedal measured 13 cm (5.1 in) wide by 6 cm (2.4 in) tall.

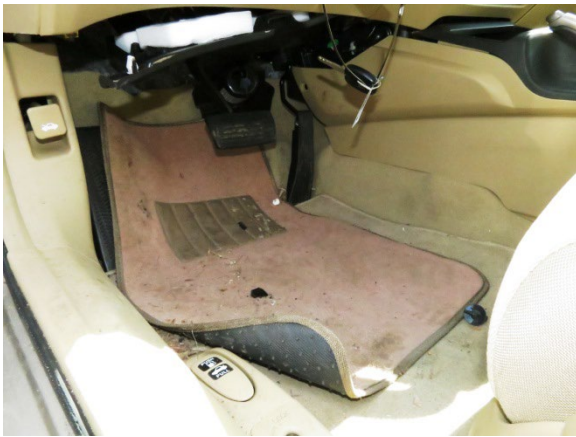
The Honda had original carpeted floor mats, which were identical in color to the carpet and upholstery in the vehicle. The driver's floor mat had two anchors at its rear aspect. At the time of the SCI inspection, the OEM floor mat remained secured in position by these two anchors. The mat did not interfere with the pedals' operation, nor was it capable of contacting either pedal while anchored in position. A second aftermarket carpeted floor mat, put in place by the vehicle's owner, was found covering the OEM floor mat. The aftermarket floor mat was slightly pink in color in comparison to the OEM floor mats and remaining OEM interior carpeting/upholstery. The aftermarket floor mat did not have anchors but had a rubber-type tread pattern on its underside to aid in holding the mat in position. At the time of the SCI inspection, this aftermarket mat was slightly angled with respect to the orientation of the OEM floor mat beneath it. The aftermarket floor mat as positioned did not interfere with the pedals' operation, nor did it restrict the restitution of the pedals to their respective original positions following their operation. Even if fully depressed, the brake pedal did not interact with either floor mat. Similarly, the positioning of the floor mats did not interfere with the operation of the accelerator pedal, and it was able to freely return to position if applied pressure was released. Figure 10 shows the floor area of the Honda at the time of the SCI vehicle inspection. Figure 11 shows the OEM and aftermarket floor mats, and their dimensional characteristics.

Figure 10. Aftermarket floor mat in the Honda, positioned undisturbed at the onset of the SCI vehicle inspection

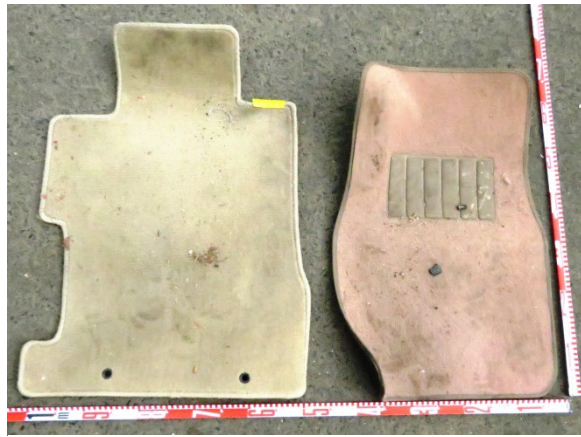
Figure 11. View of the driver's floor mats found in the Honda at the time of the SCI vehicle inspection

The evidence gathered during this investigation led the SCI investigator to conclude that there was no evidence to support mechanical malfunction of the vehicle's foot controls. There also was no impingement of the floor mats with the vehicle's pedals, nor were there any objects present, foreign or other, to have interfered with the pedals' operation. It is the opinion of the SCI investigator that the driver experienced a misapplication of the pedals and continued to depress the accelerator pedal. Due to human reaction timing, when the driver did recognize that the vehicle was unexpectedly accelerating and on an errant trajectory, the crash sequence had already begun. These circumstances likely led the driver to believe that the vehicle had accelerated unintentionally, which precipitated in his report of a possible mechanical defect. The SCI investigator was unable to identify any evidence or circumstance to support the driver's allegation.
