DOT HS 813 277

**Special Crash Investigations:  
On-Site School Bus Crash  
Investigation;  
Vehicle: 2012 IC Corporation  
CE-300 School Bus;  
Location: New Jersey;  
Crash Date: May 2018**

**Special Crash Investigations**  
**On-Site School Bus Crash Investigation**  
**Case Number: CR18014**  
**Vehicle: 2012 IC Corporation CE-300 School Bus**  
**Location: New Jersey**  
**Crash Date: May 2018**

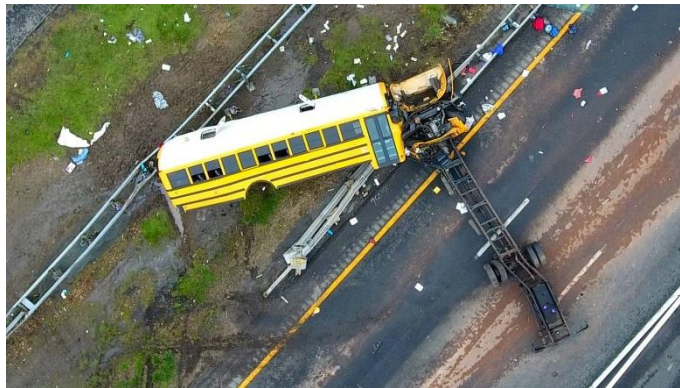
*Figure 1. Overhead view of the crashed school bus (Andre Malok/NJ Advance Media via AP)*

The force of the initial impact and subsequent deformation of the bus's ladder frame caused a separation of the school bus body from the chassis. As the bus body interacted with the guardrail, the frame of the bus continued to rotate and completely separated. The frame rotated back out into the interstate travel lane. Arcing tire marks attributed to the rear axle of the bus were observed in the on-scene news images and denoted the rotating trajectory. At rest, the frame of the bus was located 31.5 m (103.3 ft) west of the area of the initial impact, and it had rotated roughly 360 degrees.

Now separated from the frame (refer to Figure 1, page 1), the school bus body tipped to the left as it interacted with the median guardrail. The upper rear aspect of the left plane contacted a

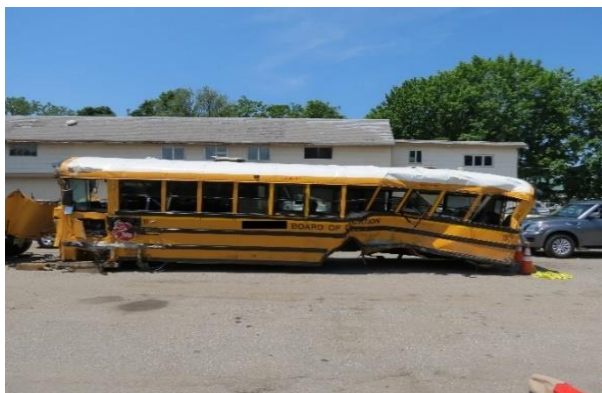
The school bus was crossing the westbound lanes in a near-perpendicular orientation at impact (Event 1). The forward aspect of the school bus was just entering the median crossover and due to its overall length, the aft aspect of the vehicle was in the center lane. Without the time and distance to avoid the bus, the front plane of the Kenworth struck the left plane of the school bus (Figure 6) at an impact speed of 109 km/h (68 mph). The centerline of the Kenworth was located roughly 56 cm (22.0 in) aft of the school bus's rear axle at impact.

*Figure 6. Left side view of the school bus body showing the location of the deformation and locations of the impacts (Events 1, 2, and 3)*

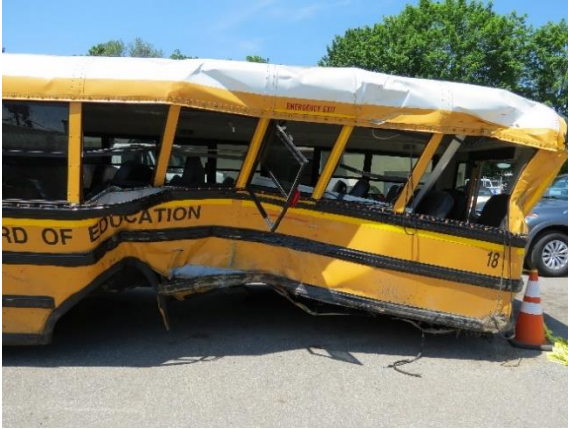
The left plane of the school bus sustained two regions of damage directly related to the events of the crash. The Event 1 direct contact damage resultant to the impact with the Kenworth began at the G-pillar (Figure 8) that was located 66 cm (26.0 in) forward of the rear axle position. The direct contact damage from the G- to H-pillar consisted of red paint transfer and minor deformation. Significant deformation was located between the H-pillar and the L-pillar in the region of direct impact with the front plane of the Kenworth. This area of direct contact extended vertically to the elevation of the top of the windows and wrapped onto the roof. Red paint transfer from the Kenworth was observed on the roof above the K-pillar (Figure 9).

*Figure 8. Left side view of the school bus body deformation*

The crush profile was measured at the sill, beltline, and roof elevations using the total station. The lateral deformation at the beltline was considered the most representative profile of the vehicle to vehicle interaction and was as follows: C1 = 5 cm (2.0 in), C2 = 22 cm (8.7 in), C3 = 46 cm (18.1 in), C4 = 43 cm (16.9 in), C5 = 3 cm (1.2 in), and C6 = 0. The combined width of the direct and induced damage pattern from the G-pillar to the rear plane measured 436 cm (171.7 in). The maximum crush was 61 cm (24.0 in) and was located 89 cm (35.0 in) aft of the rear axle. The maximum lateral crush at the sill measured 70 cm (27.6 in) and was located immediately aft of the wheel opening. The Truck Deformation Classification assigned to this damage pattern was 09LBAW4.

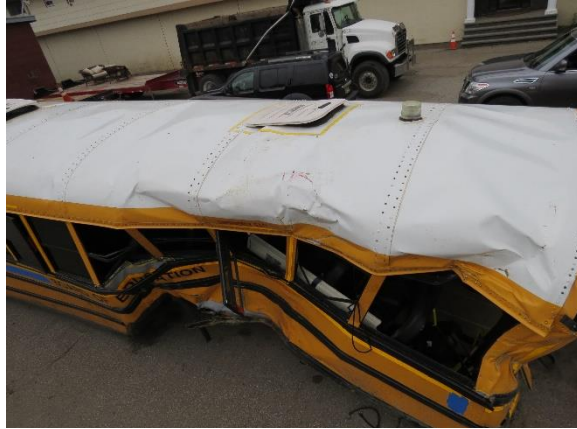
*Figure 9. Overhead view showing the left plane deformation of the school bus body and red paint transfer on the roof*

The maximum lateral roof deformation measured 24 cm (9.4 in). The roof deformation was not entirely attributable to the Event 1 impact with the Kenworth. Overlapping damage from the roof's impact to the guardrail after the bus body's separation from the frame (Event 3) was present in the profile.

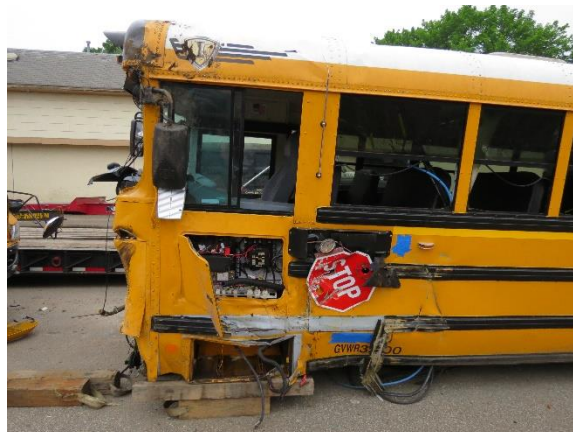
*Figure 10. Left side view of the bus body showing damage attributed to Event 2*

A second pattern of contact damage was present on the left plane below the B-pillar. The contact pattern was approximately rectangular and measured 152 cm x 86 cm (59.8 in x 33.9 in). The pattern began 41 cm (16.1 in) rearward of the A-pillar (Figure 10). The damage consisted of body panel abrasions, sheet metal tearing, and paint transfer. The damage was related to the bus body's impact with the northmost guardrail located in the median adjacent to the westbound lanes. The on-scene police investigators observed red paint transfer on the guardrail related to direct contact with the stop sign attached to the bus body. The Truck Deformation Classification assigned to this damage pattern was 09LZEW1.

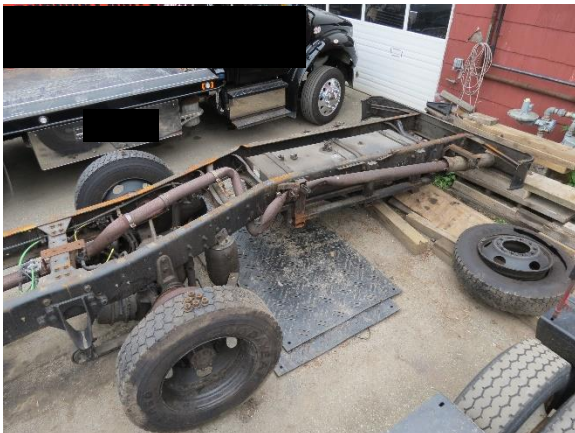
The ladder frame of the chassis was constructed of two 11 m (36.1 ft) long structural steel C-channels. Each channel measured 25 cm x 7 cm (10.0 in x 3.0 in) with a thickness of x 6 mm (0.25 in). Seven reinforced lateral cross members supported the 88 cm (34.6 in) width of the frame. Inspection of the ladder frame revealed that the structure was deformed in an elongated S-pattern (Figures 11 and 12). The maximum lateral deformation measured 45 cm (17.7 in) and was located 100 cm (39.4 in) aft of the left rear axle position. The force of the impact and subsequent deformation skewed the rear axle with a 4 cm (1.6 in) forward displacement of the left rear axle position and a 7 cm (2.8 in) rearward displacement of the right rear position.

*Figure 11. Oblique left side view of the deformation of the ladder frame bus chassis*

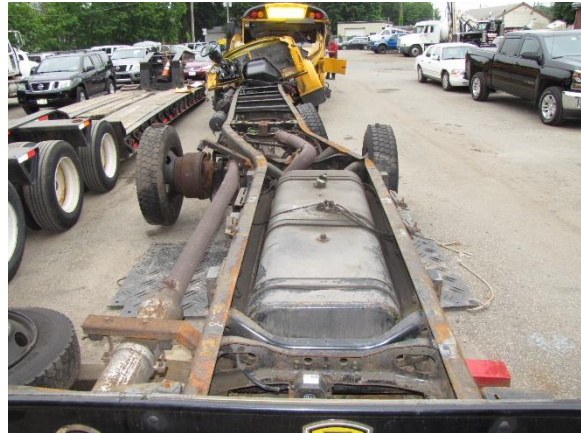
*Figure 12. Forward-looking longitudinal view of the deformed bus ladder frame*

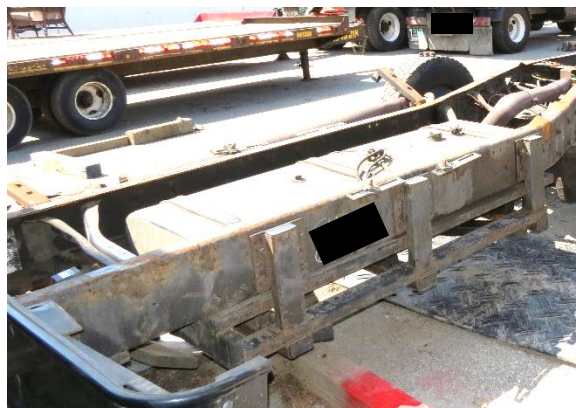
The fuel tank was protected by a fabricated safety cage (Figure 13) constructed of welded 5 cm x 10 cm (2.0 in x 4.0 in) structural steel tubing 5 mm (3/16 in) thick. The cage consisted of three vertical mounts that were bolted to the outer aspects of the frame with three lateral cross members spanning the width of the cage at the bottom aspect and two diagonal supports originating from the left center vertical mount to the right fore and aft vertical mounting supports. The only damage to the cage was minor deformation to the edge of the forward cross member. The overall shape of the cage was not compromised, and the fuel tank was not damaged, having been located in the initial impact zone of the vehicle-to-vehicle crash. The frame at the location of the fuel tank and safety cage was deformed to the right; however, it retained its original 88 cm (34.6 in) width.

*Figure 13. Right oblique view of the bus's fuel tank and surrounding safety cage*

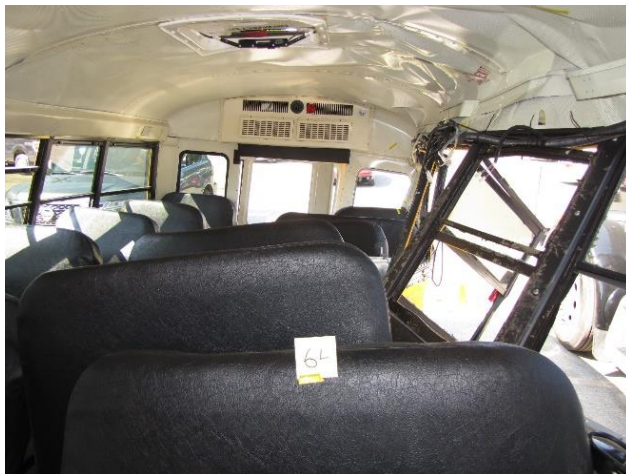
*Figure 16. Rear-looking view of the bus interior showing the maximum intrusion at row 8 of the school bus*

The left plane/rear aspect of the school bus's sidewall intruded as a result of the impact (Figures 16 and 17). The intrusion began behind row 6 between the G-pillar and the H-pillar. The sidewall intrusion measured 26 cm (10.3 in), 51 cm (20.0 in), 36 cm (14.3 in), and 6 cm (2.3 in) in rows 7 through 10, respectively. There was no measureable intrusion at row 11. The right sidewall was bowed out at rows 8 and 9 approximately 18 cm (7.1 in). The impact force buckled the floor and caused it to intrude vertically in rows 8 through 10. The magnitude of the intrusion measured 30 cm (11.8 in) at row 8, 15 cm (5.9 in) at row 9, and 7 cm (2.8 in) at row 10.

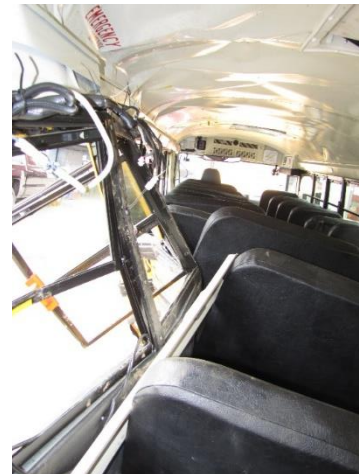
*Figure 17. Forward-looking view along the left interior wall of the bus*

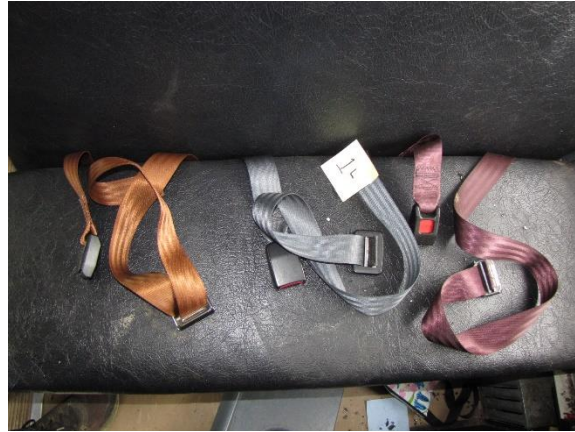
The SCI investigators inspected all 54 lap belts in the school bus. There was no typical occupant loading evidence to any of the belt systems. This typical evidence can include gathering of the webbing in the latch plate, frictional abrasions on the webbing from interaction with the latch plate, clothing fabric transfers, scuff marks on the webbing, or waffling/cupping of the webbing from occupant engagement. At the inspection, it was observed that 18 latch plates of the 54 seat belts were adjusted at the end [or in 7 cm (2.8 in) of the end] of the webbing (Figure 18). Due to

*Figure 18. Observed condition and adjustment of the seat belts at row 1 left seat*

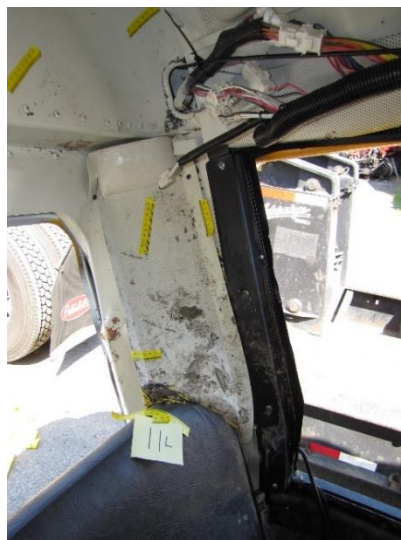
Figure 19. Blood and hair evidence observed at the left M-pillar of the school bus

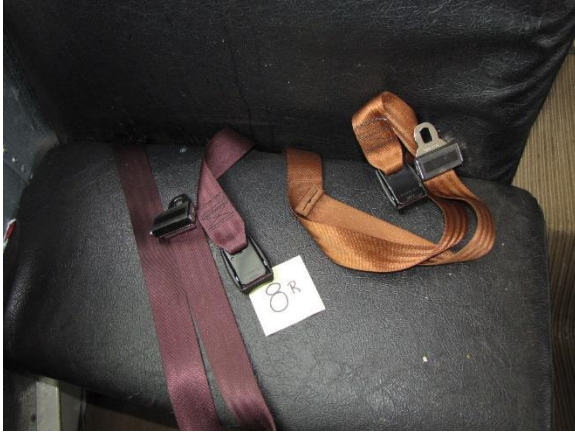
The police report stated that this female passenger was seated in the right-side, 8th-row window seat. The abrasions and contusion to her lower extremities suggest that the seat belt may have been in use. However, at the inspection, the lap belt for this position was found unbuckled, with the latch plate at the end of the webbing (Figure 20). If this seat belt had been in use, the observed position indicated that the seat belt would have been worn extremely loose around her pelvis.

Figure 20. Observed condition of the row 8 right seat belts

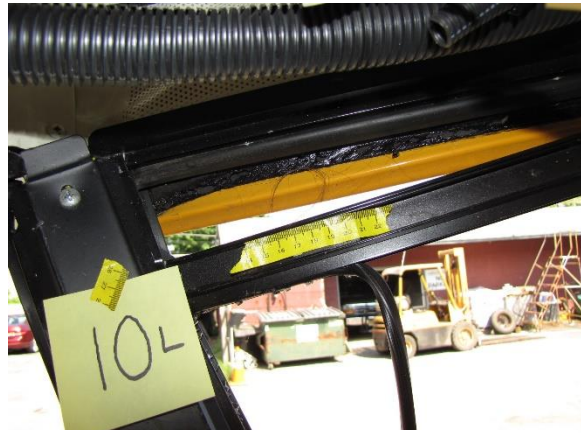
Figure 21. Hair observed at the junction of the left upper window and side rail at row 10

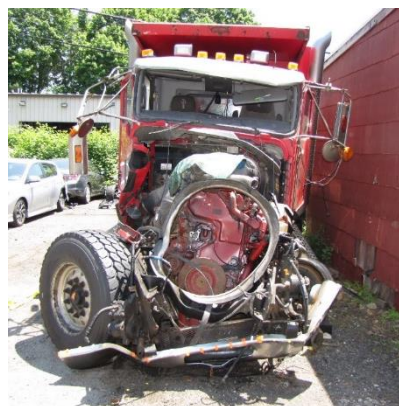
Figure 23. Front view showing the impact damage of the Kenworth

The exterior damage to the Kenworth consisted of front plane deformation consistent with the school bus impact (Event 1) and left plane damage associated with its contact with the left guardrail (Event 4) as it traveled to final rest. The front direct contact damage (Figure 23) extended laterally across the truck's entire 244 cm (96.1 in) end width and vertically 267 cm (105.1 in) to the windshield header. Its impact and interaction with the bus fractured the fiberglass hood and deformed the steel bumper rearward and down. Deformation was measured at the forward end of the truck frame rails and along the steel bumper (as a reference). The longitudinal deformation of the left and right frame rails measured 17 cm (6.7 in) and 29 cm (11.4 in), respectively. The radiator had separated during the impact and was missing. The truck's engine was displaced rearward roughly 61 cm (24.0 in) and had intruded into the center and right aspects of the day cab. The left front tire debeaded and separated from the rim. This axle position was displaced rearward by the impact force, which also caused a separation of the steering shaft. The left front wheel rim contacted the fuel tank mounted below the left door into the cab. The Truck Deformation Classification assigned to this damage pattern was 12FDAW6.

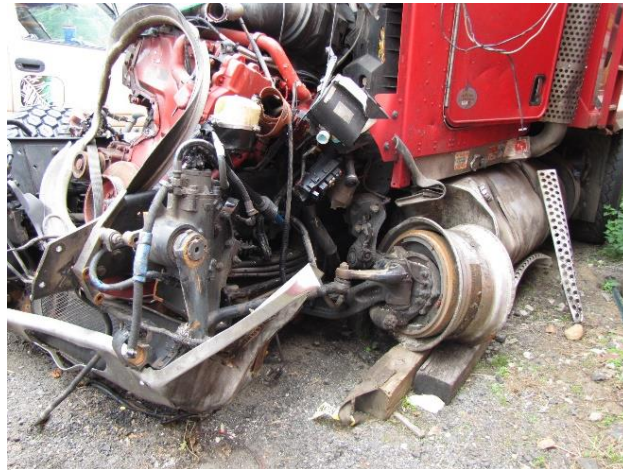
The extent of left plane damage (Figure 24) and its height were consistent with the secondary contact to the guardrail as the Kenworth traveled to its uncontrolled final rest. Swiping contact, abrasions, and sheet metal snagging along the left plane were noted over an approximately 439 cm (173 in) length. The tag axle was displaced 8 cm (3.1 in) rearward from the contact. The Truck Deformation Classification assigned to this damage pattern was 12LDES9.

*Figure 24. View showing the left plane damage of the Kenworth that extended rearward to the tag axle*
