DOT HS 813 278

**Special Crash Investigations:
On-Site Seat Belt Separation Crash
Investigation;
Vehicle: 2011 GMC Terrain;
Location: Florida;
Crash Date: June 2020**

Special Crash Investigations
On-Site Seat Belt Separation Crash Investigation
Office of Defects Investigation
Case Number: CR20025
Vehicle: 2011 GMC Terrain
Location: Florida
Crash Date: June 2020

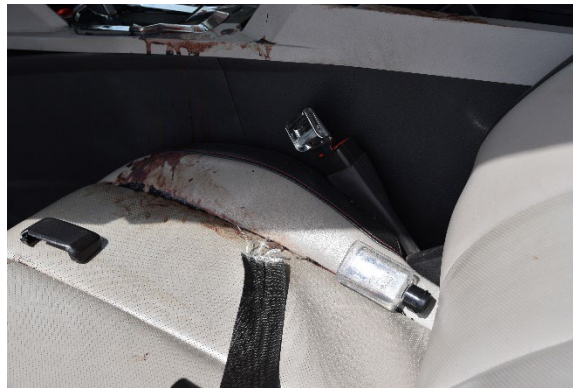
This report documents the offset frontal crash of a 2011 GMC Terrain SUV and the shear/separation of the driver's seat belt webbing at the belt path of the latch plate (Figure 1). The GMC was involved in a head-on crash with a 2011 Subaru Forrester. A belted 41-year-old male drove the GMC at the time of the crash, which occurred when the Subaru, driven by a belted 39-year-old female and occupied by a belted 9-year-old female second-row right passenger, crossed over the centerline of a two-lane roadway. The front of the GMC struck the front of the Subaru head-on. The GMC rotated counterclockwise and the Subaru rotated clockwise, with both vehicles coming to final rest blocking the roadway. The driver of the GMC and the driver of the Subaru both sustained police-reported non-incapacitating (B-level) injuries in the crash and were transported to a local hospital for treatment. The 9-year-old female second-row occupant of the Subaru was also transported by ambulance to a local hospital, where she was pronounced deceased.

Figure 1. View of the buckled latch plate and portion of the separated webbing of the GMC driver's seat belt system (image provided to NHTSA by the investigating law enforcement agency)

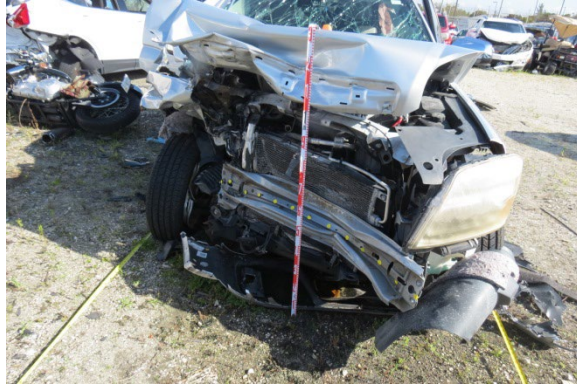
The GMC sustained severe frontal damage from its impact sequence with the Subaru. The direct contact damage began 26 cm (10.2 in) left of the vehicle's centerline and extended 112 cm (44.1 in) along the front plane to the right corner. The offset-right engagement produced an angular damage pattern to the front plane (Figure 7) of the GMC, resulting in a combined induced and direct damage length of 97 cm (38.2 in), measured across the front reference line. Maximum crush was 56 cm (22.0 in) located 35 cm (13.8 in) right of the centerline (Figure 8). Components damaged by the crash involved the front bumper fascia, bumper beam, the right frame rail, grille, headlamp assemblies, hood, right front fender, windshield, leading edge of the right front door, AC condenser, radiator, radiator support, and rearward displacement of the drivetrain. The right wheelbase was reduced in length by 28 cm (11.0 in). Due to wheelbase reduction, the right front tire was compressed against the aft aspect of the wheel opening and was aired out and restricted. A crush profile was documented at the level of the bumper beam and was as follows: C1 = 0 cm, C2 = 11 cm (4.3 in), C3 = 29 cm (11.4 in), C4 = 40 cm (15.7 in), C5 = 46 cm (18.1 in), and C6 = 56 cm (22.0 in). The collision deformation classification for this damage was 01FZEW3.

Figure 7. Frontal damage to the GMC

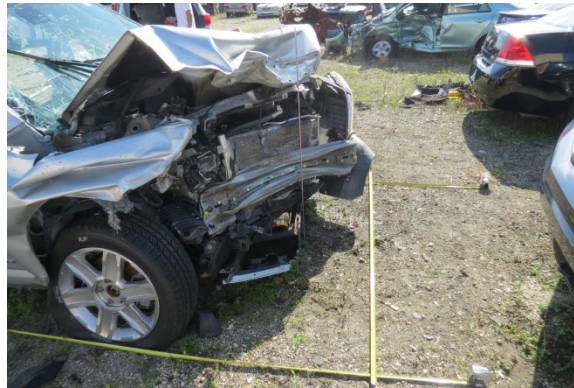
Figure 8. Right lateral view documenting the extent of crush to the GMC

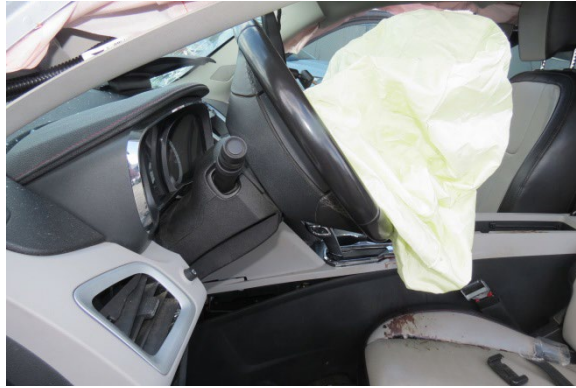
During the impact, the driver translated forward and loaded the deployed frontal air bag. His loading force was transmitted through the air bag and into the steering assembly. There was no deformation of the steering wheel rim; however, his loading force deformed the steering wheel mounting flange evidenced by a closure of the gap between the wheel and the column jacket at the 6 o'clock sector (Figure 9) and compressed the energy absorbing steering column, while displacing the column vertically upward.

Figure 9. Bending of the steering wheel flange from driver loading

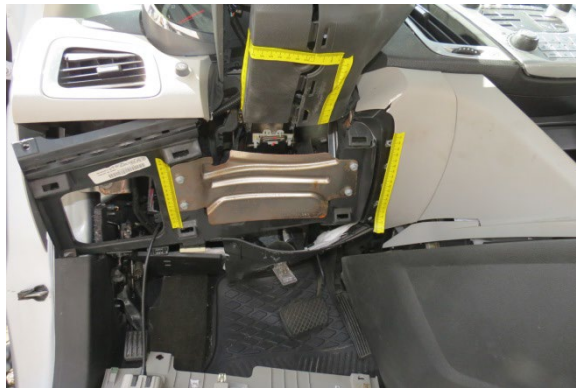
The driver's knees contacted, scuffed, and deformed the knee bolster and the bottom of the steering column cover. His left knee deformed the steel backer plate (Figure 10), left of the steering column.

Figure 10. Driver knee contact evidence and damage to the lower steering column cover and knee bolster backer panel

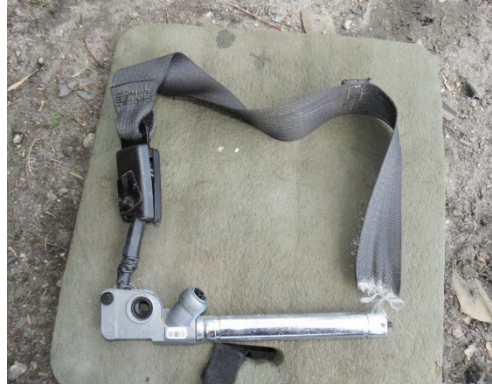
The left B-pillar had been removed during the extrication of the driver, and during its removal the driver's seat belt retractor at the base of the pillar was damaged (Figure 13). The separated webbing had spooled back into the retractor and could not be extended. The ending of this webbing matched the separated section attached to the lower anchor pretensioner.

Figure 11. Post-crash status of driver's seat lower anchor pretensioner, lap webbing fractured

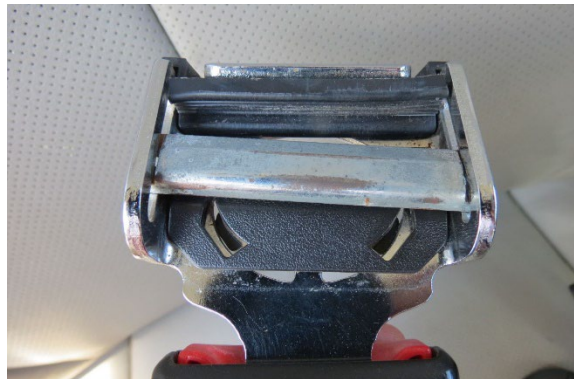
Figure 12. Close-up view of the GMC driver's lightweight locking latch plate

- The buckle stalk appeared undamaged and in working order.
- The buckle tongue did not appear mechanically damaged. Plastic parts of the tongue were broken and missing. The sliding pin portion of the tongue (transition point lap belt to shoulder belt) displayed mild corrosion and rust. The edge of the pin, interaction point with the belt, was shiny/polished.

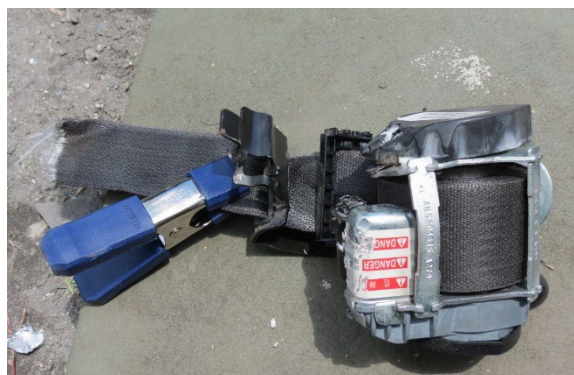
Figure 13. Close-up view of the driver's retractor removed from the GMC

- The anchor pretensioner activated and appears to have operated as designed.
- The retractor bracket was severely bent which would be expected in a high-energy event.

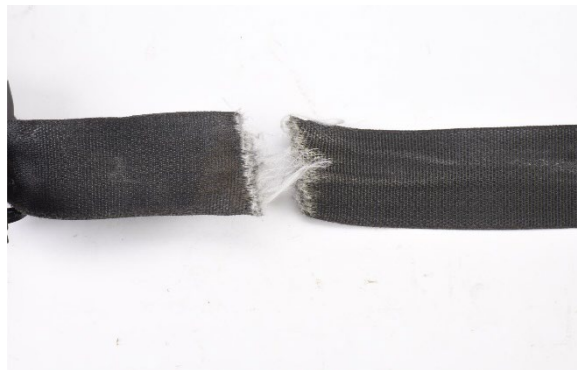
- The seat belt webbing was separated at the tongue. The webbing displayed signs of puckering and uneven separation of filaments indicating high stress.

- The belt webbing and tongue were examined at various magnifications using a Leica DVM 2500 digital microscope.
- Microscopic imaging: Magnified images of the filament ends of the belt were taken. Examination of the filament ends at the area of separation indicate probable overstress (tensile) fracture failure mode. The images represent a sampling of the filament ends examined in the separation area. Many of the filament ends reveal minor mushrooming, typically formed during a high-speed tensile fracture. The globular appearance of some filaments suggests melting of the material, which is also indicative of high-speed tensile fracture (Figure 14).

*Figure 14. Tensile fracture of the lap belt webbing.
Image taken during VRTC inspection*

The SCI investigation determined that the driver's seat belt separation occurred due to occupant loading during the impact. The maximum longitudinal velocity change recorded by the EDR was -56 km/h (-35 mph). Several undetermined factors may have contributed to the separation and remain unknown. These factors include seat belt geometry and placement, pre-crash condition of the webbing, as well as the potential presence of stress concentrations in the area of separation and degradation of webbing due to age, heat, and exposure to the elements.

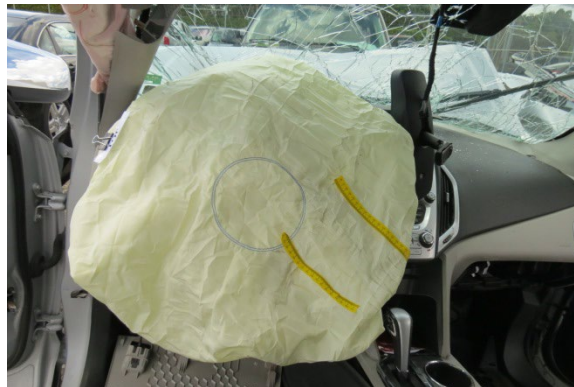
The driver's frontal air bag deployed through an I-configuration module cover from the center hub of the steering wheel (Figure 15). The module cover flaps were 13 cm (5.1 in) in overall width and 12 cm (4.7 in) in overall height. A scuffmark was present at the lower left corner of the cover flap that probably resulted from deployment. The air bag was tethered and had an overall diameter of 58 cm (22.8 in) as measured in its deflated state. The air bag was directly vented to the occupant compartment by two ports located on the bag side of the air bag at the 10 and 2 o'clock positions. Vertically oriented scuffing was noted to the lower aspect of the air bag that appeared to be related to air bag expansion during the deployment sequence. There was no residual evidence of occupant contact or damage to the air bag.

Figure 15. Deployed GMC driver's frontal air bag

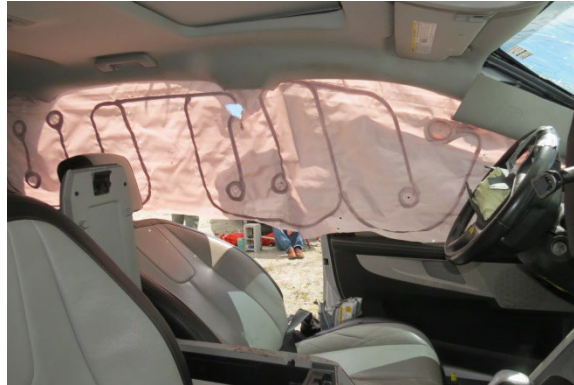
The roof side-rail mounted IC air bags (Figure 16) deployed through the separation of the roof headliner from the side rail. The IC air bags were 206 cm (81.1) in overall length inclusive of a sail panel to fill the triangular void of the A-pillar and were 49 cm (19.3 in) in vertical height. The IC air bags provided a full coverage of the side glazing areas extending from the A-pillar to the D-pillar and below the level of the beltline. There was no driver contact evidence on the left IC air bag. A hole was documented to the left IC air bag that resulted from the post-crash

Figure 16. Deployed GMC left IC air bag

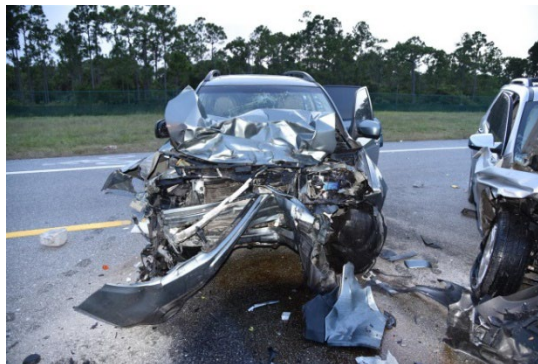
The on-scene police images (Figures 17 and 18) provided the basis for the estimated damage. The exterior damage to the Subaru was distributed across the front plane. It involved damage to the bumper system, the grille, the hood, both front fenders, the upper radiator support, and the driver train, as well as fracturing of the windshield. Maximum crush was an estimated 38-51 cm (15-20 in), located at the left front corner of the bumper beam. The estimated CDC for this damage pattern was 11FDEW3. The severity of the crash calculated by the “missing vehicle” algorithm of the WinSMASH was 45 km/h (28 mph). The longitudinal and lateral velocity changes were -42 km/h (-26 mph) and 15 km/h (9 mph). These results were considered borderline and low.

*Figure 17. Frontal damage to the Subaru
(image obtained from the police)*

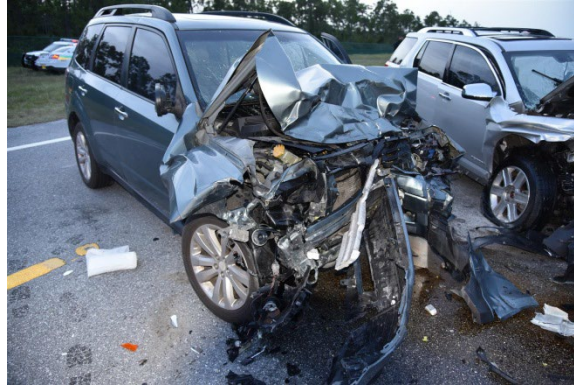
Figure 18. Front right three-quarter view of the damage to the Subaru (image obtained from the police)
