DOT HS 813 284

**Special Crash Investigations:  
On-Site School Bus Crash  
Investigation;  
Vehicle: 2013 Thomas Type D  
School Bus;  
Location: Tennessee;  
Crash Date: October 2020**

**Special Crash Investigations**  
**On-Site School Bus Crash Investigation**  
**Case Number: CR20032**  
**Vehicle: 2013 Thomas Type D School Bus**  
**Location: Tennessee**  
**Crash Date: October 2020**

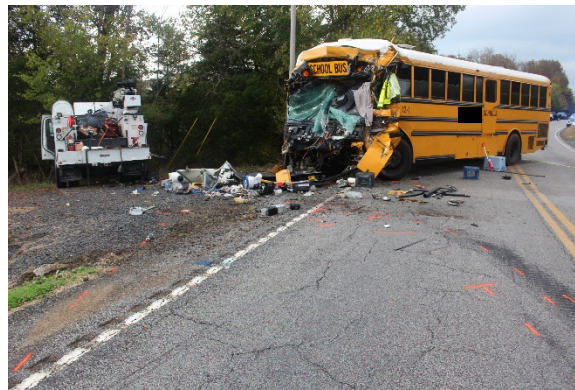
*Figure 1. On-scene police image of the school bus and utility truck at final rest*

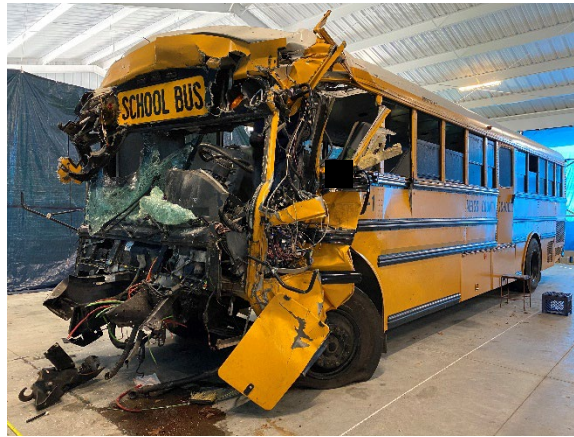
The entire front plane of the bus sustained direct damage during contact with the Freightliner (Figure 6). The direct damage extended across the entire 217 cm (85.4 in) front end-width and 323 cm (127 in) height. The crush measurements were documented along the front panel above the frame rails and the Field L was 217 cm (85.4 in). The residual crush values were C1 = 90 cm (35.4 in), C2 = 91 cm (35.8 in), C3 = 92 cm (36.2 in), C4 = 88 cm (34.6 in), C5 = 80 cm (31.5 in), and C6 = 86 cm (33.9 in). The maximum residual crush was 92 cm (36.2 in) and was located at the left front corner. The WinSMASH program could not be used to determine velocity change because both vehicles involved in this crash were out of scope for the program. The truck deformation classification (TDC) for this impact was 11FDAW9 (340 degrees).

*Figure 6. Front plane damage of the bus*

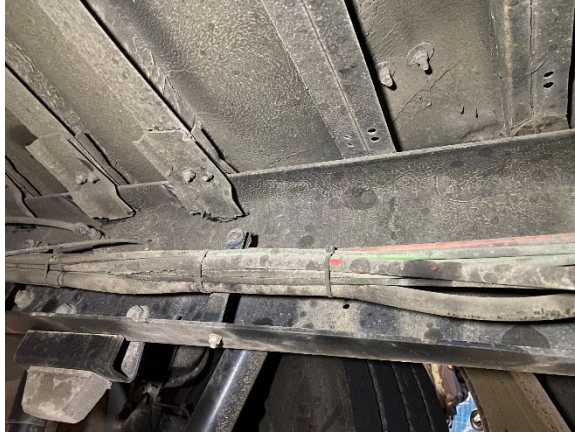
Figure 7. Right frame rail at RF wheel, ribs with and without flanges

During the inspection, it was noted that the first 12 ribs experienced between 1 cm (0.4 in) and 10 cm (3.9 in) of lateral shift to the right. The first 17 ribs also experienced between 0.5 cm (0.25 in) and 12 cm (4.7 in) of shift upward (see Figure 7).

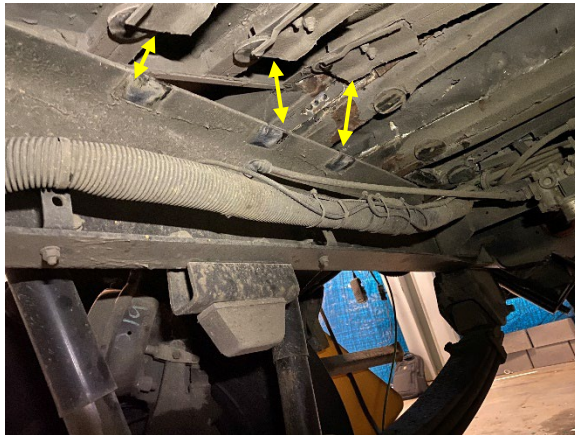
Figure 8. Left frame rail at LF wheel (note rib/flange lateral and vertical displacement and separation)

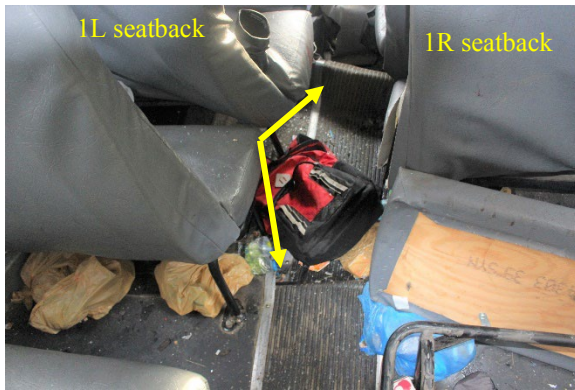
Figure 9. On-scene police image showing lateral lines of floor buckling at driver's seat and second row

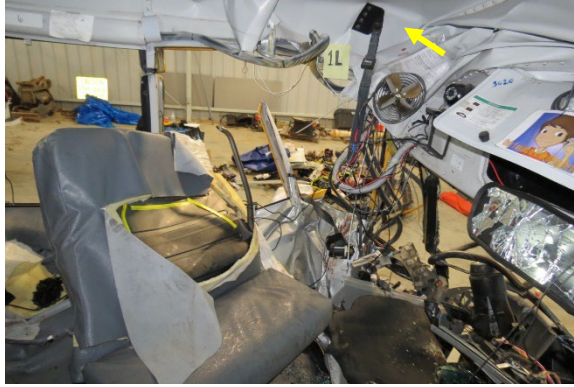
The front of the bus sustained severe intrusion damage (Figure 11) from the impact with the Freightliner. Figure 12 is a right-looking image of the driver's area in an exemplar bus for comparison. Table 1 presents the intruded component, location, magnitude of intrusion, and direction of intrusion.

Figure 11. Intrusion to the driver area and the first row (note the proximity of bulkhead to the shoulder belt D-ring anchor compared to the exemplary in Figure 12)

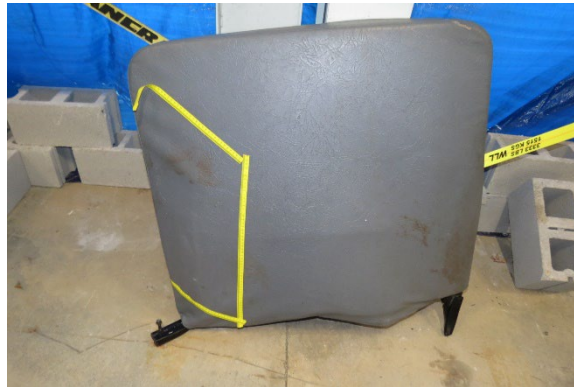
She likely struck the left edge of the padded partition (Figure 13) and the left sidewall with her head. At final rest, she was entrapped between the partition and the left sidewall.

*Figure 13. Padded partition between the driver's seatback and the first row, left seat*

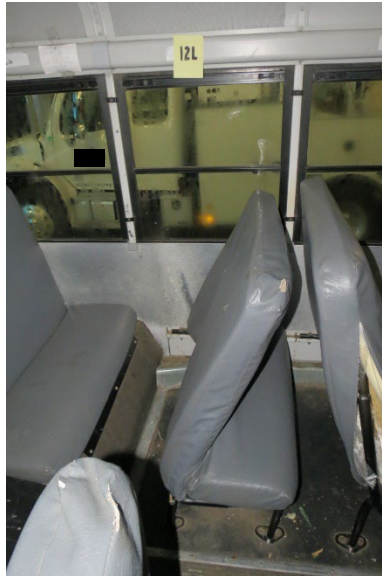
All of the bench seat anchors remained secured to the floor. Many of the seatbacks were deformed in a forward direction as a result of occupant loading (Figure 14). Ten of the seat cushions separated from their rear bracket attachments (Figure 15).

*Figure 14. Damage to row 12 left seatback from row 13 left occupant contacts*

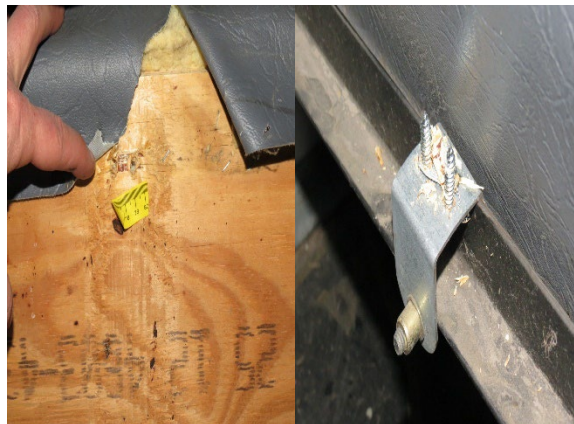
*Figure 15. Holes (L) on the bottom of the seat cushion that tore away from the bracket (R)*

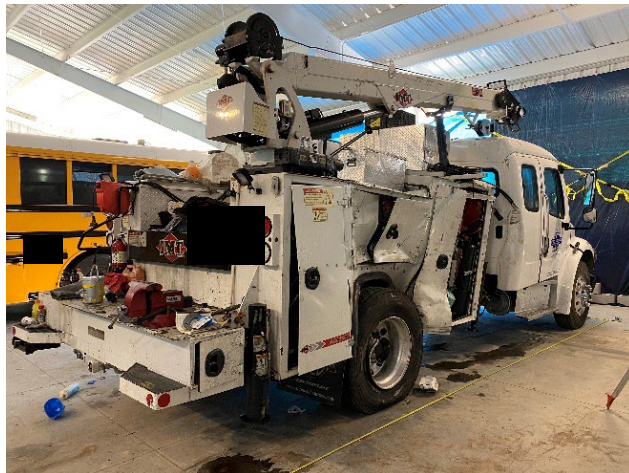
The Freightliner sustained direct contact to the right plane during the impact with the bus (Event 2, Figure 16). The right cargo box, rear wheel, crane, and back right corner of the cab were directly damaged. The direct damage began 63 cm (24.8 in) behind the right rear axle and extended 301 cm (118.5 in) forward. The WinSMASH program could not be used on this to determine velocity change because both vehicles are out of scope for the program. The TDC for this event was 02RZAWB.

Figure 16. The Freightliner, right plane damage (rear half)
