DOT HS 813 287

**Special Crash Investigations:
On-Site Reported Air Bag Non-
Deployment Crash Investigation;
Vehicle: 2007 Volkswagen GTI;
Location: Florida;
Crash Date: March 2017**

Special Crash Investigations
On-Site Reported Air Bag Non-Deployment Crash Investigation
Office of Defects Investigation
Case Number: CR17017
Vehicle: 2007 Volkswagen GTI
Location: Florida
Crash Date: March 2017

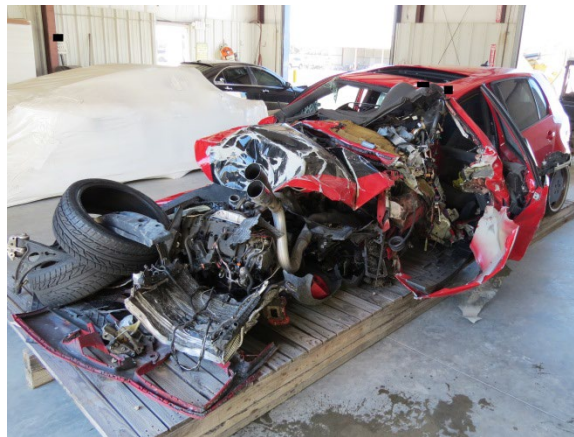
Figure 1. Left-front oblique view of the 2007 Volkswagen GTI at the time of the SCI vehicle inspection

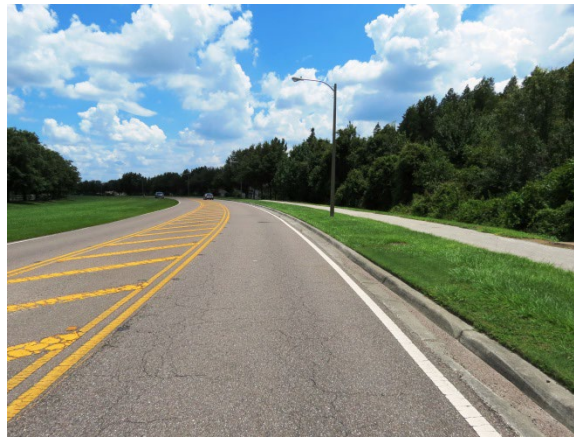
Figure 2. Southbound view of the Volkswagen's pre-crash travel trajectory

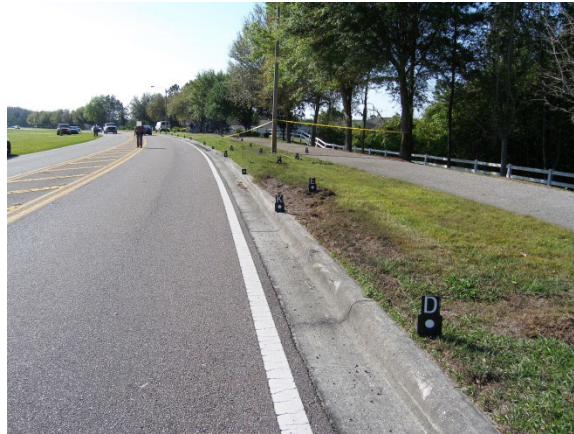
Figure 3. Location of the Volkswagen's roadside departure and first crash events (on-scene image obtained from the investigating law enforcement agency)

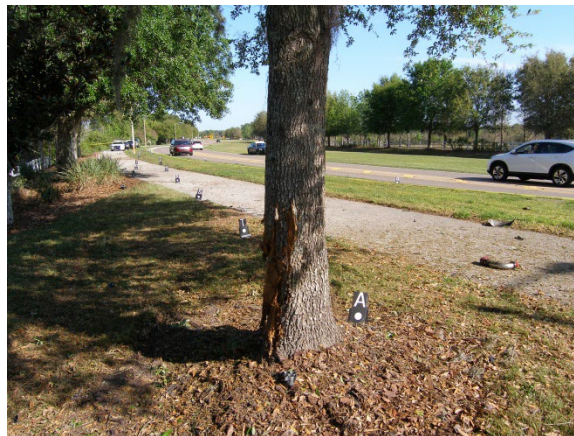
Figure 4. North-facing lookback view of the large-diameter tree along the vehicle's crash trajectory travel path (on-scene image obtained from the investigating law enforcement agency)

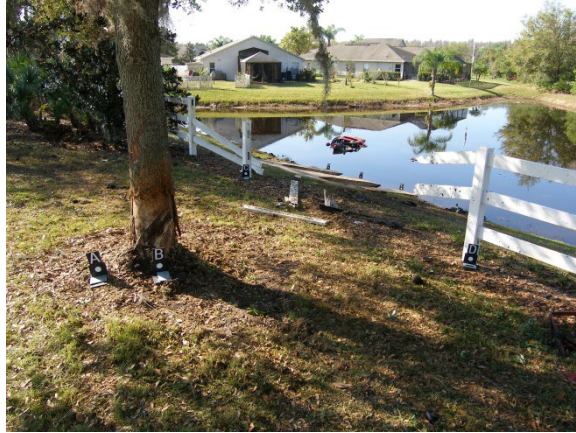
Following impact with the large-diameter tree, the Volkswagen rotated counterclockwise and was redirected to the west. The fifth impact event occurred as the vehicle's right and back planes contacted and displaced sections of a white vinyl fence (Event 5). Due to the slope of the roadside toward a drainage pond, the Volkswagen traversed backward along the downslope. Its undercarriage overrode the concrete end of a drainage culvert system (Event 6) that served the pond. This impact did not alter the vehicle's trajectory or induce occupant injury. The Volkswagen continued rearward and into the drainage basin, where it came to rest fully submerged in the water (Figure 5).

Figure 5. Southwest-facing view of the large-diameter tree, white vinyl fence, and concrete drainage culvert, with the vehicle at final rest in the pond (on-scene image obtained from the investigating law enforcement agency)

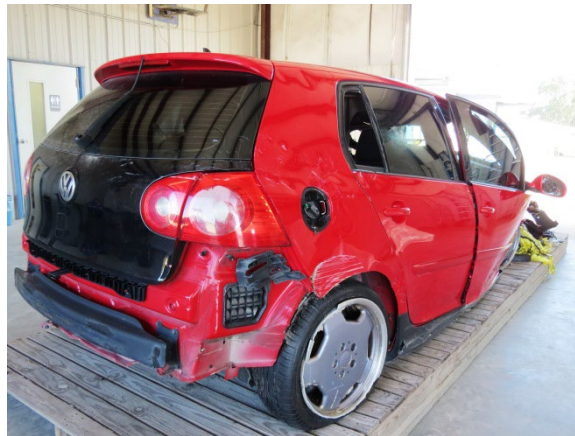
Figure 8. Right-rear oblique view of the Volkswagen's Event 3 damage, overlapped by damage from Event 5

Minor damage was visible to the rear aspect of the Volkswagen's right plane from the sideswiping impact with the concrete utility pole (Event 3). This damage was overlapped by damage from the impact with the white vinyl fencing (Event 5). However, the distinct differences in the type of the deformation patterns from these events made it possible to distinguish the damage attributable to each specific event. Associated with the sideswipe of the concrete utility pole was minor lateral deformation of the right quarter panel, with lengthy longitudinal abrasions that extended across the right quarter panel. The most pronounced deformation and damage was located on the fender flare directly above the right rear axle (Figure 8). The CDC assigned for the Event 3 damage was 12RBES1. No WinSMASH calculations could be computed due to the lack of residual deformation and sideswiping nature of the crash forces that were beyond the scope of the model's capabilities.

Damage to the Volkswagen from the Event 5 impact with the vinyl fence was located at the right rear corner of the vehicle and partially overlapped the Event 3 damage pattern. However, the damage from the white vinyl fence was more angular to the vehicle's right plane, and therefore was distinguishable from the Event 3 damage profile. The white fence left multiple small dents in the right quarter panel/C-pillar area of the vehicle that were highlighted with white transfer onto the vehicle's red-painted surface. There were also spots of white vinyl transfer on the backlight of the Volkswagen's hatch, as well as on the red polymer surface of the right taillight assembly. The minor severity of the damage profile did not include a measurable deformation profile. However, distribution of the damage above the beltline increased the extent of the damage. The CDC assigned to the Volkswagen for the vinyl fence impact was 05RBAE2. No WinSMASH calculations could be computed for this event due to the lack of deformation and yielded status of the struck object, which were beyond the scope of the model.

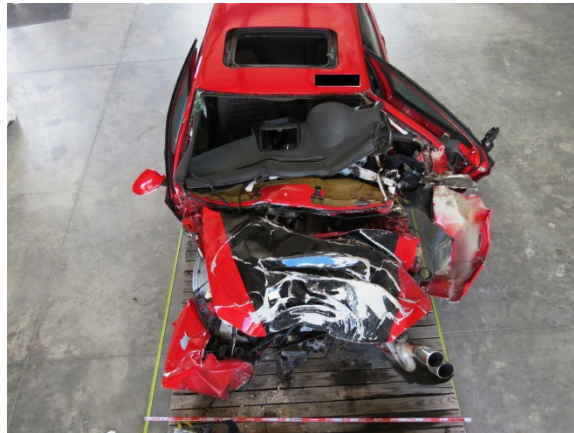
Catastrophic damage occurred to the forward half of the vehicle relative to the frontal impact with the large-diameter tree (Event 4). The front bumper fascia, bumper filler, grille, headlights, and entire bumper beam were completely separated from the vehicle. Underhood components, including the entire engine and transmission, had sheared from their mounts and were completely separated during the impact. The hood was separated on the left side, with a distinct U-shaped pattern of deformation on its leading aspect. The front plane damage included the collapse of the left frame rail, which was wrapped outward and rearward with the end of the frame rail displaced to the area of the left sill/left lower A-pillar. The structure of the Volkswagen's left plane was deformed/displaced outward from the front plane to the left B-pillar, with separation of the left front fender, left sill, left A-pillar, and left front door.

Figure 9. Overhead view of the damaged Volkswagen at the time of the SCI inspection

Figure 9 is an overhead perspective of the Volkswagen showing the separation of front components, structural overload, and the outward separation of the forward left plane. Figure 10 shows a left lateral view of the deformation severity and extent. The CDC assigned to the Volkswagen for the Event 4 impact with the large-diameter tree was 12FDEW5.

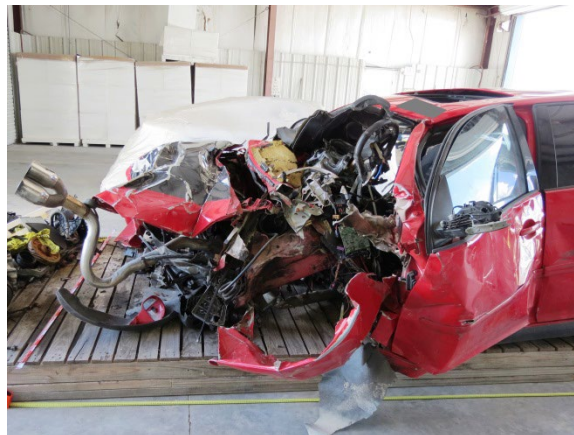
Figure 10. Left-lateral view of the damaged Volkswagen at the time of the SCI inspection

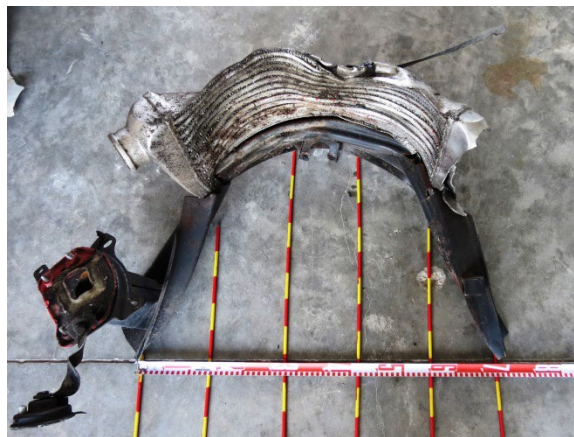
deformation profile. The separated bumper beam of the Volkswagen was located during the vehicle inspection process, and it was observed that the deformed beam had a distinct U-shaped deformation pattern that matched the approximate dimensional width of the large-diameter tree it struck. In its deformed state, the overall width of the bumper beam measured 68 cm (26.8 in). Although not representative of the total crush to the vehicle, a profile of the separated bumper beam was documented using calibrated measuring tape and rods (Figure 11) to provide at least some representation of the deformation to the Volkswagen and facilitate an estimation of the absolute minimum delta V for analysis purposes. This profile produced the following measurements: C1 = 0 cm (0 in), C2 = 21 cm (8.3 in), C3 = 40 cm (15.7 in), C4 = 40 cm (15.7 in), C5 = 20 cm (7.9 in), and C6 = 0 cm (0 in). Maximum crush was located near the bumper beam's centerline and measured 42 cm (16.5 in) in magnitude. Again, these measurements were substantially less than and not representative of the actual deformation to the vehicle, but they provided a minimum degree of estimation/analysis. WinSMASH calculations using the bumper beam crush alone produced a calculated minimum delta V of 39 km/h (24 mph). This value is a substantial underrepresentation of the actual delta V of tree impact (Event 4), provided for informational purposes only and not to be used as a reliable source of crash severity in this crash.

Figure 11. Overhead view of the deformed and separated bumper beam, with the crush measurement gauge

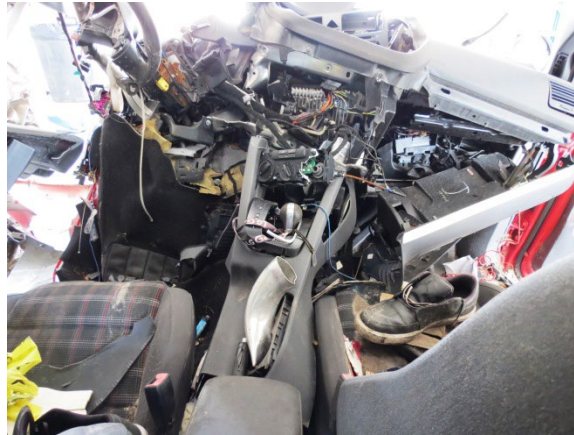
instrument panel. Forward of the driver's space, the instrument panel was flattened forward and displaced upward. The steering wheel was collapsed, and the column was displaced vertically. It was evident that the driver had experienced severe loading of the steering wheel, steering column, and instrument panel during the crash sequence. Figure 12 shows a forward-facing view of the instrument panel from the second-row center perspective. Figure 13 shows an overhead lateral perspective of the collapsed steering wheel and displaced column.

Figure 12. Forward-facing view of the Volkswagen's intruded and heavily damaged instrument panel

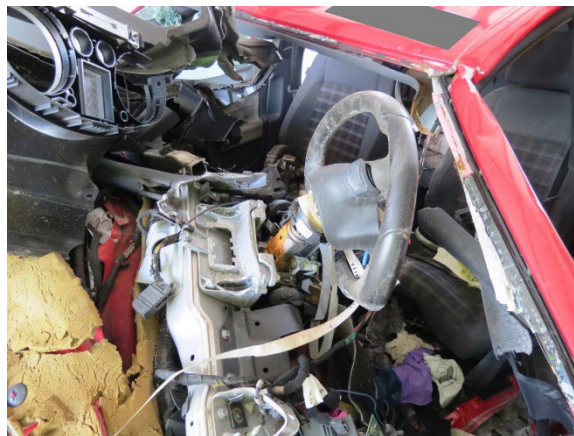
Figure 13. View of the Volkswagen's displaced and severely damaged steering column

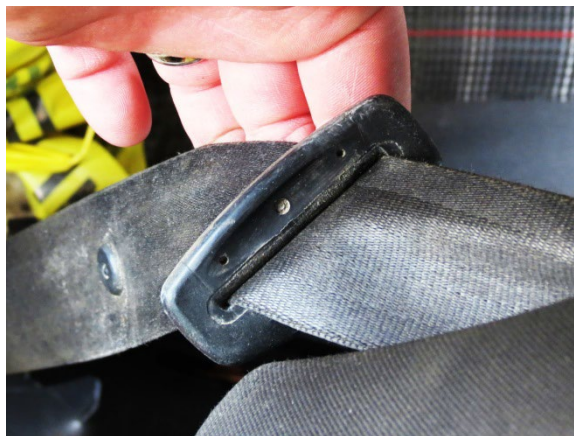
At the time of the SCI vehicle inspection, the driver's seat belt system was locked in position. In the absence of EDR data and an inability to disassemble the driver's retractor for inspection, it remains unknown if the driver's retractor was locked due to actuation of the pretensioner or from the engagement of the system's ELR mode. Much of the webbing had retracted into the pillar, with little slack remaining. The SCI investigator documented the exposed webbing and seat belt system, then attempted to spool the remainder of the webbing from the retractor. More webbing was fed into the retractor, but the retractor remained locked in position. The SCI investigator was unable to spool any additional webbing from the retractor, therefore unable to inspect the condition of the remaining webbing. However, there was evidence of heavy loading visible in the belt path of the latch plate (Figure 14). Based on the post-crash condition of the driver's seat belt system observed by the SCI investigator, it was apparent that the driver was belted at the time of the crash. This conclusion was supported by on-scene photographs obtained from the investigating law enforcement agency, which showed the upper portion of driver's body restrained by the shoulder portion of the buckled driver's seat belt system.

Figure 14. Heavy loading evidence visible in the belt path of the Volkswagen driver's seat belt latch plate

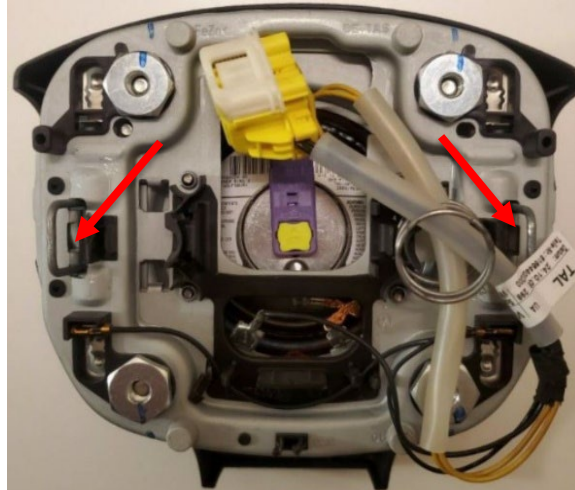
Figure 15. Rear view of an exemplar 2008 Volkswagen Golf driver air bag module, with the press-fit retainer clasps indicated by the red arrows

The design of the Volkswagen's driver air bag module consisted of a press-fit module retained by tension. There were two metallic, U-shaped hooks, one each at the 3 o'clock and 9 o'clock positions on the rear aspect of the driver's air bag module (Figure 15), which clasped onto the steering wheel hub when the module was pressed into position. The U-shaped clasps held the module in the hub using tensional and frictional forces; there were no hardware/fasteners. Because no mechanical fasteners were used in its design to physically secure the driver's air bag module in the steering wheel hub, removal of the module could be done using only a flathead screwdriver. The process¹ began by disconnecting the battery and adjusting the steering wheel to its highest and fully extended position, rotated 90 degrees counterclockwise. The screwdriver was then inserted into a hole on the rear of the wheel to a depth of approximately 8 mm (0.3 in) and rotated to unlock the right U-shaped hook. The wheel was then rotated 180-degrees clockwise, with the same process using the screwdriver repeated to disengage the left U-shaped hook. The entire air bag module could then be completely separated from the vehicle by disconnecting the wiring harnesses.

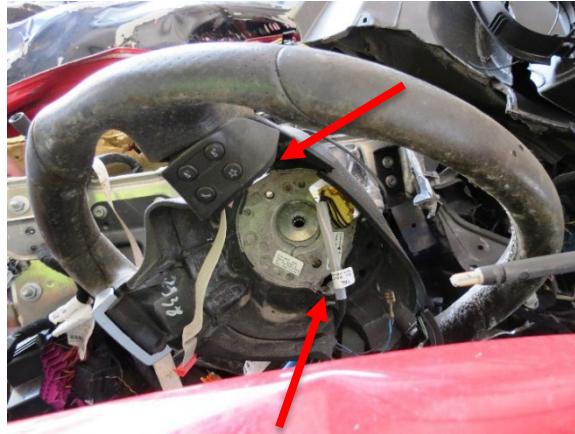
At the time of the SCI vehicle inspection, the steering wheel assembly was observed to be severely deformed, and the entire driver's frontal air bag assembly was missing from its mounted location. The wheel was collapsed circumferentially about the hub. The column was deformed vertically and laterally, and awkwardly protruded upward through the opening created by the missing windshield glazing (refer to Figure 13, page 13). The hub was fractured through its center aspect, as well as at both of the air bag module's press-fit anchor locations (Figure 16) and also around its outer circumference. Therefore, in this case, the severe compromise of the hub/assembly had the potential to release the tension on the U-shaped hooks, which could possibly release the air bag module from the hub and allow the entire air bag module to separate from the vehicle.

Figure 16. View of the Volkswagen's fractured steering wheel hub, with fractured clasp locations highlighted by red arrows

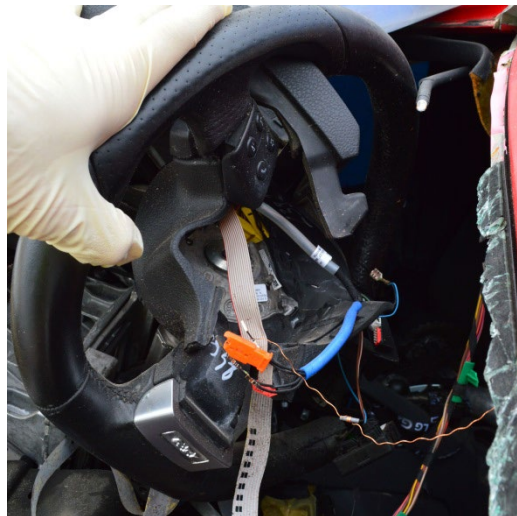
Figure 17. Law enforcement image of the steering column and damaged electrical wiring/connectors

Electrical wires, including those for the air bag module, were pulled apart from the hub and exposed. Several of the connectors and wires were broken and/or severed. One of the law enforcement images showed the severed/pulled electrical wires during their on-scene investigation of the crash (Figure 17). The vehicle history report had no indication of service, replacement, or alteration to the vehicle's supplemental restraint systems, and the vehicle was equipped with the OEM steering wheel/assembly. However, the driver's air bag module was missing from the steering wheel hub/assembly and was not with the vehicle at the time of the SCI inspection. Law enforcement documentation reported the observation that the driver's air bag module was missing from the vehicle and could not be located following recovery of the vehicle from the pond. No EDR data were available during the SCI vehicle inspection to confirm that the driver's retractor pretensioner and driver's frontal air bag were commanded to actuate/deploy relative to the crash. However, the SCI inspection of the vehicle concluded that none of the vehicle's remaining supplemental restraint systems actuated or deployed in the
